Re: Mold and Moisture Assessment
Former TGI Fridays Restaurant
45001 Schoenherr, Utica, MI 48315

**BASELINE MOLD ASSESSMENT
SAMPLE LOCATION PLAN**

Former TGI Fridays Restaurant
45001 Schoenherr, Utica, Michigan

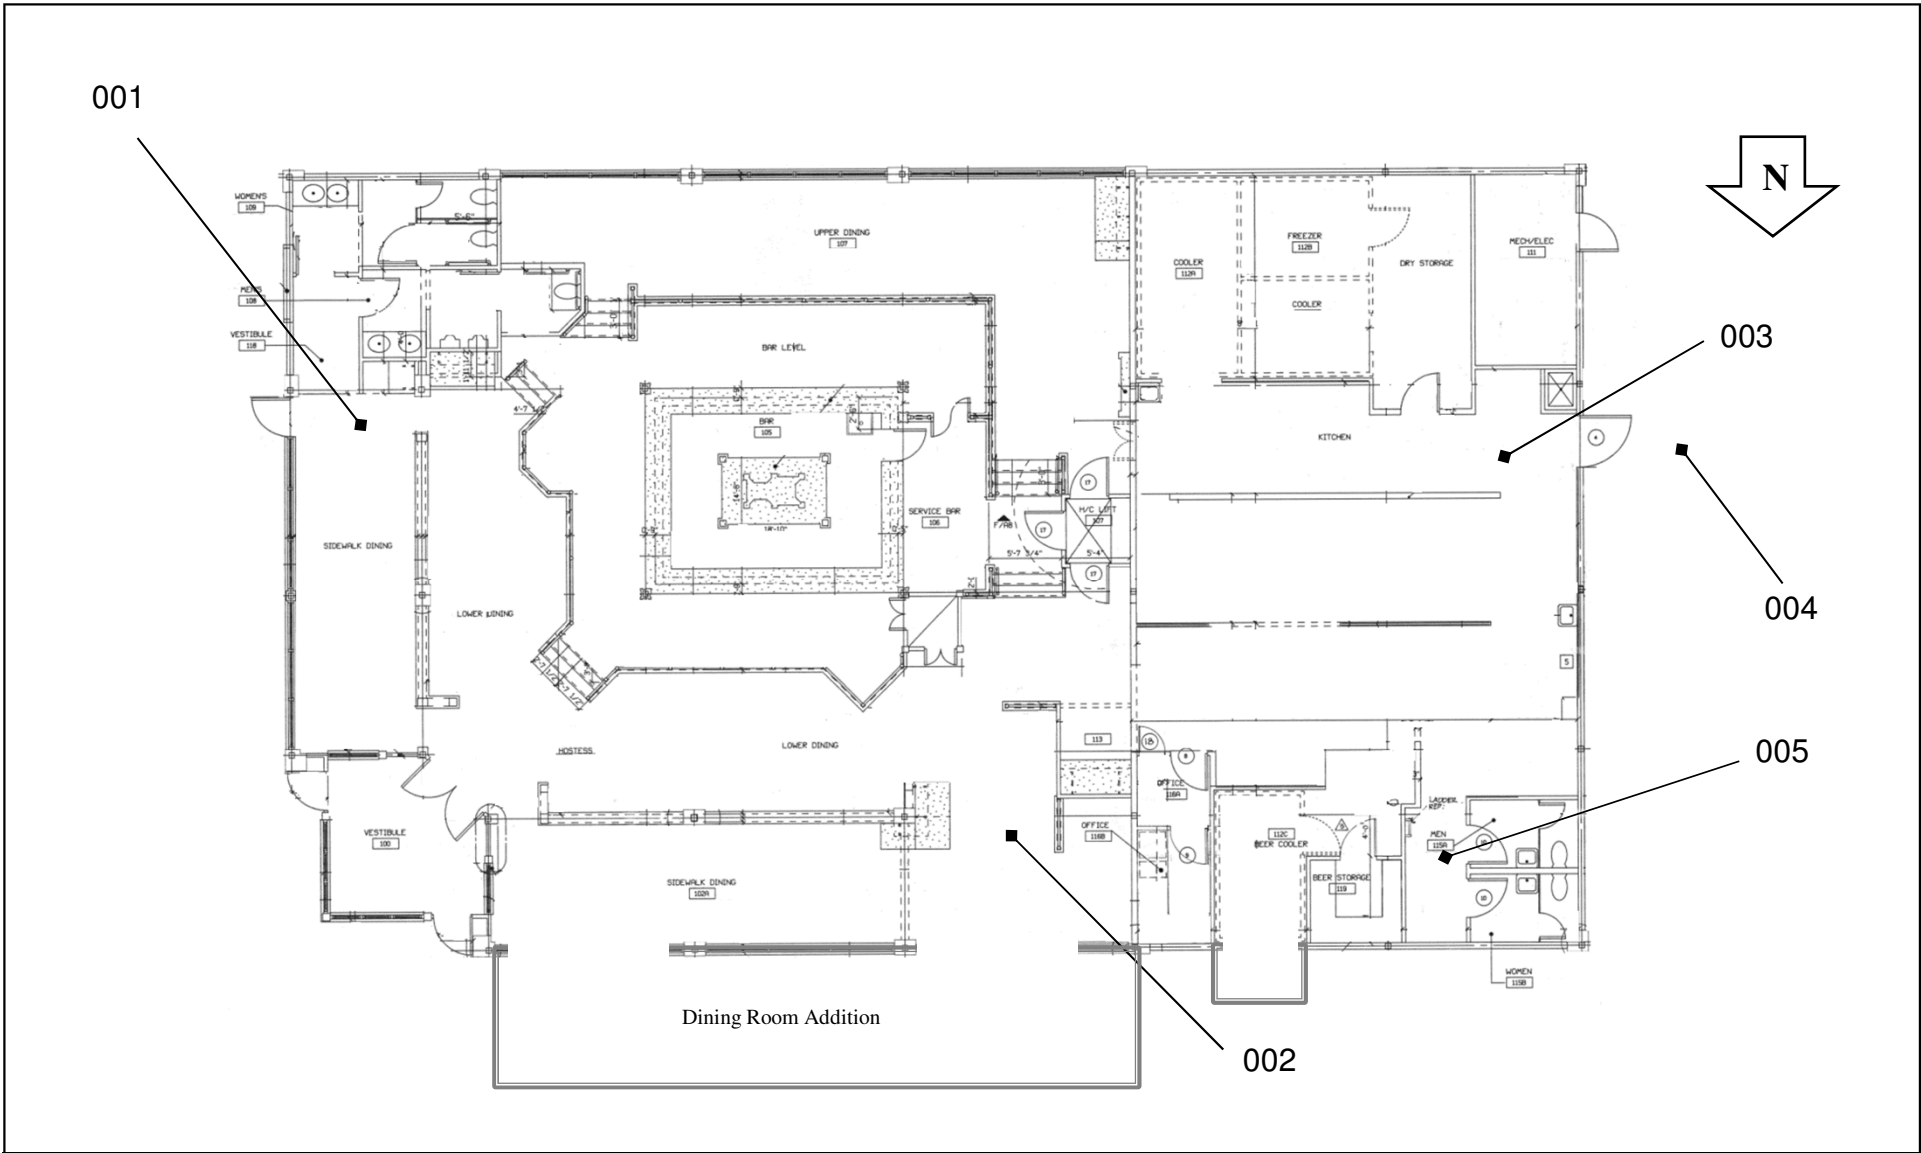
Attachment A
Sample Location Plan

Tri-Tech collected four mold spore air samples staggered throughout the building. In addition, an outdoor air reference sample was collected to assess potential outdoor air influences.
