Re: Pre-Renovation Asbestos Survey
Former TGI Fridays Restaurant
45001 Schoenherr, Utica, MI 48315

**ASBESTOS SURVEY
SAMPLE LOCATION PLAN**

Former TGI Fridays Restaurant
45001 Schoenherr, Utica, Michigan

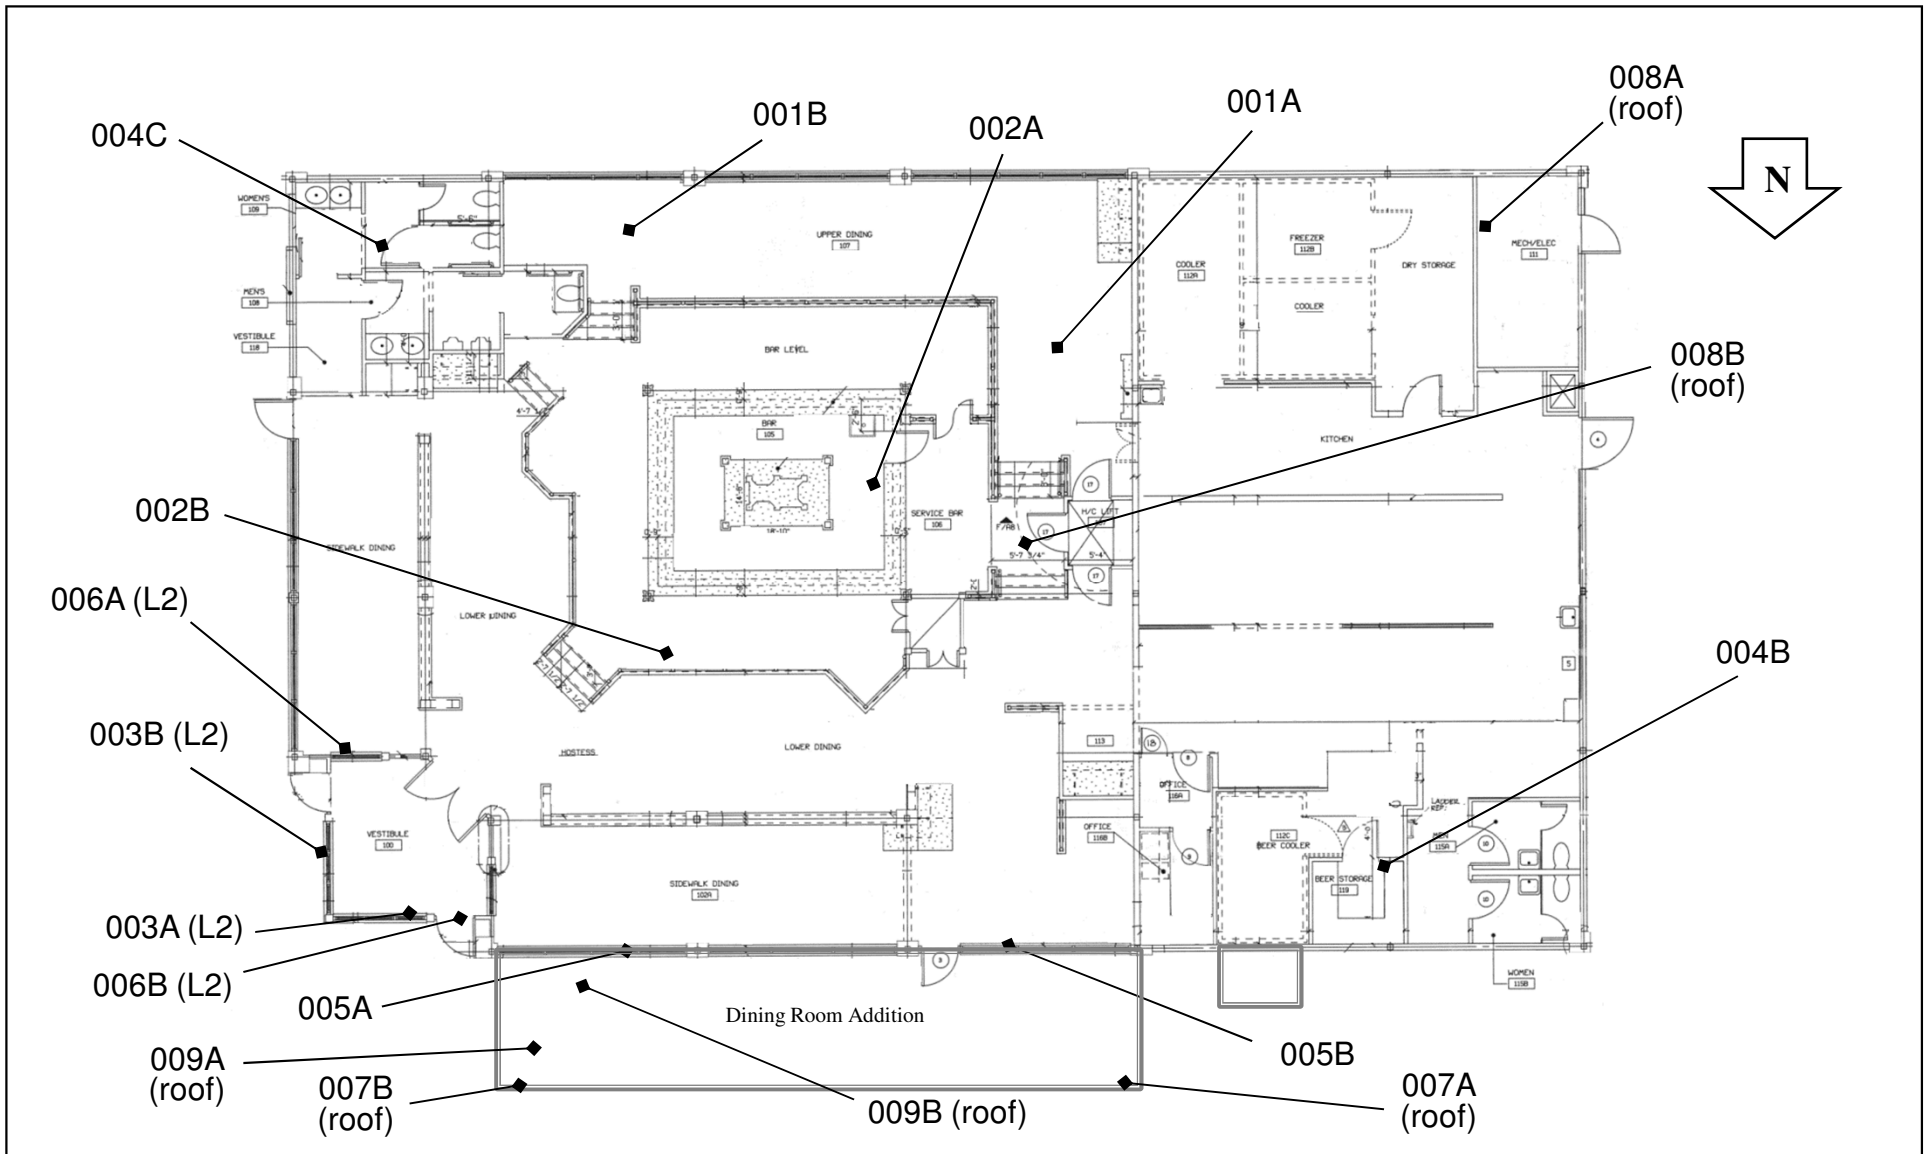
No asbestos-containing building materials were identified by this survey.
