# PROPERTY CONDITION REPORT

## ADA TIER III SURVEY

Project Number: ADA062121SmokeyBonesUticaMI

Inspection Address: 45001 Schoenherr Road, Utica, MI 48315. This is currently an abandoned TGI Friday restaurant facing north.

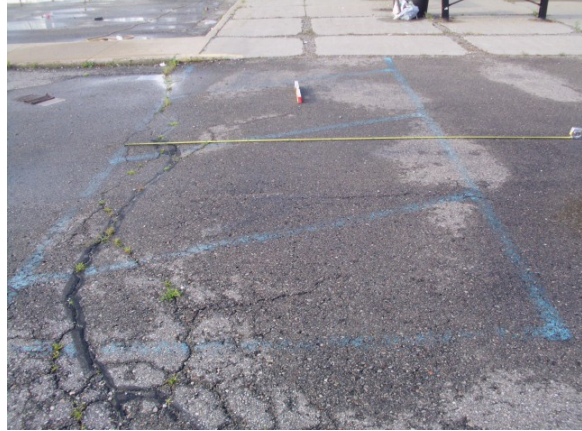
**Item 1. Discrepancies at the five ADA accessible parking spaces include poor striping/marketing for the parking spaces and access aisles, the access aisles do not have adequate width, the narrow aisles do not connect directly to an accessible route, depressions with excessive slopes and trapped standing water, cracks with excessive openings in the surface of the parking spaces and access aisles, no vertical signage to**

**identify the parking spaces, no wheel stops at any of the parking spaces near the exterior walkways.** The photo above shows the poor striping/marketing at one of the access aisles. All of these five accessible parking spaces and the access aisles have this discrepancy. In fact the entire parking lot has poor striping/marketing and significant damage to the surface. Part of the parking lot was blocked by the installation of a temporary tent shelter.

**RECOMMENDATION:** Re-design and resurface the existing accessible parking surfaces and access aisles to comply with the Standards. The parking spaces and access aisles should not have any slope exceeding 1:48, or 2.08%, in any direction. Repair the cracks and openings in the surface of the parking lot. Ensure that all access aisles adjoin an accessible route. Install vertical signage for each accessible parking space. Install wheel stops where parking spaces are adjacent to exterior accessible routes.

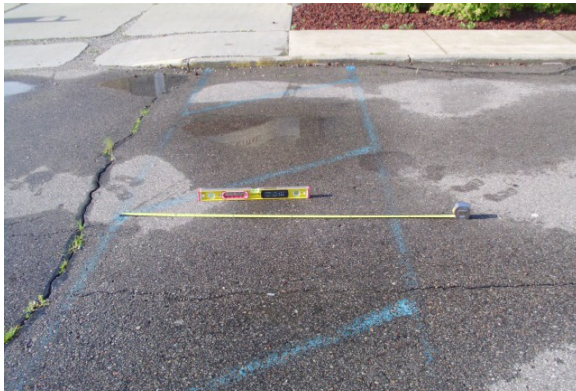
The two larger access aisles and the two smaller access aisles are too narrow in width. The larger access aisles should be at least 8 feet wide because the adjacent van-accessible parking spaces are slightly wider than 8 feet. The narrow access aisles should be at least 5 feet in width. The photo on the left shows one of the narrow access aisles.

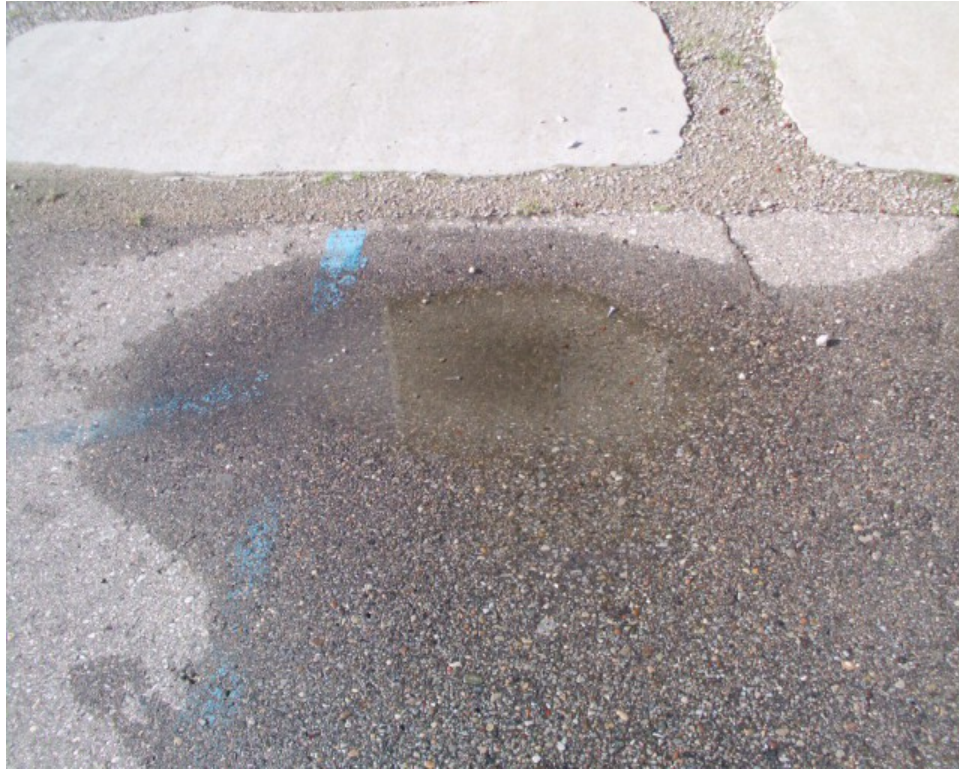
Depressions in the asphalt surface of the parking spaces were observed holding standing water and the slope of the depressions exceeds 1:48. The photo below is representative of these depressions that appear to be caused by the weight of parked vehicles.

2010 ADA Standard 502.4, [Parking Spaces] Floor or Ground Surfaces, states, "Parking spaces and access aisles serving them shall comply with [Standard] 302. Access aisles shall be at the same level as the parking spaces they serve. Changes in level are not permitted. EXCEPTION: Slopes not steeper than 1:48 [2.08%] shall be permitted."

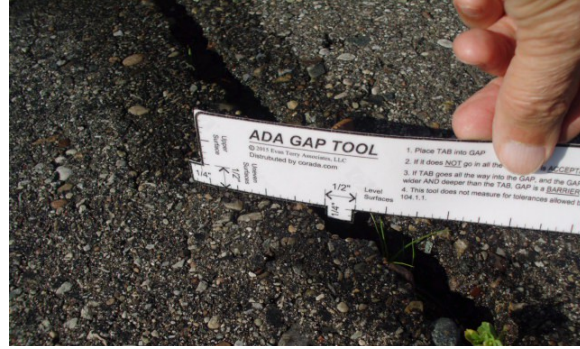
Cracks with excessive openings were observed in the surface of the accessible parking spaces and access aisles. The photo on the right is representative.

2010 ADA Standard 302.3, [Floor or Ground Surfaces] Openings, states, “Openings in floor or ground surfaces shall not allow passage of a sphere more than ½ inch (13 mm) diameter except as allowed in [Standards] 407.4.3, 409.4.3, 410.4, 810.5.3 and 810.10 [Not Applicable]. Elongated openings shall be placed so that the long dimension is perpendicular to the dominant direction of travel.” This Standard is designed for intentional openings such as a drainage grate; however, the ½ inch rule also applies to cracks in general.

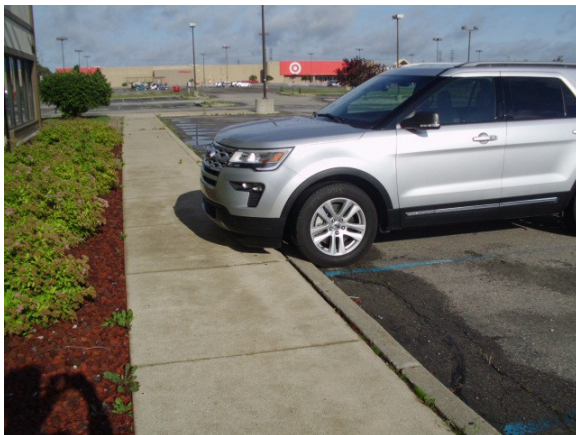
No wheel stops were observed at any of the parking spaces near the exterior walkways that are part of accessible routes. The photo on the left is representative.

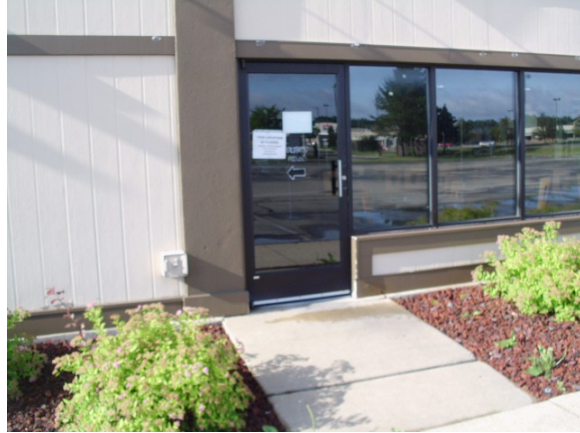
The photo on the left shows the gap between the two sections of the walkway (yellow arrow) and the excessive abrupt change of vertical elevation (red arrow). The excessive abrupt change of vertical elevation is a significant tripping hazard.

The gap between the two sections of the walkway can allow a wheelchair caster, crutch tips, cane tip, or shoe heels to enter the opening and cause an individual to fall. 2010 ADA Standard 302.3, [Floor or Ground Surfaces] Openings, states,

**RECOMMENDATION:** Rebuild this sloped walking surface to comply with the 2010 ADA Standards for either a walkway or ramp. Eliminate the gap between the two sections and the abrupt excessive change of vertical elevation at the adjacent east-west walkway. See Exterior Doors below for related comments about the exterior maneuvering space for this door.

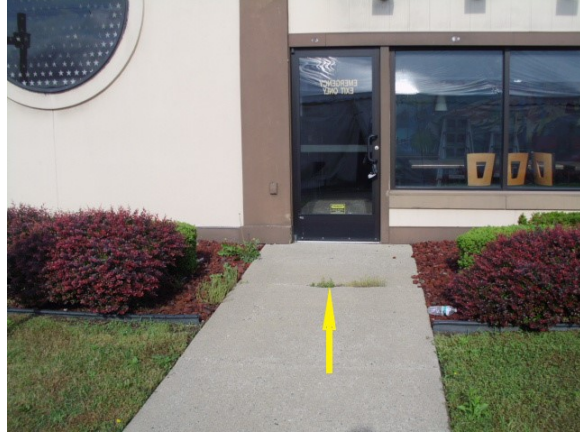
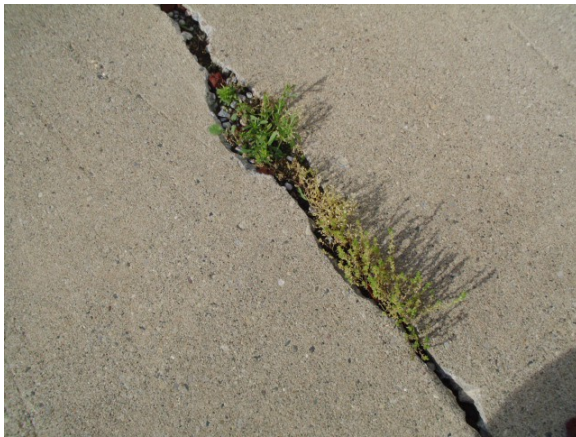
**Item 4. The exterior walking surface leading to the emergency exit on the east side of the facility has an excessive gap where the concrete has cracked. See the photo on the right.**

The photo on the left is a closeup of the crack that exceeds ½ inch along the run direction. This is a trip/fall hazard.

**RECOMMENDATION:** Rebuild this walking surface to comply with requirements for a walkway or ramp. See Exterior Doors below for related comments about the exterior maneuvering space for this door.

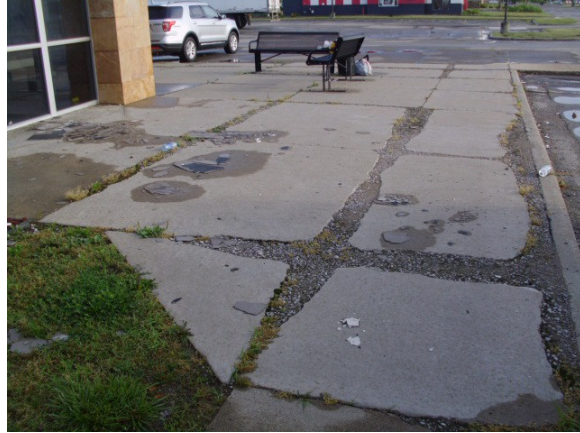
The photo on the left is a closeup example of these openings. This is a tripping hazard.

**RECOMMENDATION:** Consider rebuilding the entire patio surface or repairing the openings to create a patio walking surface that is stable, firm, slip resistant, and level with no excessive abrupt changes of elevation.

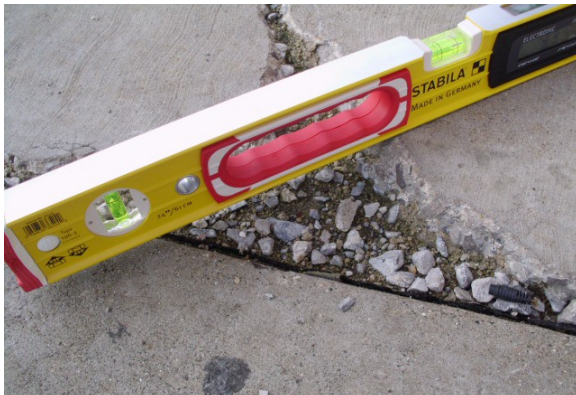
The photo on the right is another example of an opening and tripping hazard.

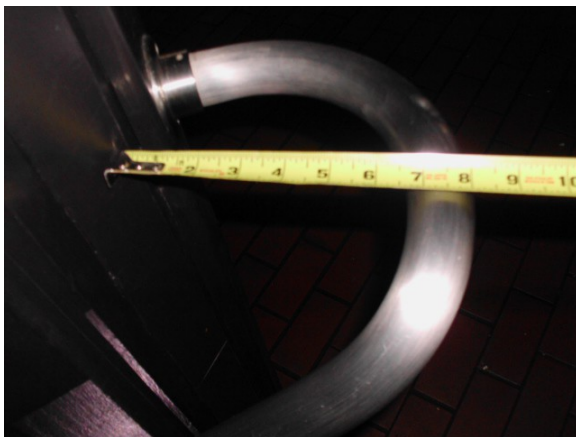
This handrail is more than 27 inches above the floor and protrudes more than 4.5 inches from the wall.

**RECOMMENDATION:** Replace this handrail installation with a model that does not exceed protrusion limits.

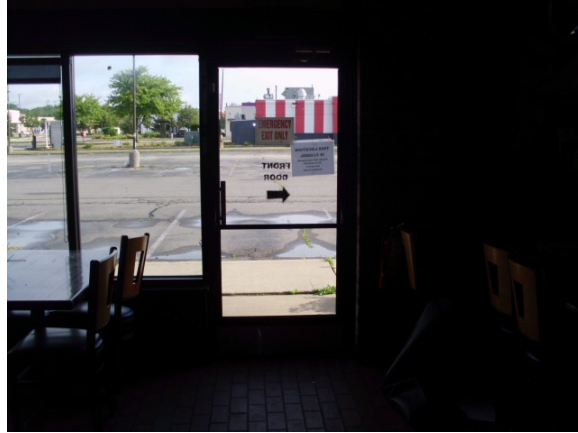
**Item 11. No interior signage was observed for the exit doors. Only limited compliant signage was observed inside the facility at the toilet rooms.** The photo on the right is the north side secondary door looking from the interior.

**RECOMMENDATION:** Install new signage required by the ADA.

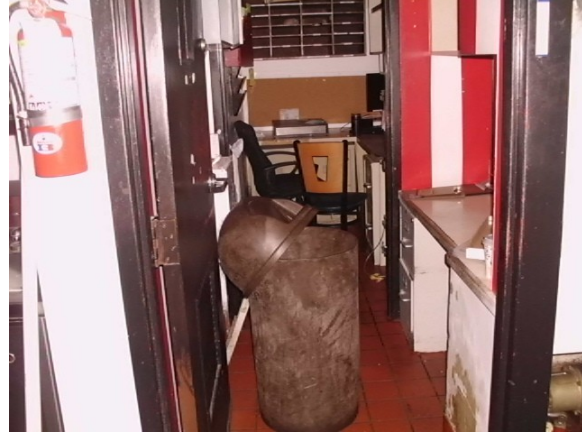
The photo on the left is where a wall mounted element and a stored ladder limits the width of the route to 32 inches or less to a desk on the opposite side of the route.

**RECOMMENDATION:** Alter the Manager's office to provide 36 inches of route width for most of the space. Door openings should be at least 32 inches wide.

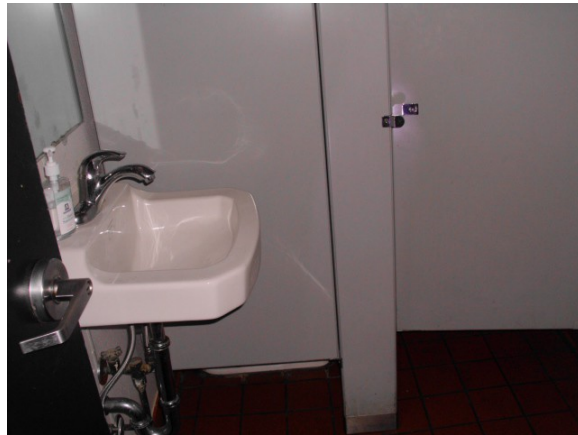
**Item 17. The partitions in these employee toilet rooms limit the stall space at the toilets to only approximately 36 inches in width. This is inadequate space for an accessible toilet stall [compartment] and for wheelchair transfer clearance at the toilet. The photo on the right is representative. The toilet is behind the partition.**

2010 ADA Standard 604.8.1.1, [Toilet Compartments, Wheelchair Accessible Compartments] Size, states, "Wheelchair accessible compartments [stalls] shall be 60 inches (1525 mm) wide minimum measured perpendicular to the side wall, and 56 inches (1420 mm) deep minimum for wall hung water closets and 59 inches (1500 mm) deep minimum for floor mounted water closets measured perpendicular to the rear wall." The graphic below is representative of this Standard.

**RECOMMENDATION:** Consider ways to increase the wheelchair transfer space in these toilet rooms, or convert the two toilet rooms to one compliant unisex toilet room. The graphic below is a representative floor plan with a wheelchair transfer clearance at the toilet and a clear space at the sink. Note that the sink clear space is allowed to overlap the toilet wheelchair transfer space.

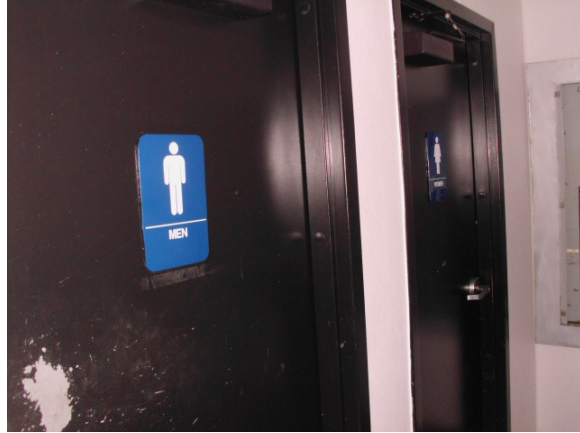
Both entry doors required approximately 8 pounds of force to open. Standard 404.2.9, Door and Gate Opening Force, states, "The force for pushing or pulling open a door or gate other than fire doors shall be as follows: 1. Interior hinged doors and gates: 5 pounds maximum."

**RECOMMENDATION:** These door closers should be adjusted, repaired or replaced.

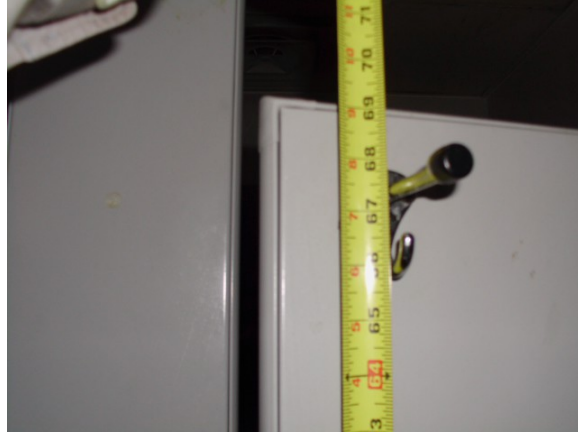
The photo on the left is representative of the community coat hooks and shelves located near the entry/exit doors.

**RECOMMENDATION:** The coat hooks on the back of the toilet stall doors should be lowered to 48 inches maximum, or add a second coat hook at 48 inches maximum above the floor. The community coat hooks should have at least one coat hook that is not more than 48 inches above the finished floor. Some shelving should be installed between 40 and 48 inches above the finished floor.

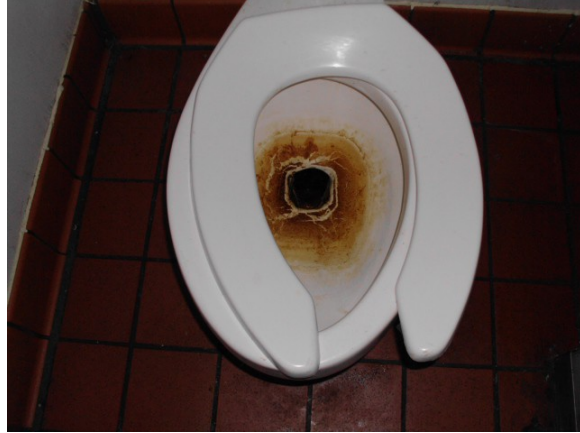
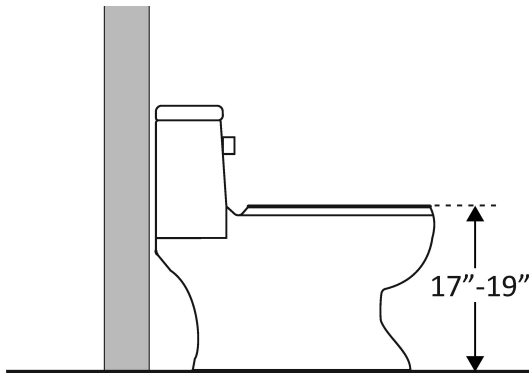
**Item 26. In both employee toilet rooms the toilet seat height is too low to the floor, the toilets are mounted too far from the side wall, the toilet paper dispensers are mounted too close to the toilet, and in the Women's toilet room the toilet flush handle is not on the open side of the toilet. The Men's toilet seat is loosely installed. See the photo on the right for the loose toilet seat in the Men's toilet room.**

Each toilet seat in each toilet room is mounted approximately 15.5 inches above the toilet room floor. 2010 ADA Standard 604.4, [Water Closets and Toilet Compartments] Seats, states, "The seat height of a water closet above the finish floor shall be 17 inches (430 mm) minimum and 19 inches (485 mm) maximum measured to the top of the seat. Seats shall not be sprung to return to a lifted position."

**RECOMMENDATION:** Replace or alter the toilet installations in the both employee toilet rooms to raise the toilet seat height, install the toilets closer to the side wall, relocate the toilet paper dispensers in both toilet rooms and re-install the covers, and alter or replace the toilet in the Women's toilet room to place the flush handle on the open side of the toilet. Repair the Men's toilet seat so it is not loose.

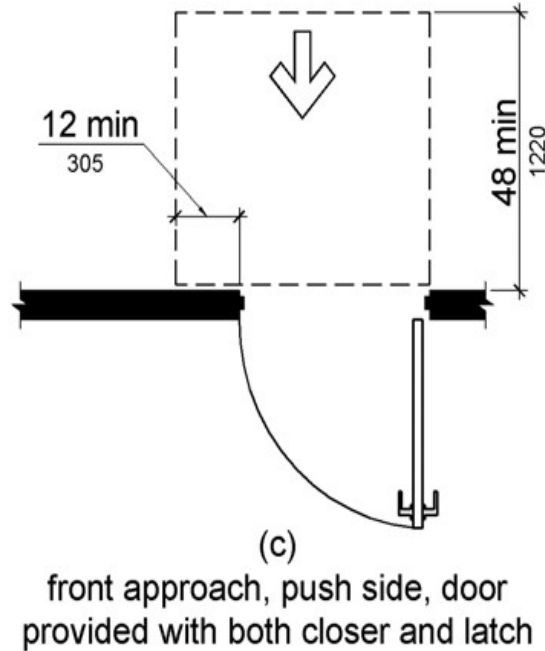
At this toilet stall door installation the 48 inch required door maneuvering space is compromised by the angled rear wall of the stall.

**RECOMMENDATION:** Alter the toilet compartment (stall) door installations to install an accessible door pull/handle on the inside of the door, and repair or replace the doors to provide stall doors that self-close.
