## Asbestos Survey Report

Taco Bell # 17314 7230 Pendleton Pike Lawrence, Indiana 46226

May 21, 2021

PSI Project Number: 00172719-1

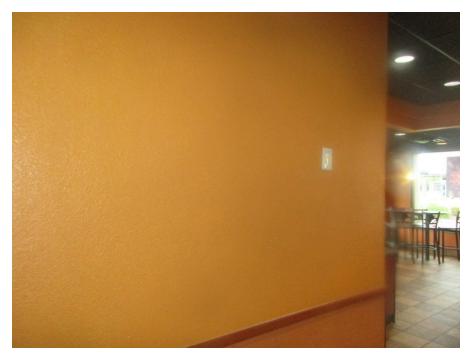
Photo 1: Drywall and skim coat

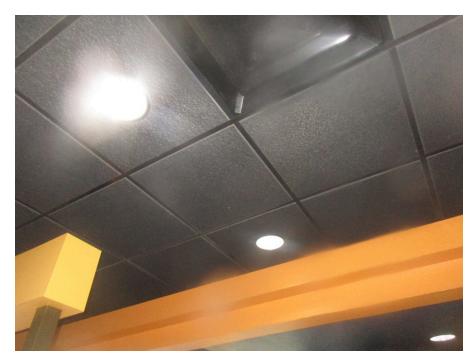
Photo 2: Black ceiling tile

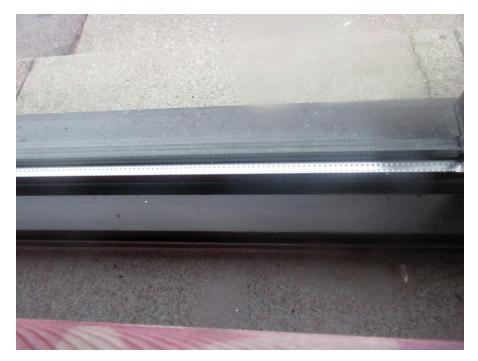
Photo 3: Window sealant
