RE: Asbestos Survey Report Taco Bell #4977 6957 W. 38th Street Indianapolis, Indiana 46254 PSI Project Number 00172733

Asbestos Survey Report

Taco Bell #4977 6957 W. 38th Street Indianapolis, Indiana 46254

PSI Project Number: 00172733

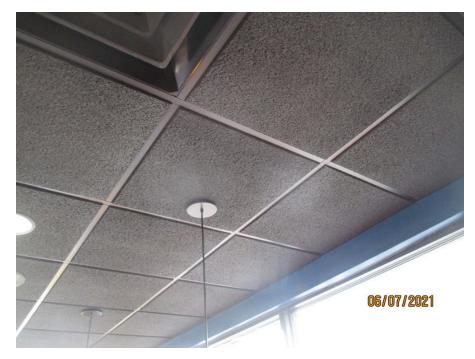
Photo 1: Non-asbestos containing ceiling tile, observed and sampled in the dining room (1A-1C)

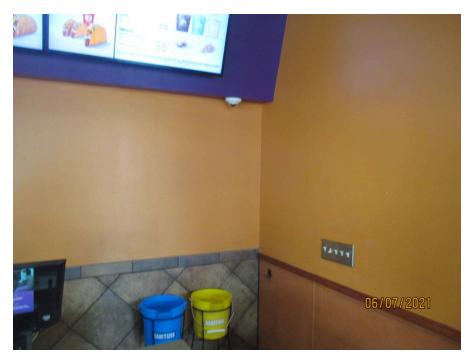
Photo 2: Non-asbestos containing drywall and joint compound, observed and sampled in the dining room (2A-2C)

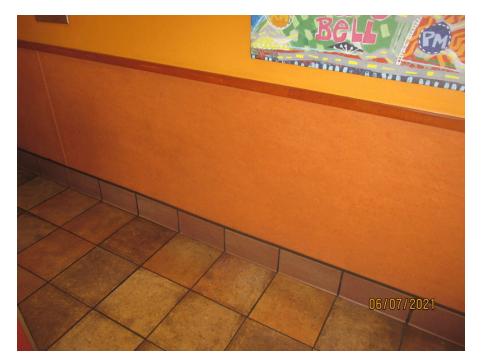
Photo 3: Non-asbestos containing orange lower wall covering, observed and sampled in the dining room (3A-3C)

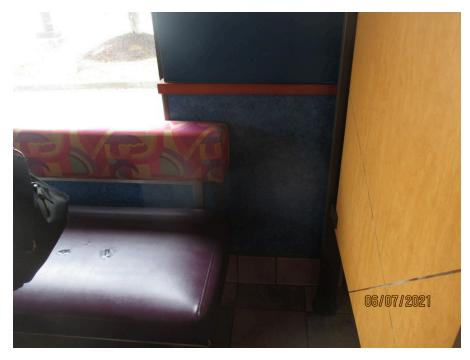
Photo 4: Non-asbestos containing blue lower wall covering, observed and sampled in the dining room (4A-4C)

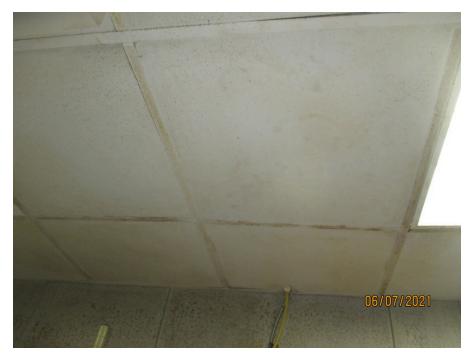
Photo 5: Non-asbestos containing gypsum board ceiling tile, observed and sampled in the kitchen (5A-5C)

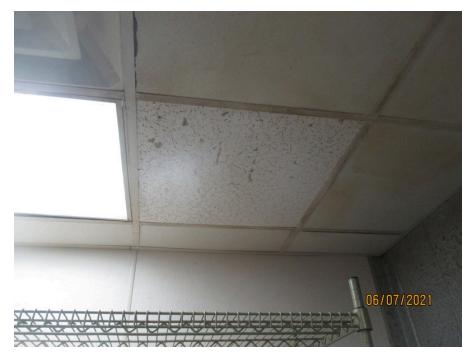
Photo 6: Non-asbestos containing ceiling tile, observed and sampled in the kitchen (6A-6C)
