Subject: Asbestos Sampling – NBC Proposal 220107-AI-01  
Burger King # 14447 - 1 Levitt Parkway – Willingboro, NJ

**Todd Markevicz, P.E - APD ENGINEERING**  
**Environmental Inspection – NBC Project - 211231-EI-01**  
**BK # 14447 – 1 Levitt Parkway – Willingboro - NJ**  
**Page Two**

**LEAD PAINT INSPECTION REPORT**

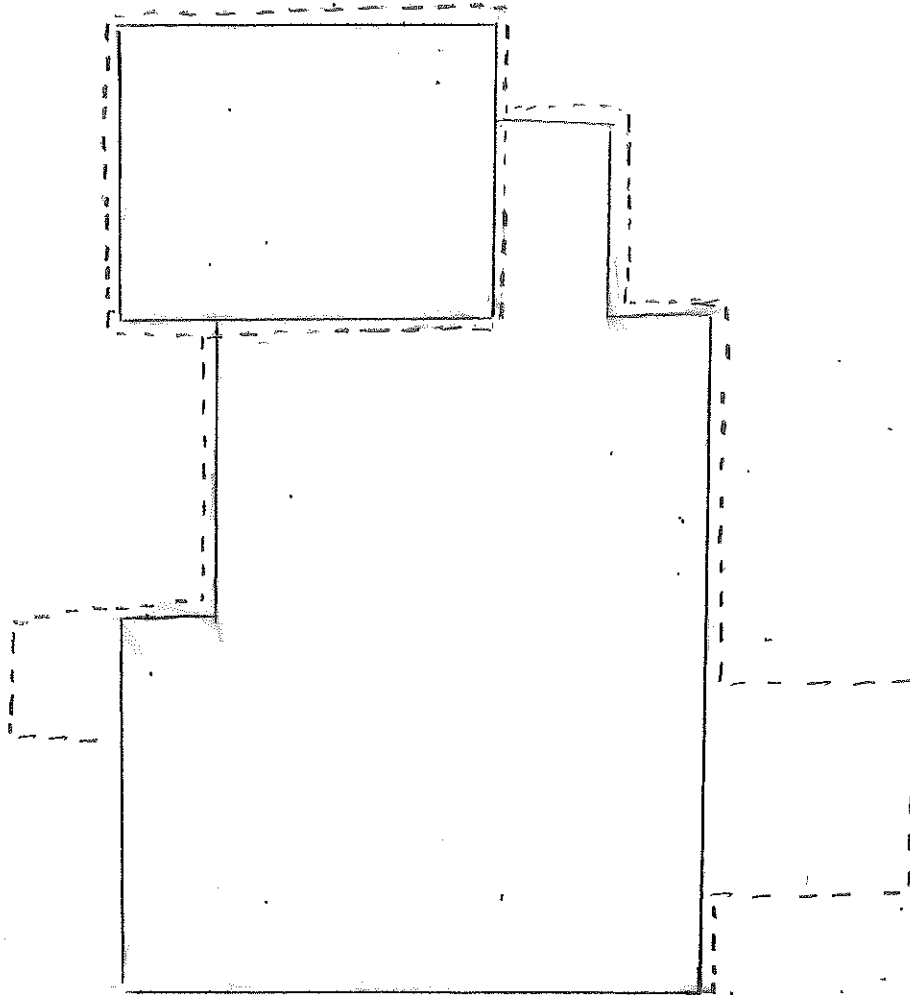
1 Levitt Parkway  
Willingboro, NJ

### **Exterior Façade yielded results in excess of 1.0 milligrams per square centimeter (mg/cm<sup>2</sup>)**

= Positive Fascia
