Subject : Asbestos Renovation Survey Report
Taco Bell #293296
403 E. Main Street
Cartersville, Georgia 30120

ASBESTOS RENOVATION SURVEY REPORT

**TACO BELL #293296
403 E. Main Street
Cartersville, Georgia**

PSI Project Number 05171227

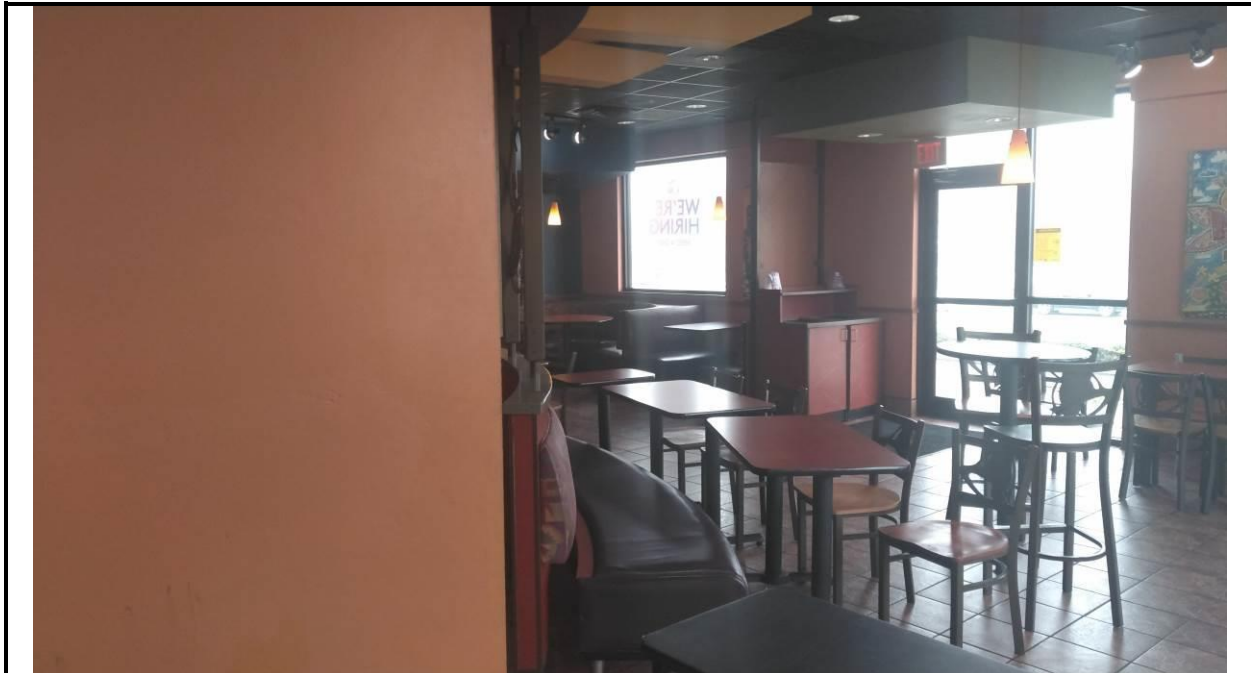
Photo 1: Non-ACM Drywall System (HSM 01)

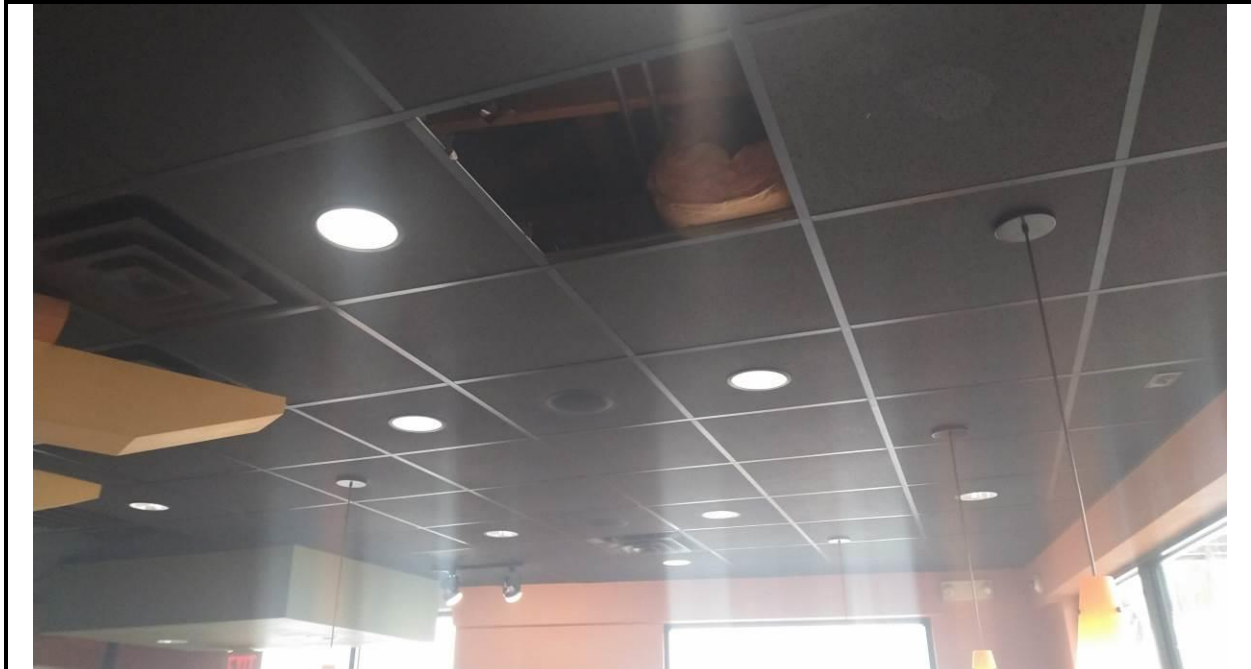
Photo 2: Non-ACM 2' X 2' Fissured Ceiling Tiles (HSM 02)
