Asbestos Survey

Former PNC Bank
3023 Dixie Highway
Edgewood, Kentucky 41018
February 14, 2022
Terracon Project No. N1227052

Re: Asbestos Survey Results
Former PNC Bank
3023 Dixie Highway
Edgewood, Kentucky 41018
Terracon Project No. N1227052

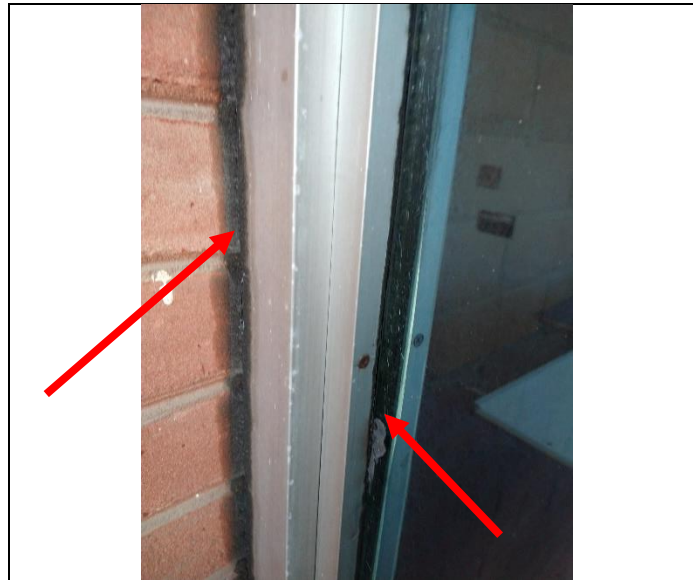
HA No.	Material Description	Material Location	% and Type Asbestos	EPA NESHAP Classification	Condition	Estimated Quantity*
17	Exterior Gray Window Caulking/Glazing	Associated with the Drive-Thru Window	2% Chrysotile	Category II Non-Friable	Good	2 Square Feet or 1 Window

Photo #1 HA 17: Asbestos-Containing Gray Exterior Window Caulking/Glazing (2% Chrysotile)

The owner and operator (contractor) are responsible for federal and state EPA Asbestos NESHAP compliance regarding the demolition project and the identified ACM which contains greater than 1% asbestos. This includes any applicable prior abatement and prior demolition notifications, and the proper handling/disposal of any identified ACM. Please note that federal and state NESHAP regulations require Category II Non-Friable ACM, which has a high probability of becoming or has become crumbled, pulverized or reduce to power by the forces expected to act on the material in

the course of demolition, to be removed prior to demolition activities. For any questions regarding EPA NESHAP compliance, please contact the Kentucky Division for Air Quality (DAQ) - Florence Region; 8020 Veterans Memorial Drive, Suite 110, Florence, KY 41042; telephone (859-525-4157); contact Mr. Clay Redmond (clay.redmond@ky.gov). Further information regarding state regulations and prior abatement and prior demolition notifications can be found online at the following web address:
