Pre-Demolition Asbestos /
Hazardous Materials Survey Report

**Taco Bell #341481
18550 E. Warren Avenue,
Detroit, Michigan 48236**

5/19/2021

PSI Project No. 01661472-1

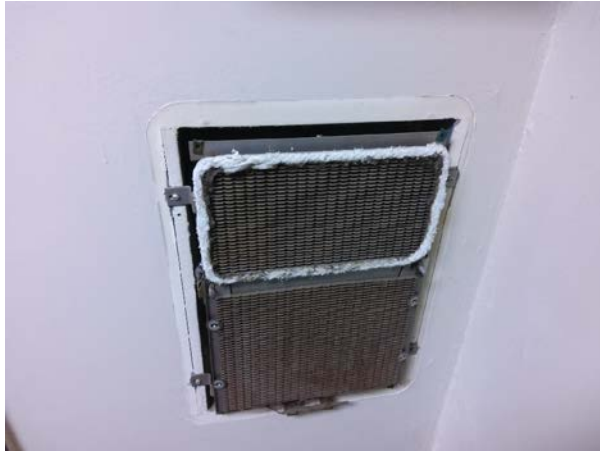
11-031, 032, 033 - White Gaskets, Rope

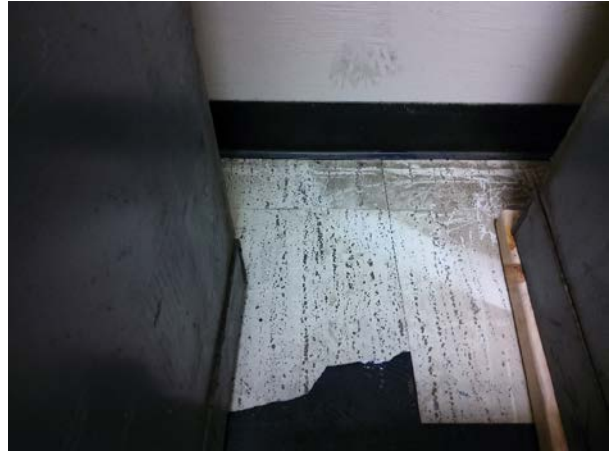
12-034, 035, 036 - 12"x12" White Floor Tile and
Black Mastic

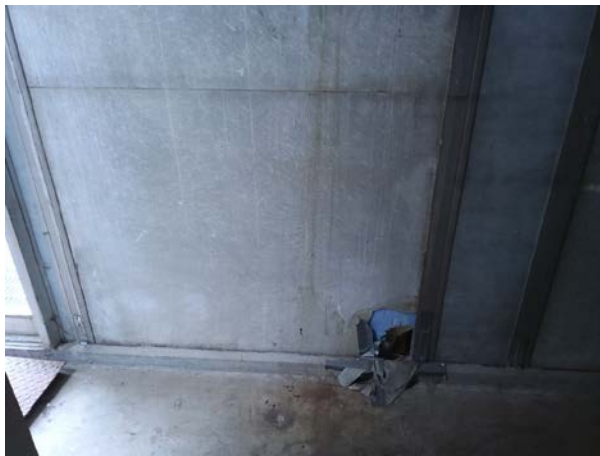
27-083, 084, 085 - Gray Transite Panel
