RE: Demolition Asbestos Survey Report  
Taco Bell #315647  
2005 East Dixon Boulevard  
Shelby, North Carolina  
PSI Project Number: 04571753

## Demolition Asbestos Survey Report

**Taco Bell #315647  
2005 East Dixon Boulevard  
Shelby, Cleveland County North Carolina**

PSI Project Number: 04571753

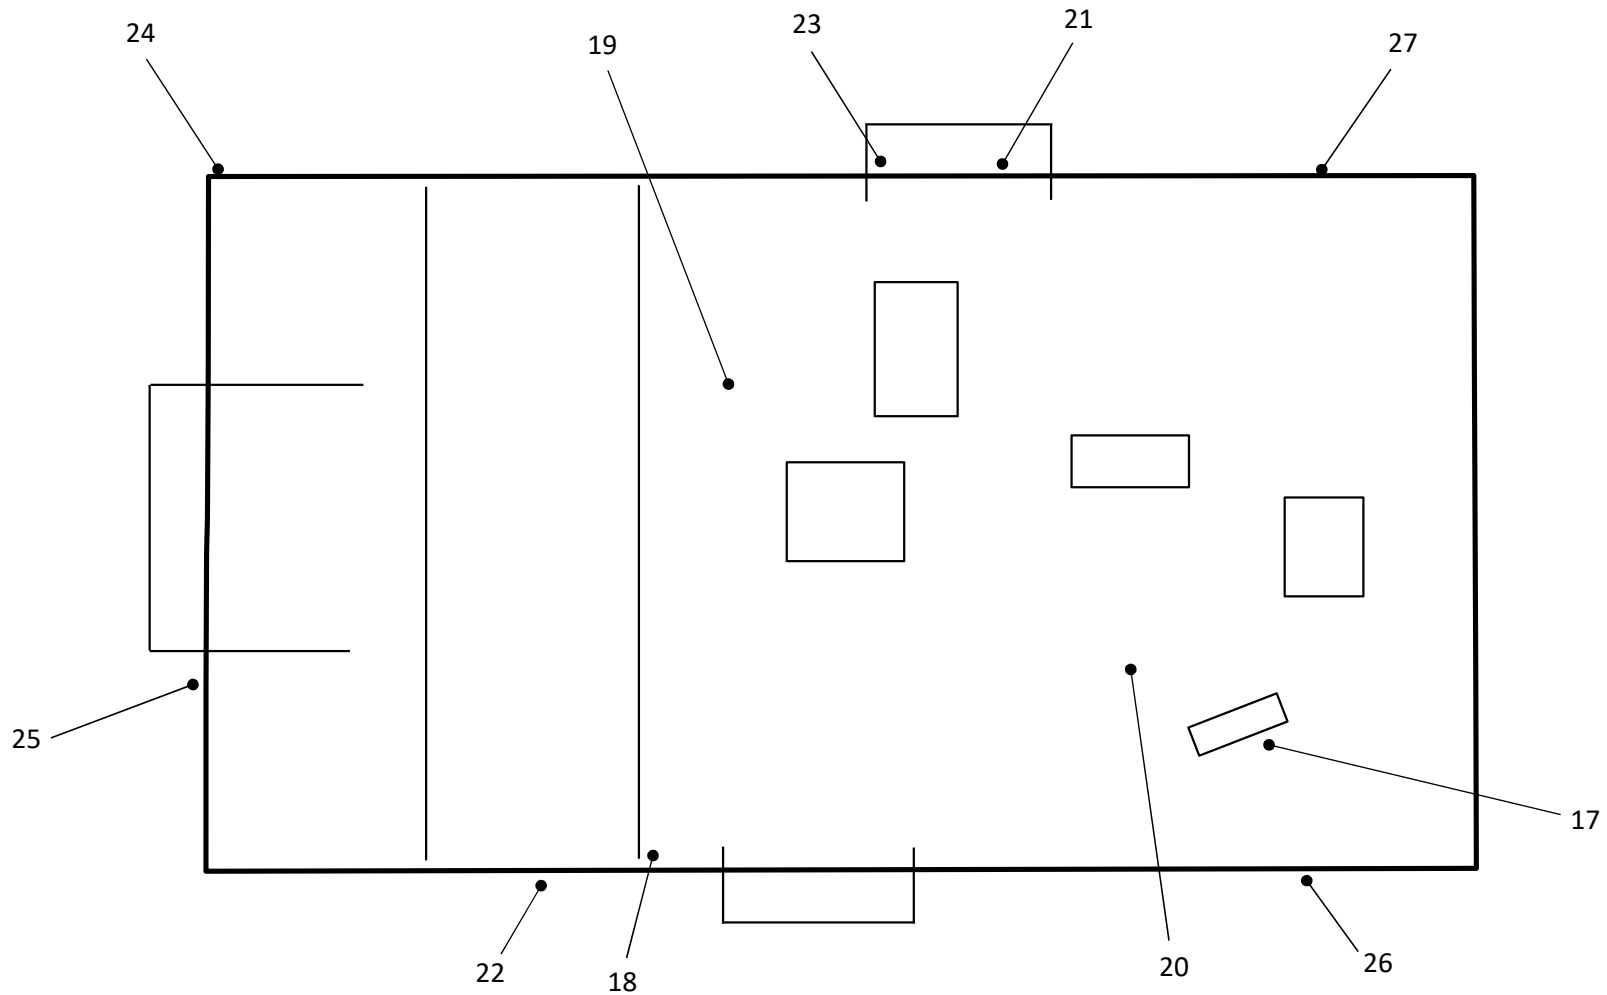
Figure 2

**Suspect ACM  
Exterior Sampling Locations**

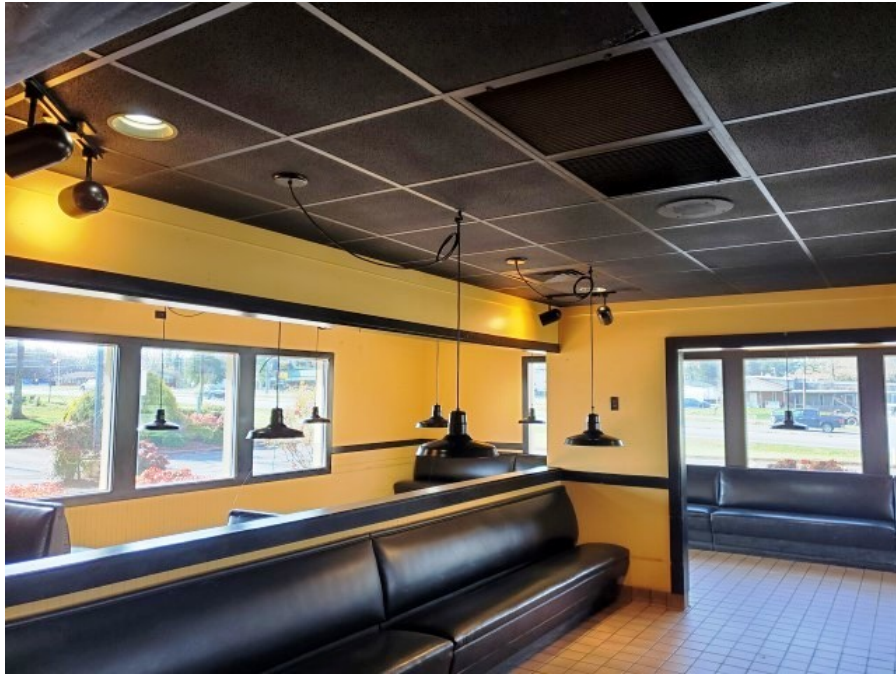
Photo 1: View of the dining room (former Zaxby's).

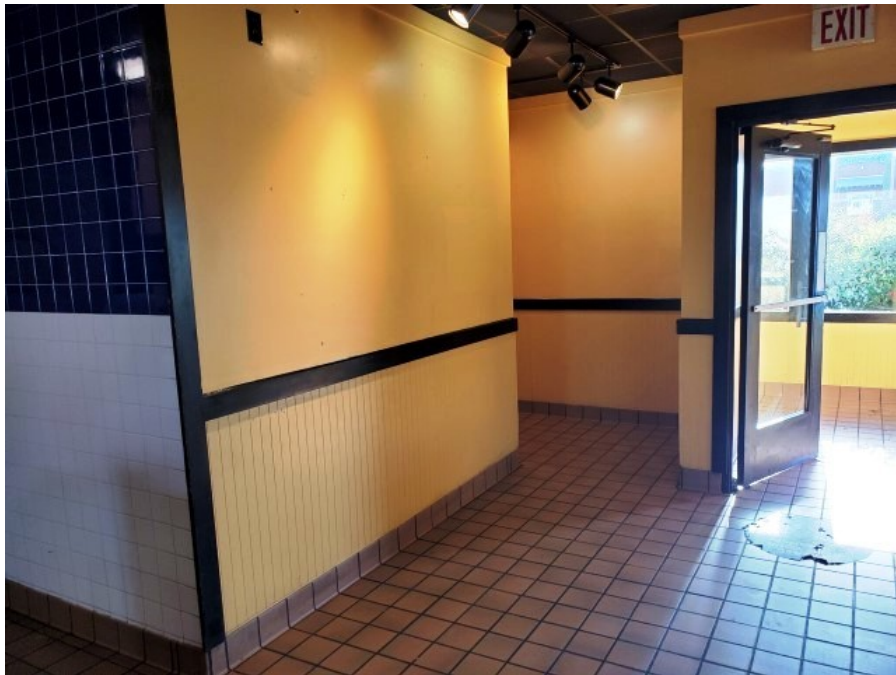
Photo 2: View of ceramic tile and wallboard systems.

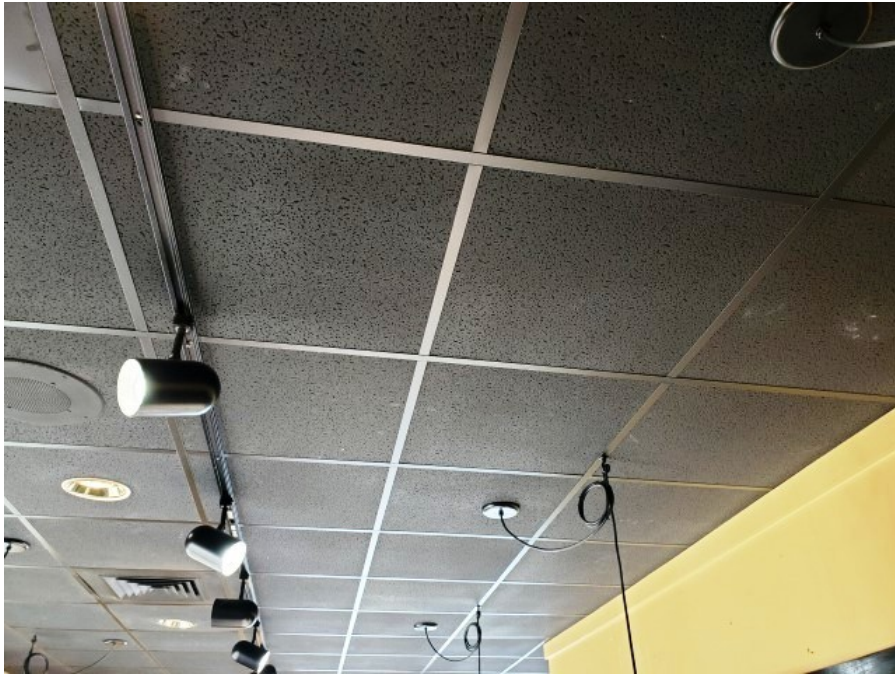
Photo 3: View of dining room ceiling tiles.

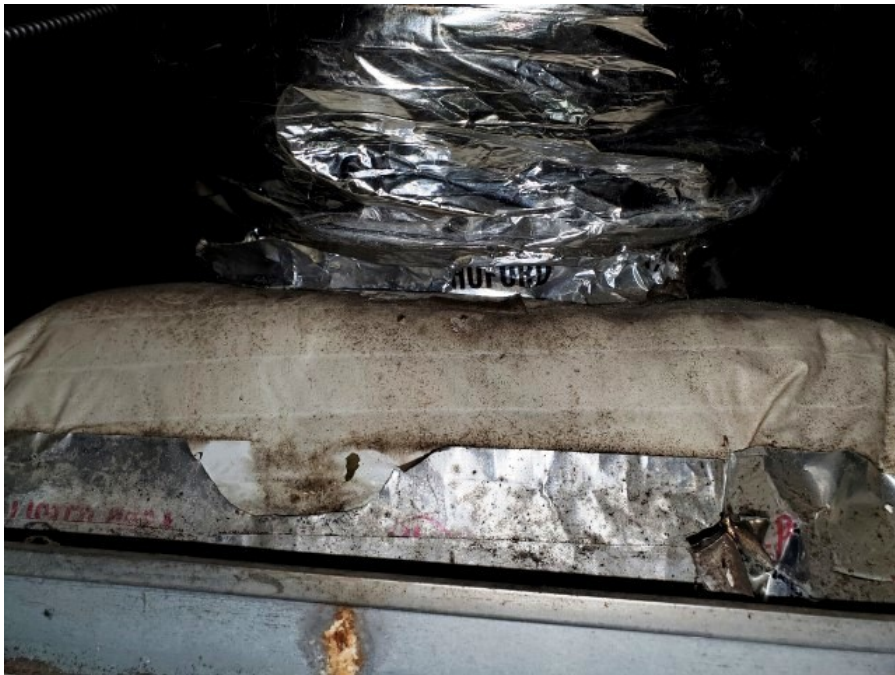
Photo 4: View of HVAC duct tape.

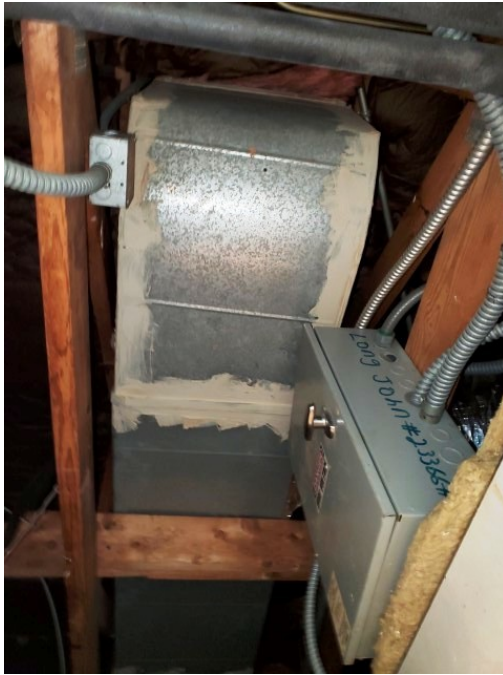
Photo 5: View of yellow duct mastic.

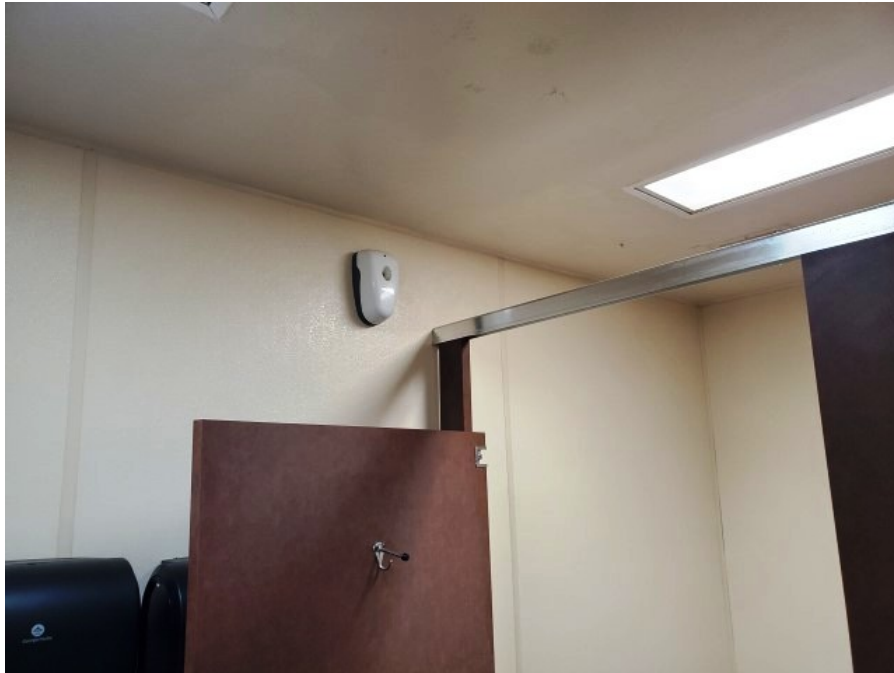
Photo 6: View of resilient wall panels and sheetrock ceiling.

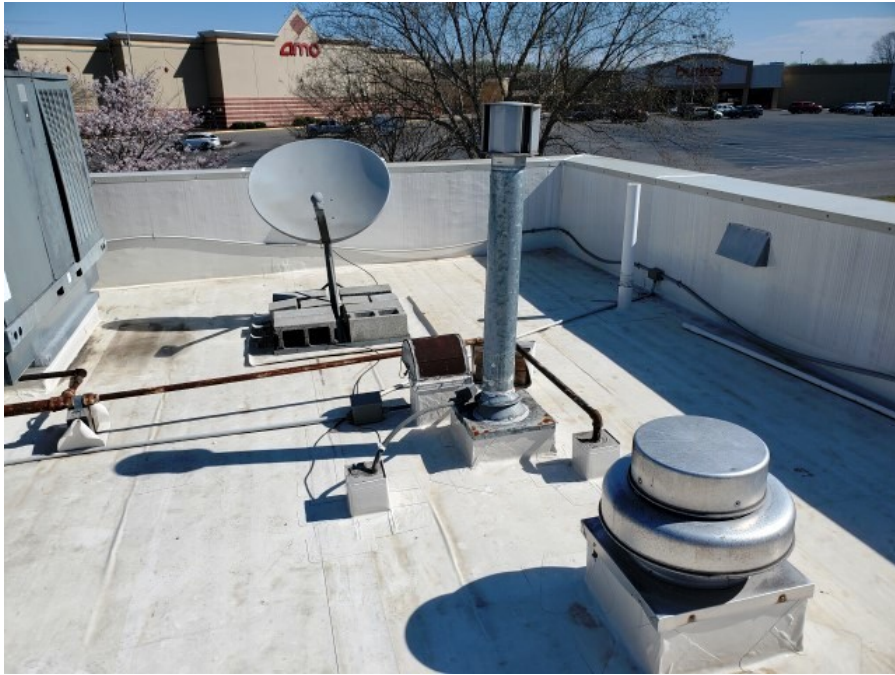
Photo 7: View of TPO roofing system.

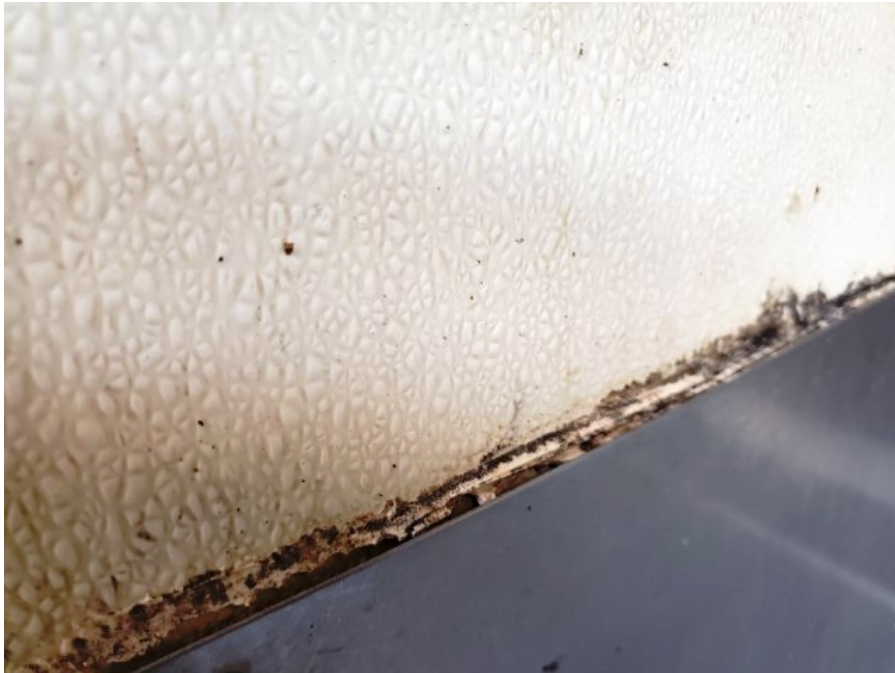
Photo 8: View of white kitchen caulk.

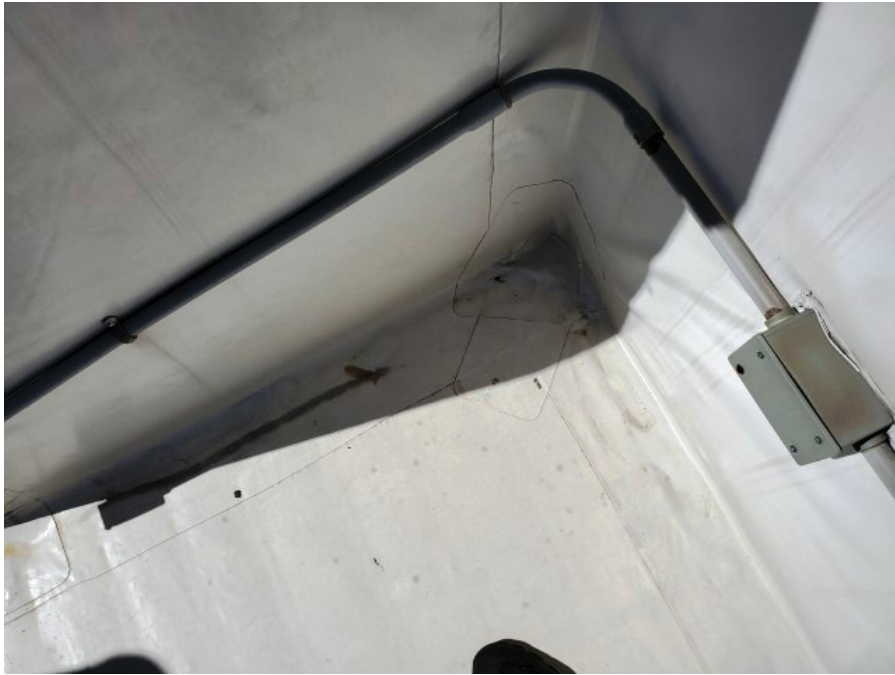
Photo 9: View of TPO flashing.

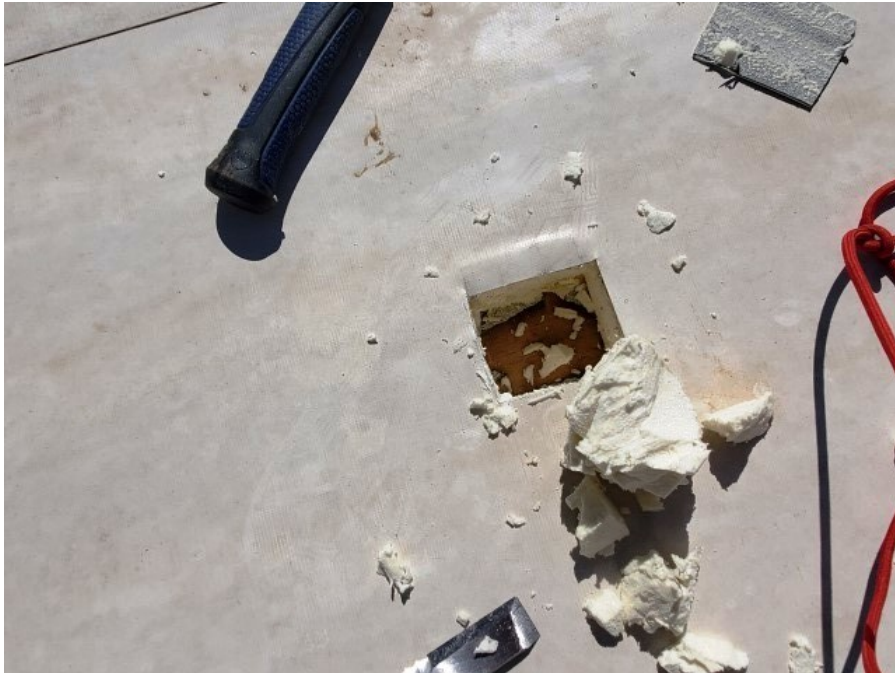
Photo 10: View of roof core sample, and wooden roof deck.

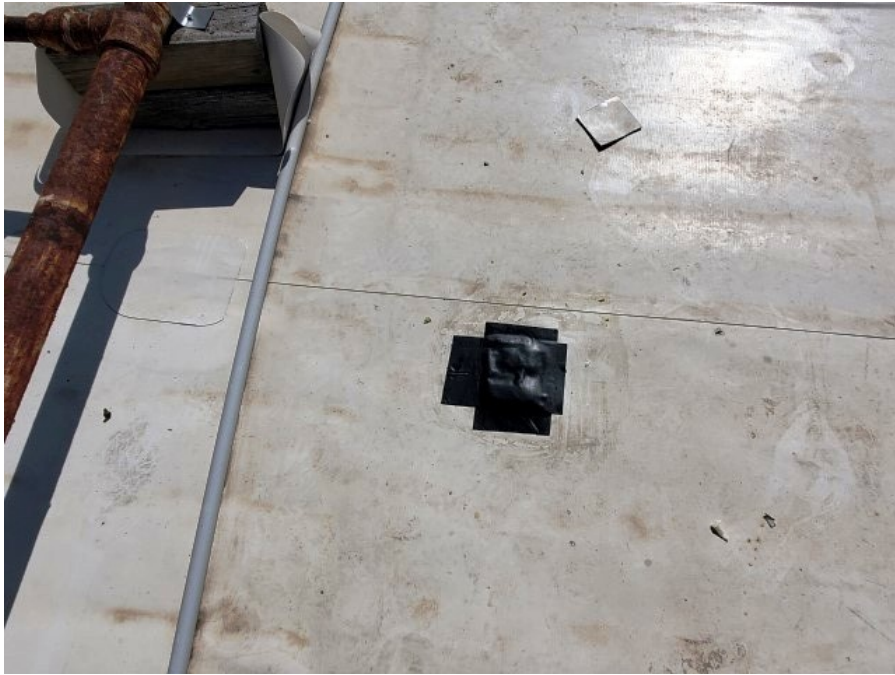
Photo 11: Temporary roof patch with primer adhesive.

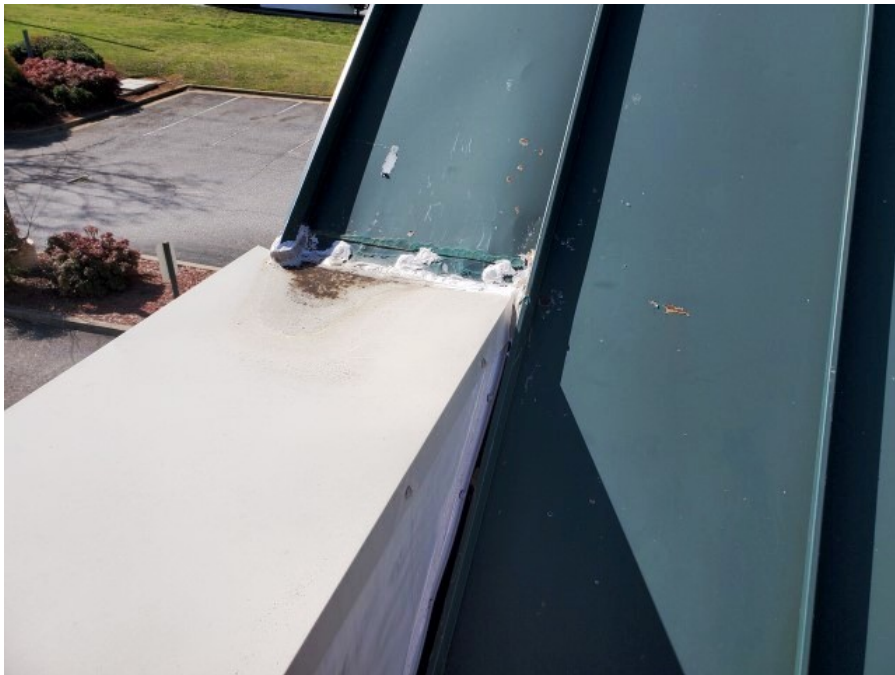
Photo 12: View of white roof caulking.
