APPLICATION STORIES

The Application:

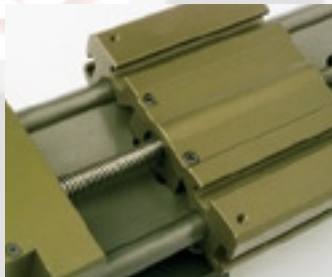
A profiled rail system was originally

installed but survived less than two weeks in this application before failing catastrophically.

A subcontractor to the automotive industry uses a silicon carbide stone to hone the ID of precision cam followers for automotive applications. The stone wears away during this process and the debris or dust from this wear flies into the hone's coolant system where the filter fails to catch the sub 5 micron contaminate (silicon carbide). This mixture of coolant and silicon carbide acts as a great lapping compound that polishes the linear guidance system to the point of failure.

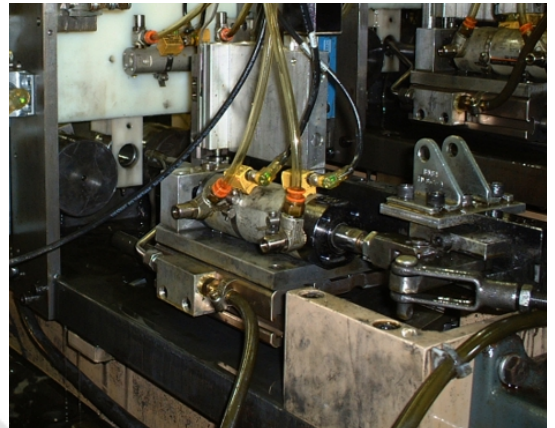
A Dolphin Guide from Pacific Bearing was installed to replace the profiled rail system. Seals or waycovers were deemed unnecessary in this application. Nine months and 66 million inches later the Dolphin Guide began to show the first signs of wear.

The Dolphin Guide became the approved solution for this linear motion application. Inventory was added and the customer was able to move onto more pressing problems.

The results were dramatic. The two week life expectancy stretched to nine months. The sub 5 micron silicon carbide contaminate that acted like a lapping compound on the THK profile rail did not have the same effect on the ceramic coated 6000 grade aluminum guide rails of the Dolphin Guide. The self-lubricating Frelon Gold liner ran over 66 million inches before the first signs of wear.
