# APPLICATION STORIES

**Customer:** A manufacturer of plastic injection molding equipment

**Machinery Involved:** Plastic injection molding machinery

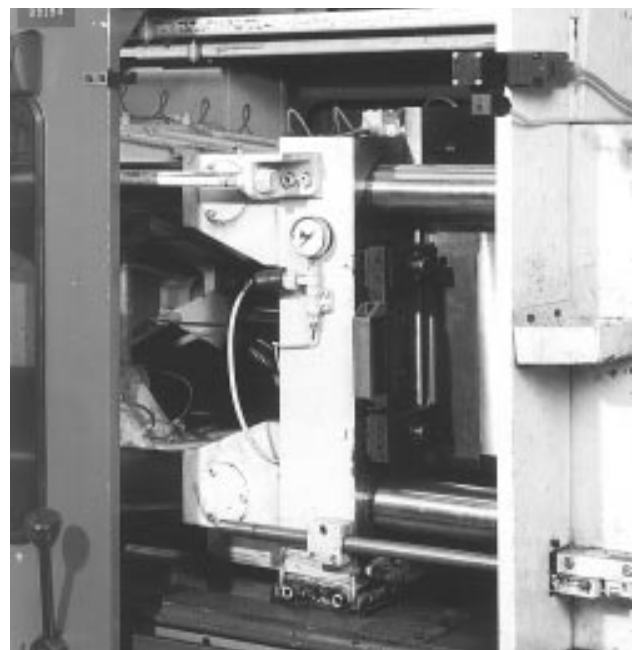
**Description of Problem:** Shafting is being grooved by linear ball bearings. Bearing failure caused by heat (lube failure) and vibration.

**Solution:** Simplicity bearings were retrofitted. Bearing failure disappeared. Shaft damage was eliminated.
