# Site Accessibility Evaluation

## Americans with Disabilities Act And ANSI A117.1

**Taco Bell Store #015908  
(Pre)**

**Pre Inspection**

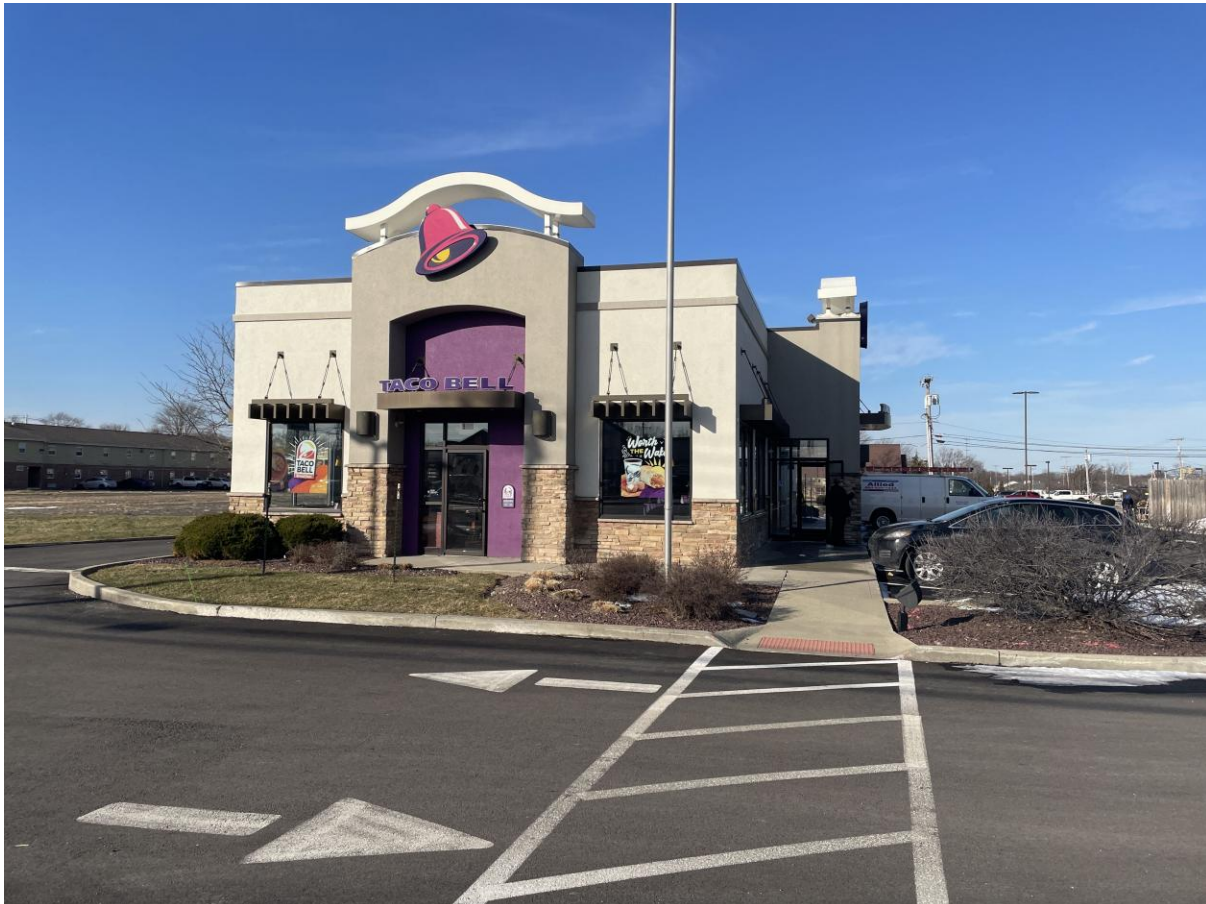
### **Finding: 1**

At least 60% of all public entrances must be accessible and on an accessible route to the public way.

Based on the number of ground floor exits provided for the building (2), at least (2) of the existing exit doors (if used as a public entrance) are required to be brought up to compliance if readily achievable to do so. This would include an accessible path of travel which is currently out of compliance for slope and cross slopes between the entrances, accessible parking stalls and public way.

N/A

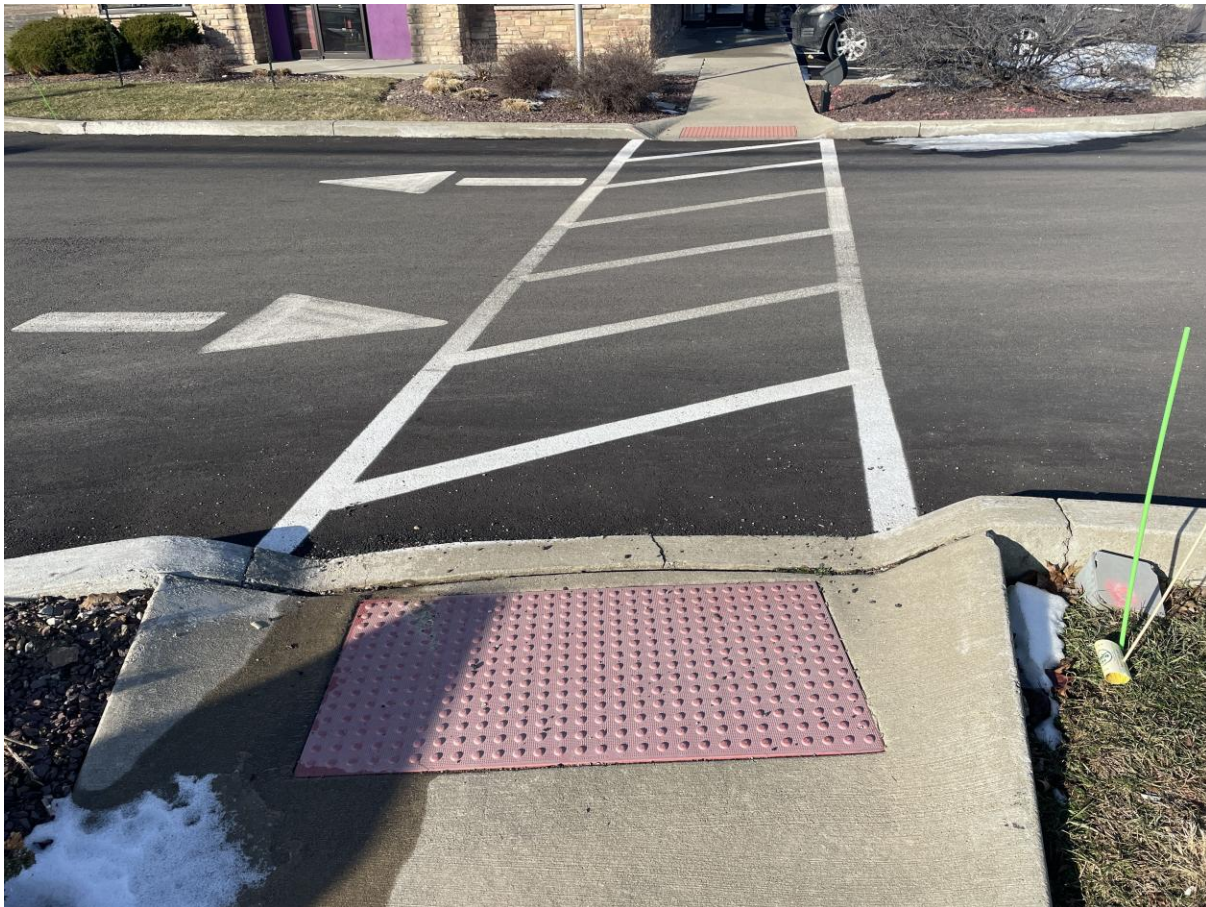
### **Finding: 2**

The accessible route of travel contains detectable warnings (truncated domes) which are not currently required by the 2010 ADAS or ANSI A117.1 for this location.

(Two) Sets of domes.

Due to the ongoing development of guidelines and lack of adopted standards and/or regulations pertaining to the installation of detectable warnings, it is recommended that detectable warnings not be installed until such time that the standards and/or regulations require them. Please confirm with the local AHJ.

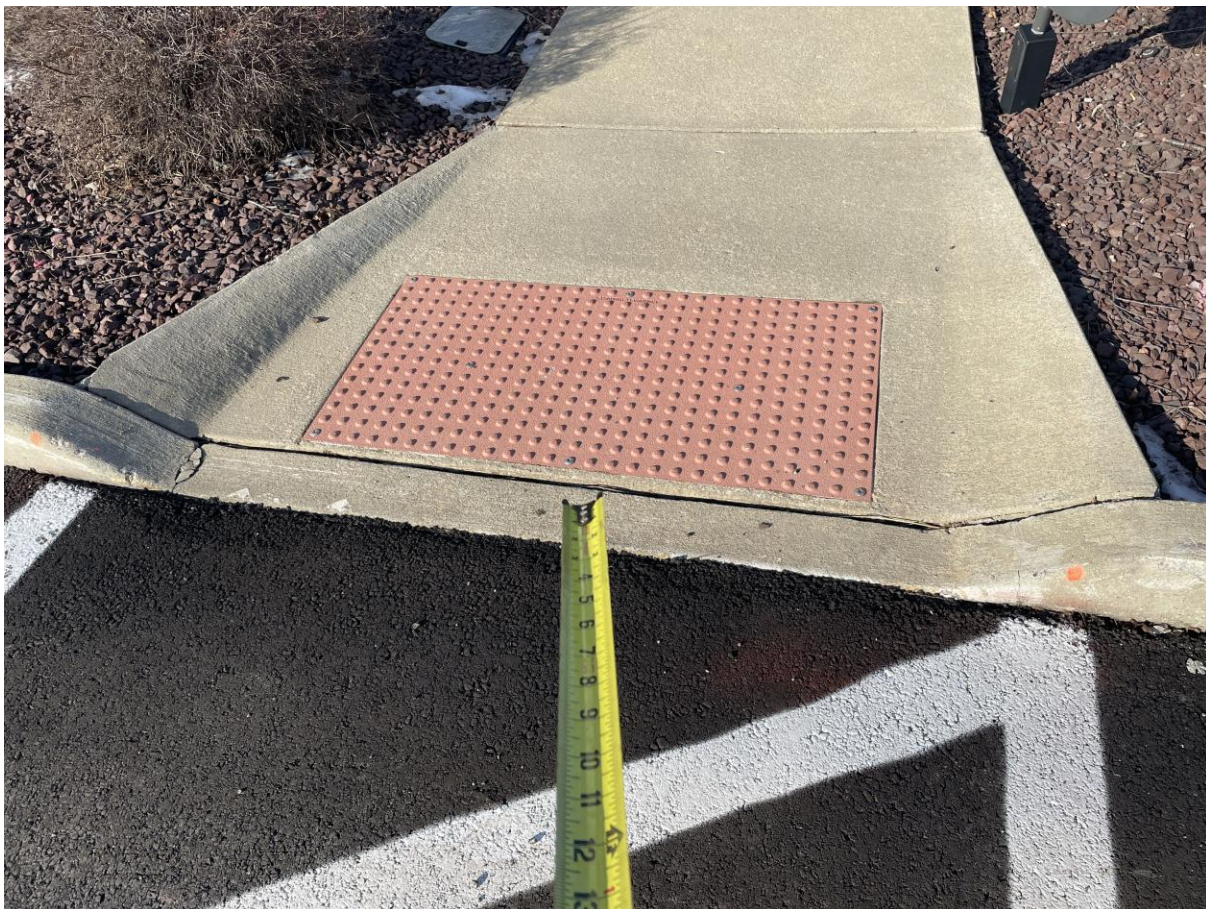
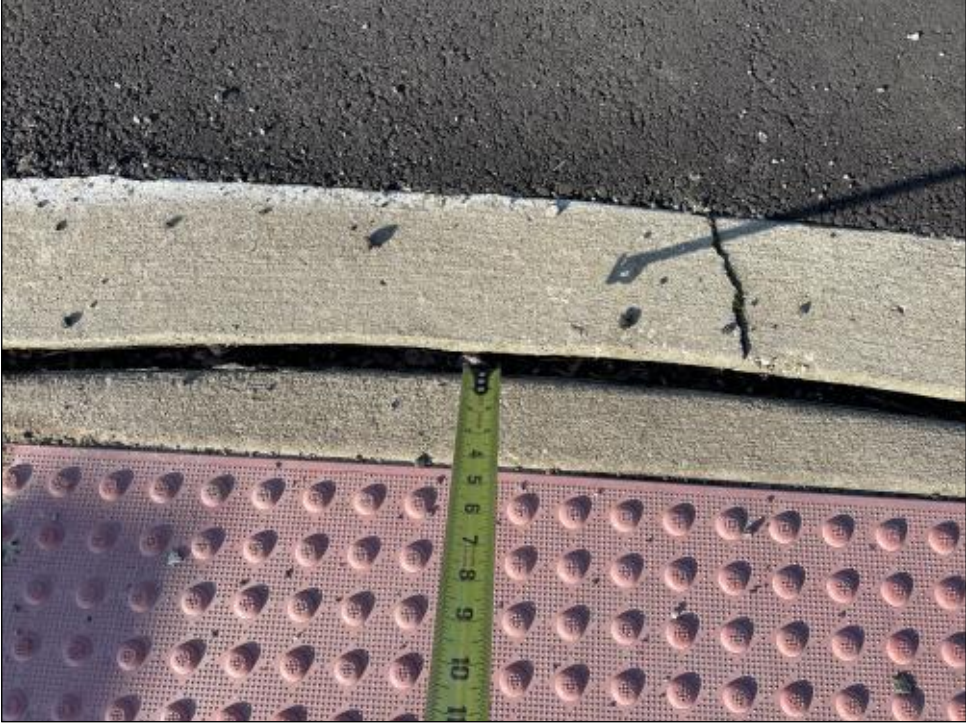
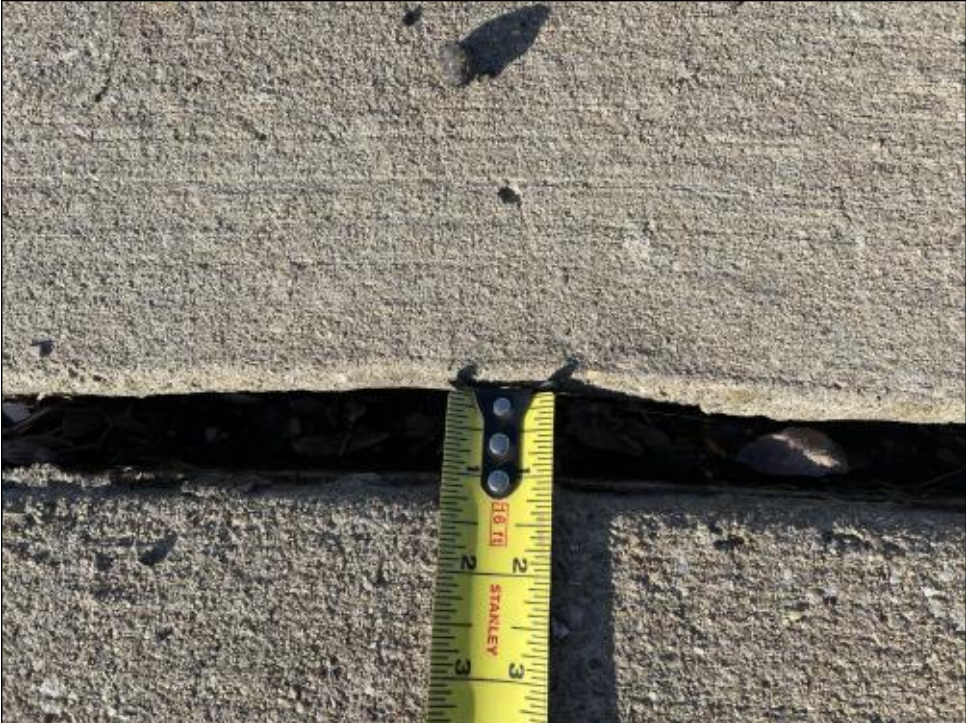
### **Finding: 3**

There is a change in level greater than 1/4 inch.

1/4 inch is the maximum vertical rise. Changes in level between 1/4 inch and 1/2 inch must be beveled at 1:2 or less. Changes in level greater than 1/2 inch must be by way of a ramp.

Gaps > 1/2"

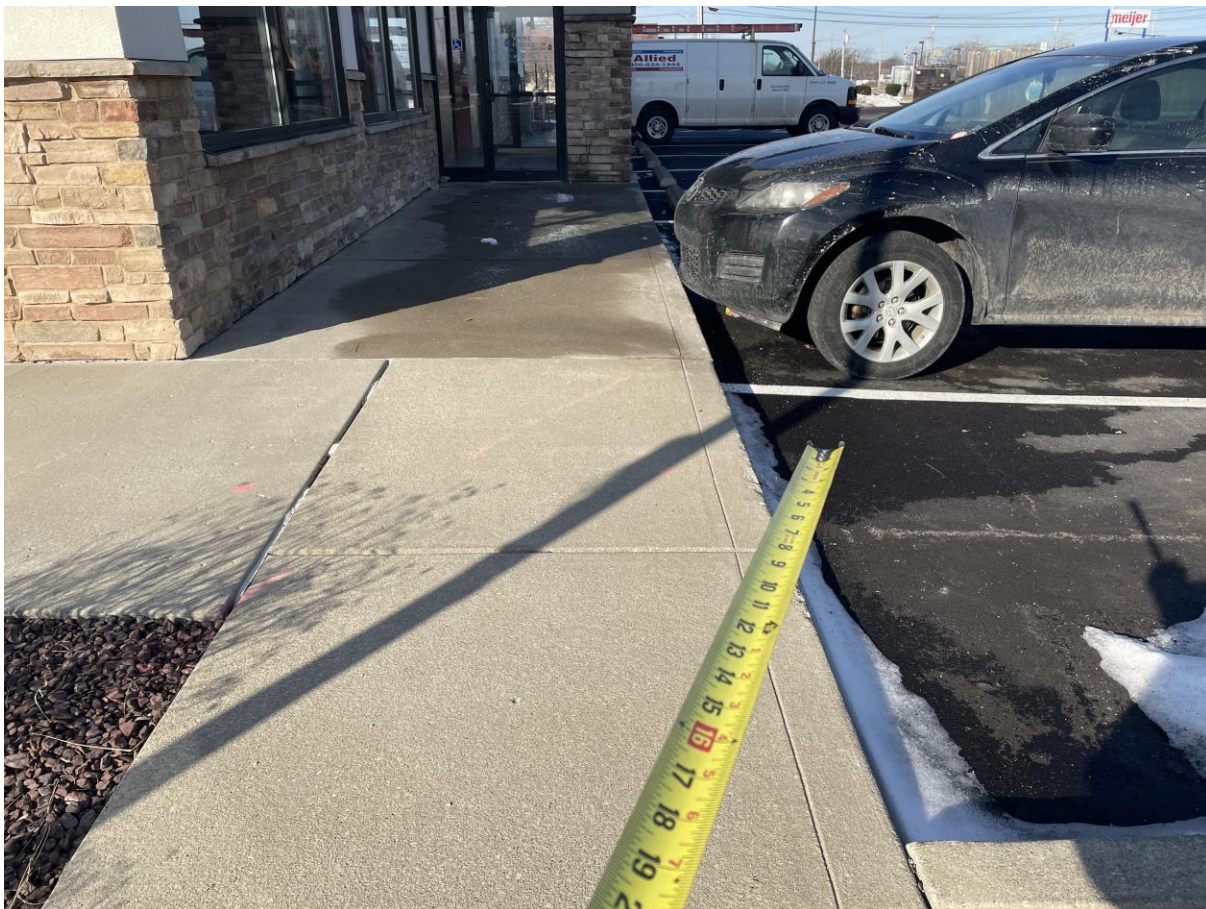
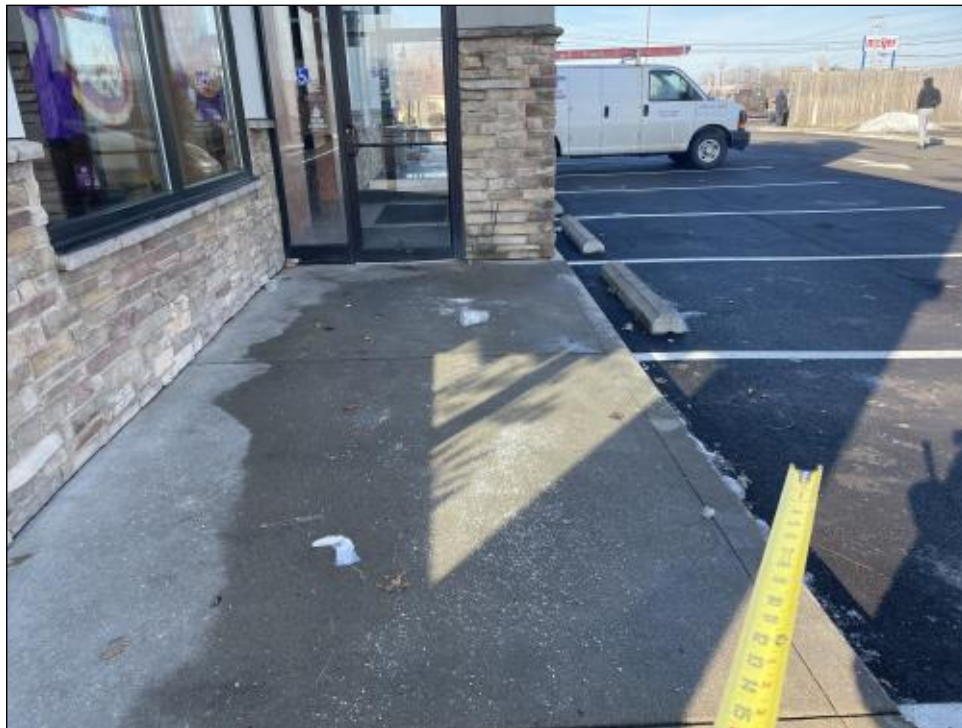
### **Finding: 4**

**Parked vehicles reduce the required width of the accessible route.**

**The accessible route of travel must be maintained at least 36 inches wide. Wheel stops are required when a car parked in any space may reduce the accessible path of travel to less than 36 inches.**

**Lack of wheel stops  
<36"**

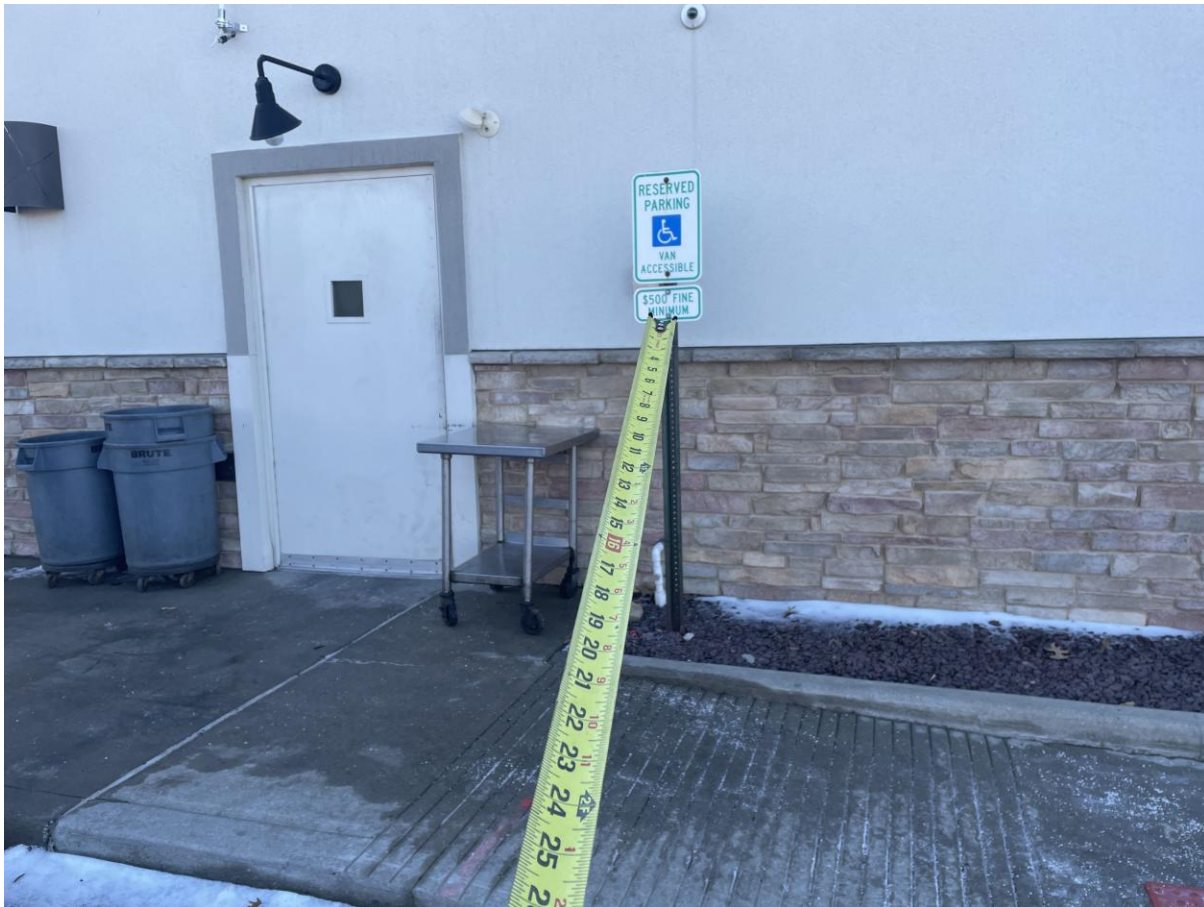
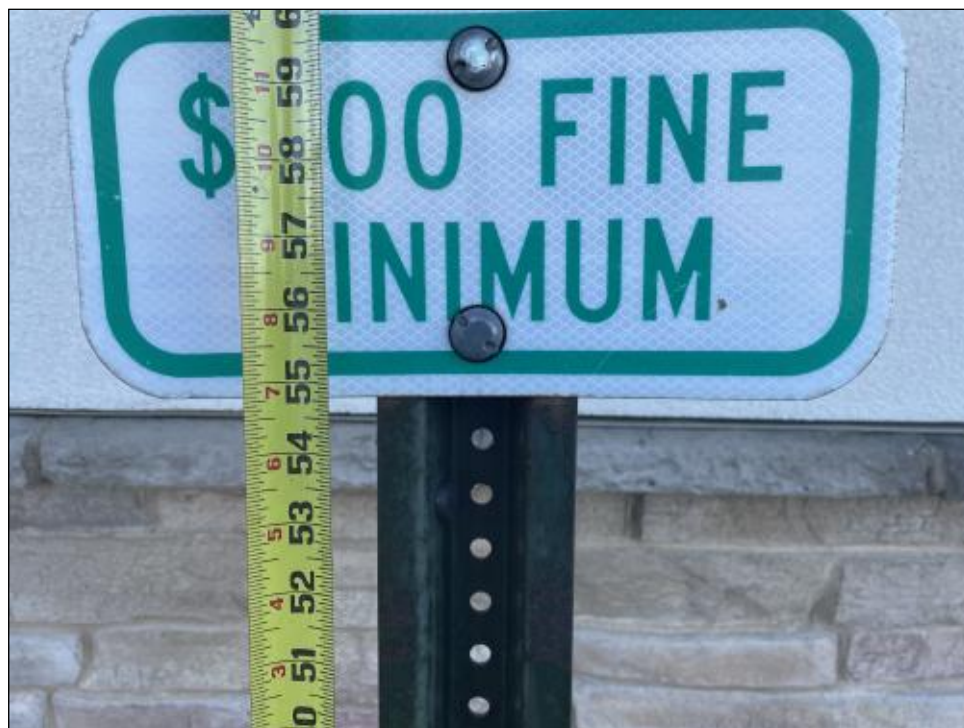
### Finding: 5

The parking sign is mounted too low.

Parking space identification signs shall include the International Symbol of Accessibility. Signs identifying van parking spaces shall contain the designation "van accessible." Signs shall be 60 inches minimum above the finish floor or ground surface measured to the bottom of the sign.

55" (one sign only)

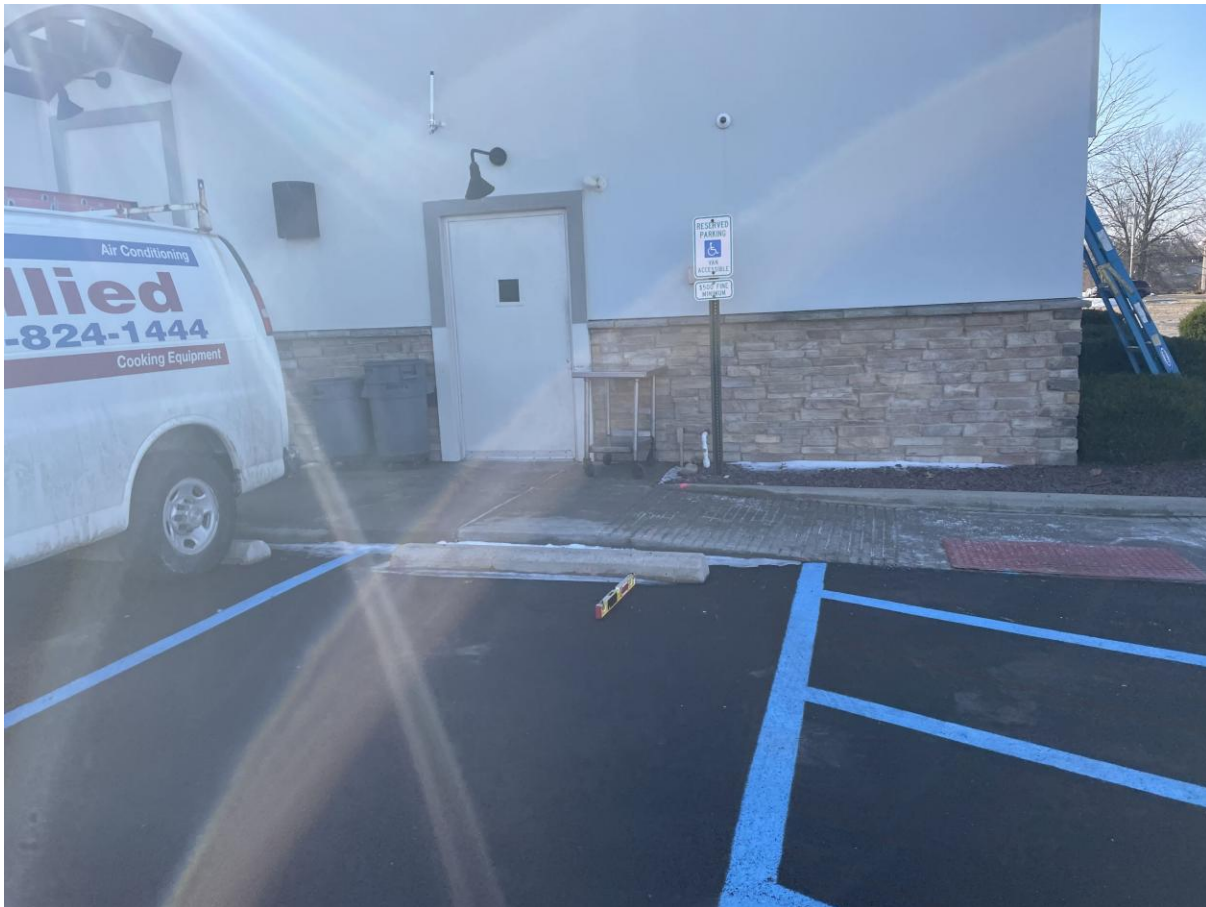
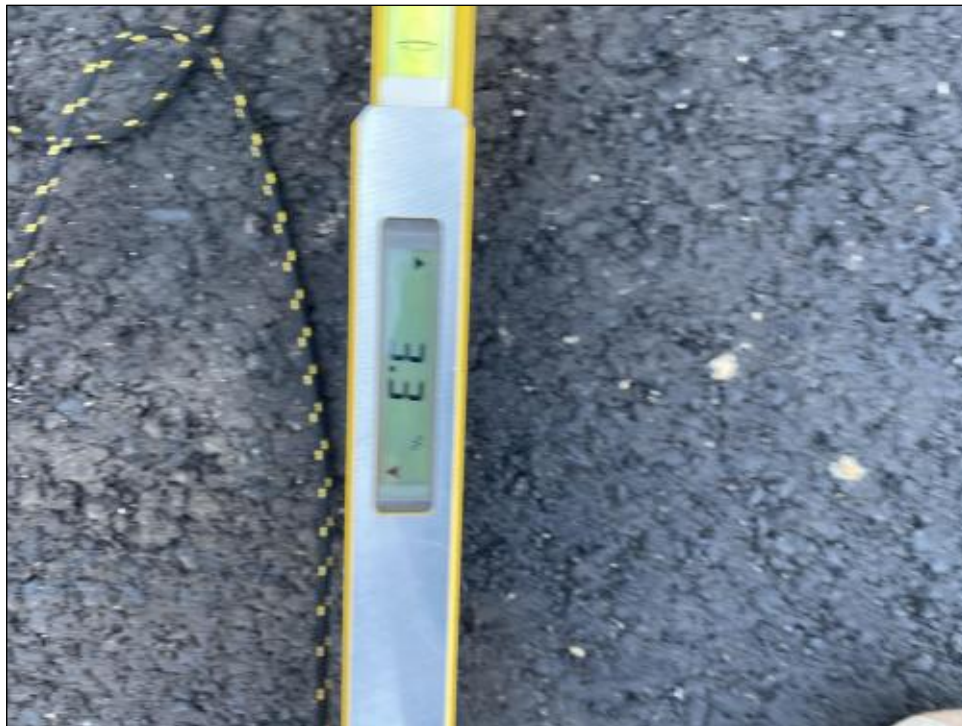
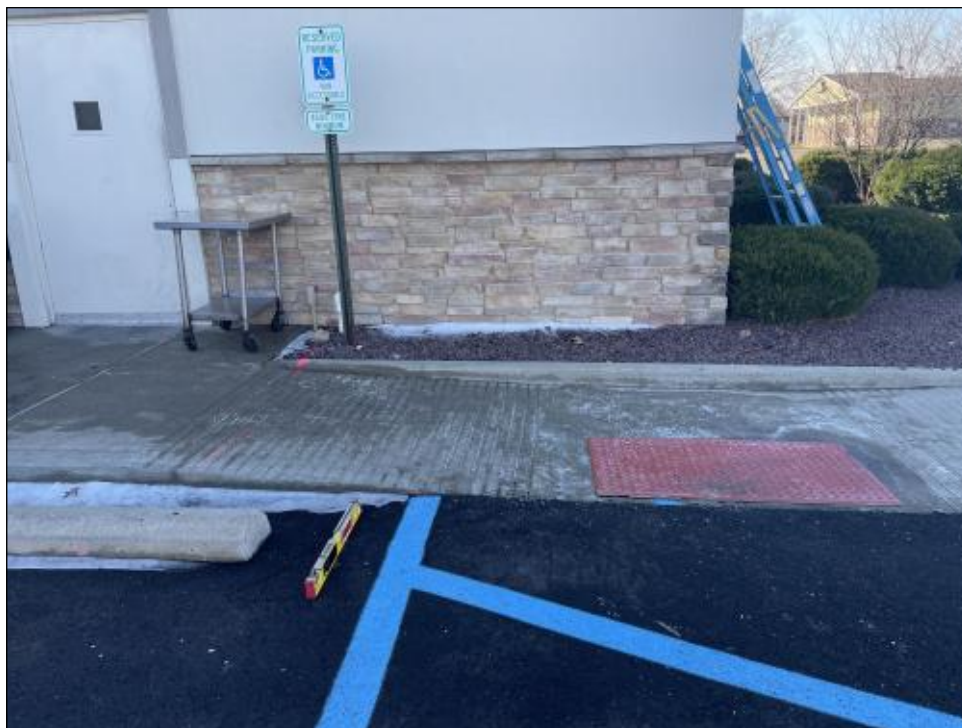
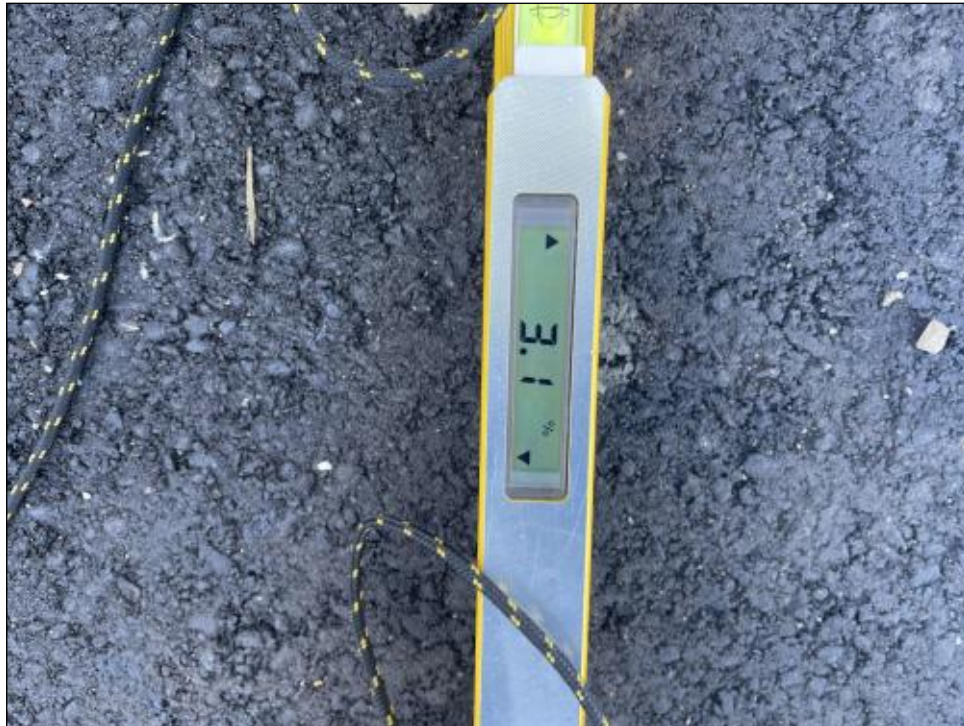
### Finding: 6

The running slope (long dimension) of the accessible parking stall exceeds 2%.

The running slope in an accessible parking stall and the access aisle must not exceed 2%.

3.1%-3.3%

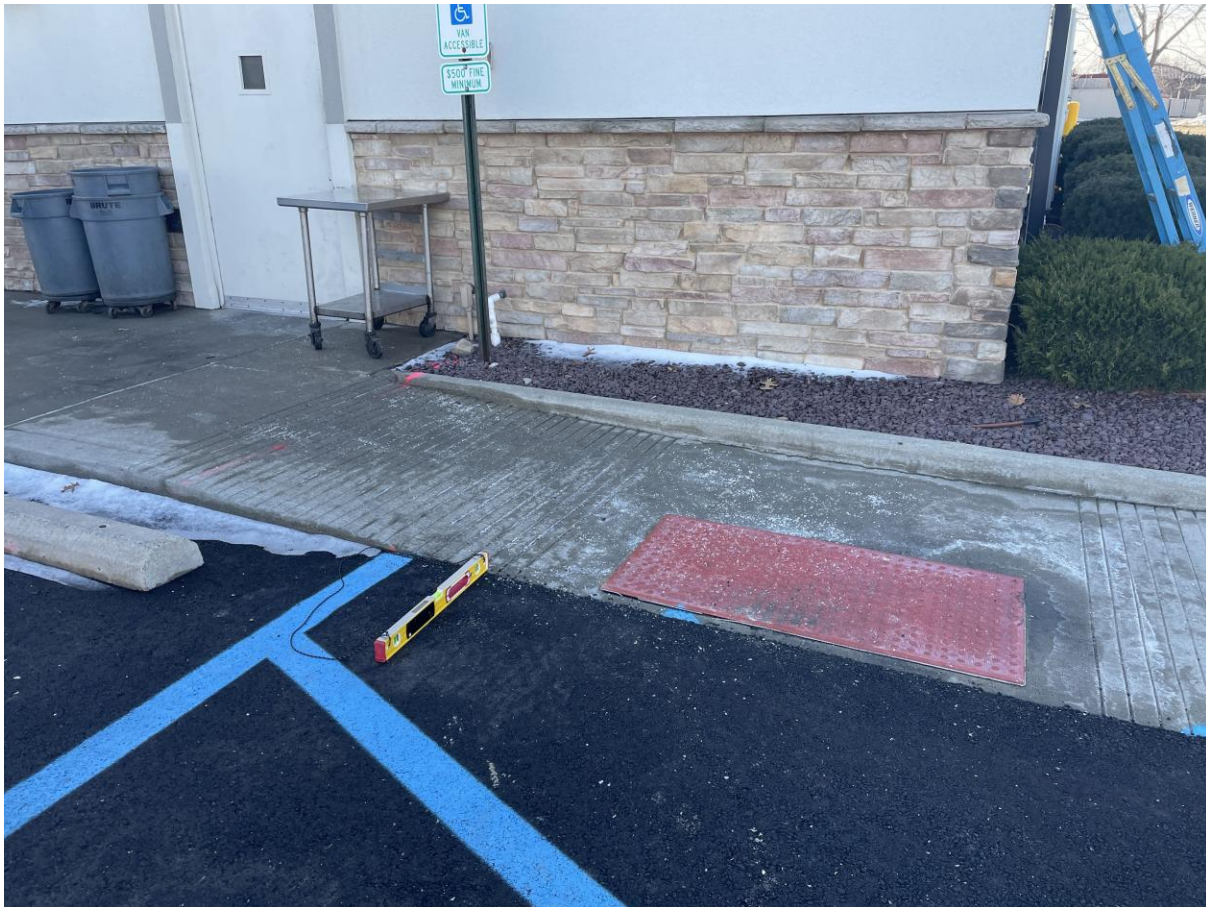
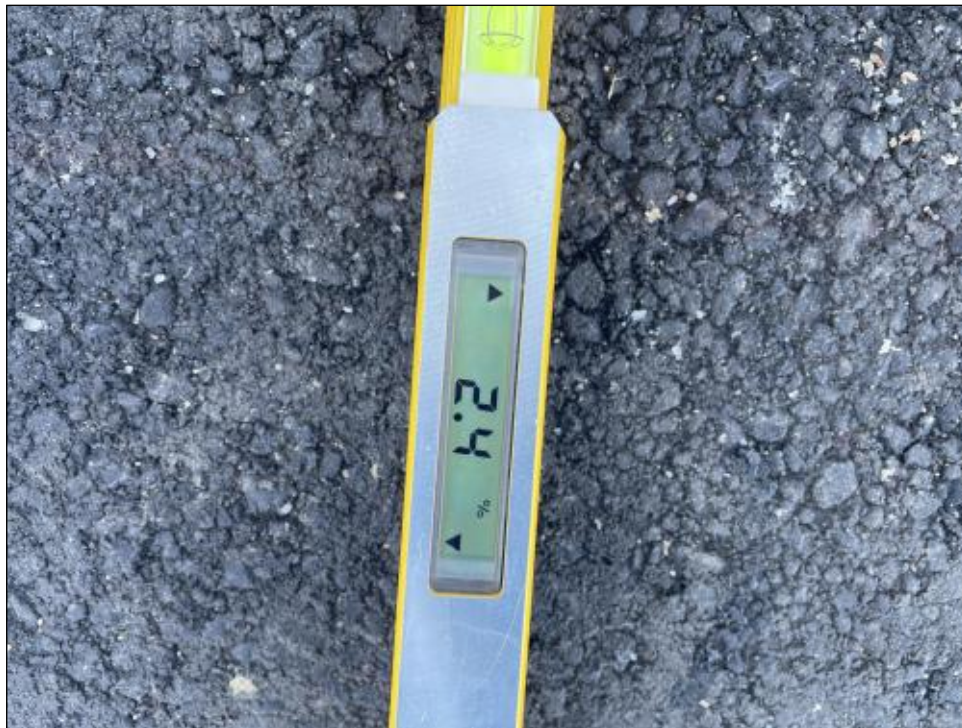
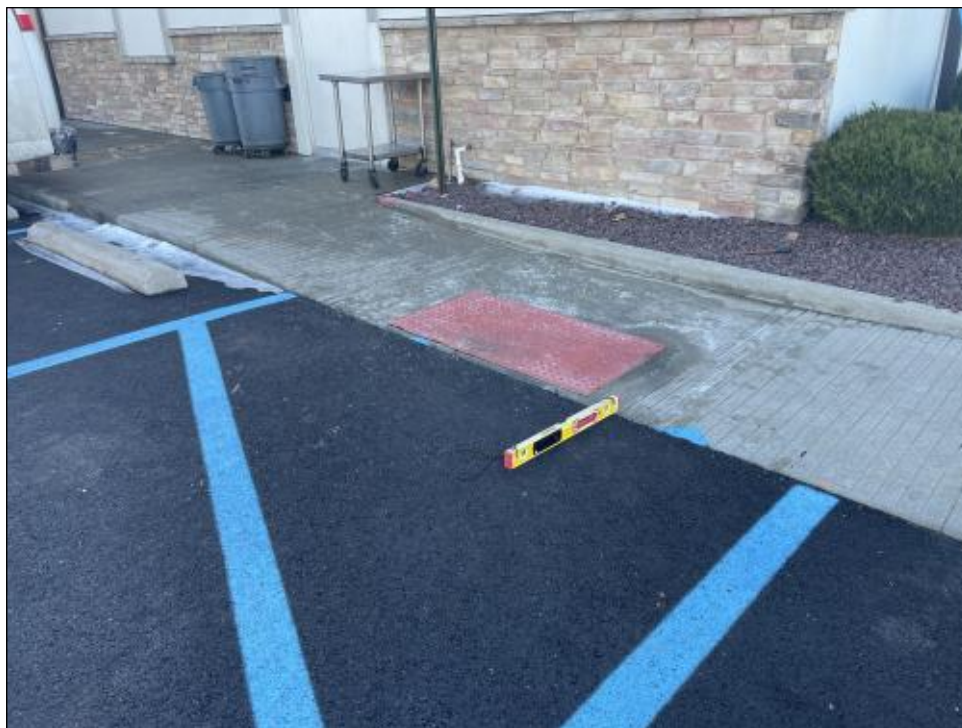
### Finding: 7

The running slope of the access aisle (long dimension) exceeds 2%.

The running slope in an accessible parking stall and the access aisle must not exceed 2%.

2.4%-4.0%

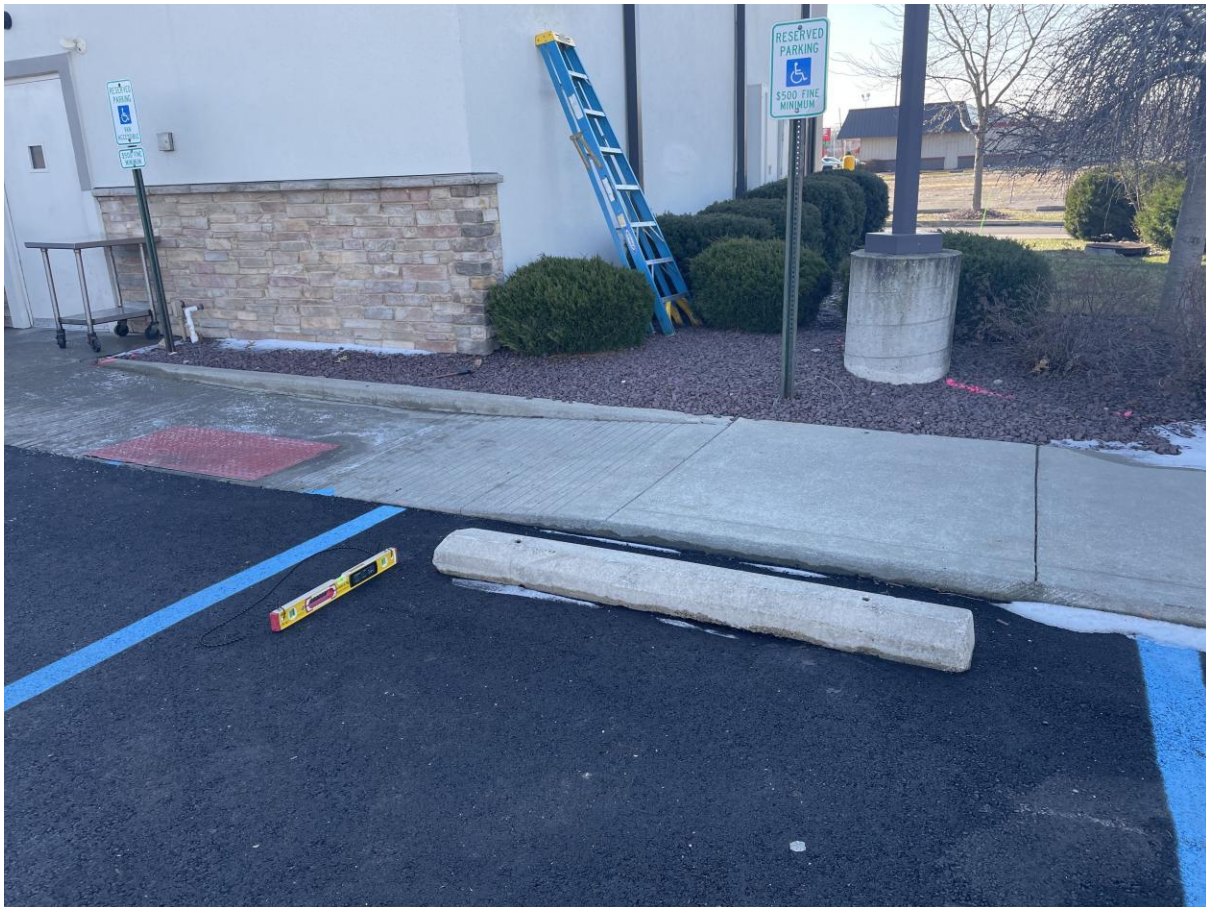
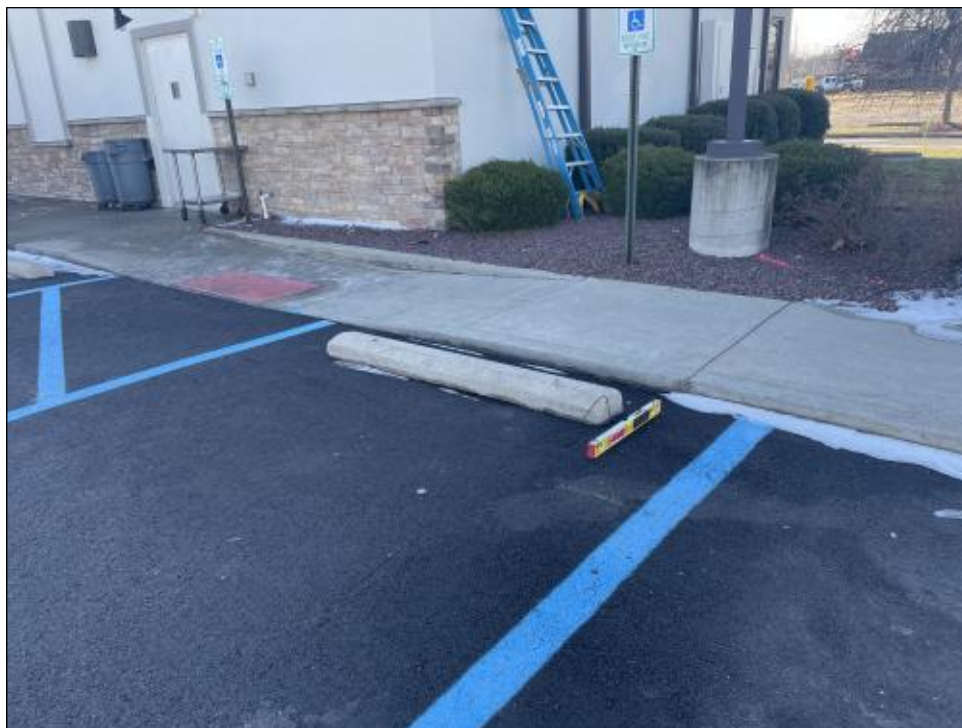
### Finding: 8

The running slope (long dimension) of the accessible parking stall exceeds 2%.

The running slope in an accessible parking stall and the access aisle must not exceed 2%.

2.7%-3.4%

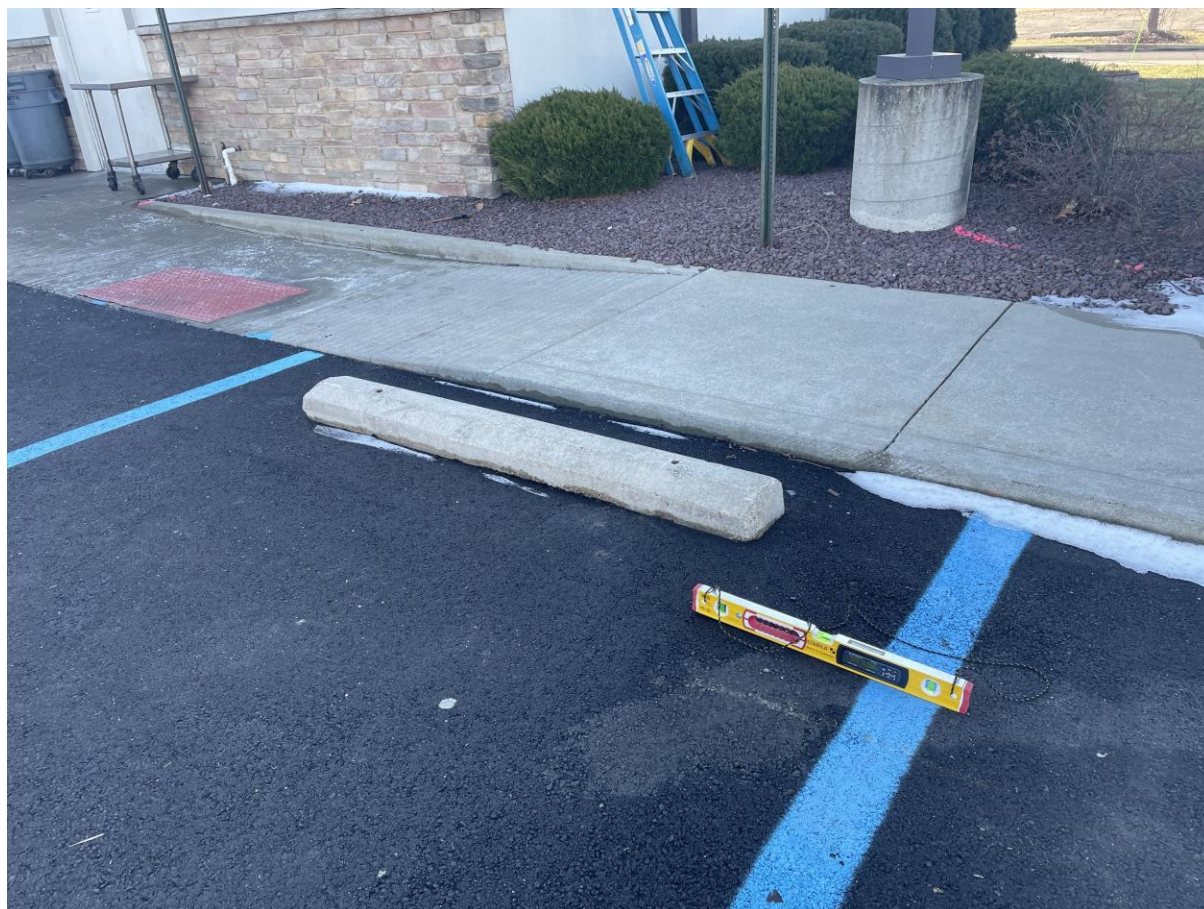
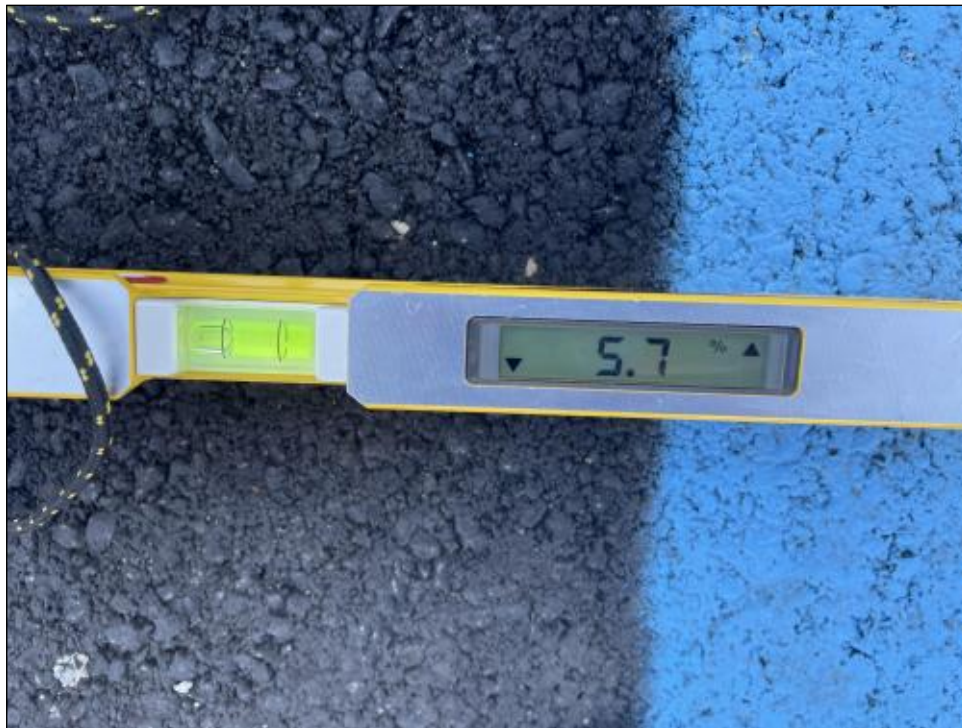
### Finding: 9

The cross slope (narrow dimension) of the parking stall exceeds 2%.

The running and cross slope in an accessible parking stall and the access aisle must not exceed 2%.

5.7% (top right corner)

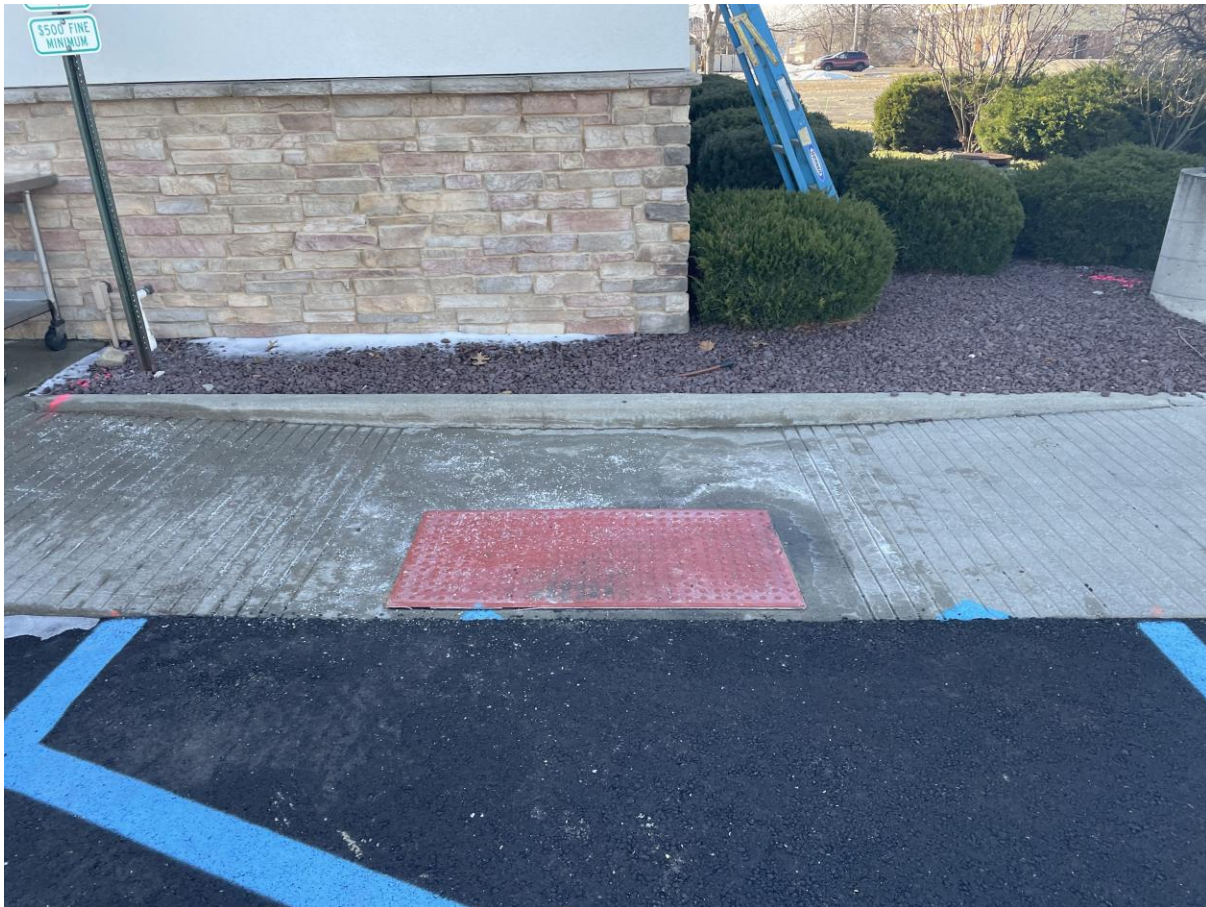
### Finding: 10

The accessible route of travel contains detectable warnings (truncated domes) which are not currently required by the 2010 ADAS or ANSI A117.1 for this location.

Due to the ongoing development of guidelines and lack of adopted standards and/or regulations pertaining to the installation of detectable warnings, it is recommended that detectable warnings not be installed until such time that the standards and/or regulations require them. Please confirm with the local AHJ.

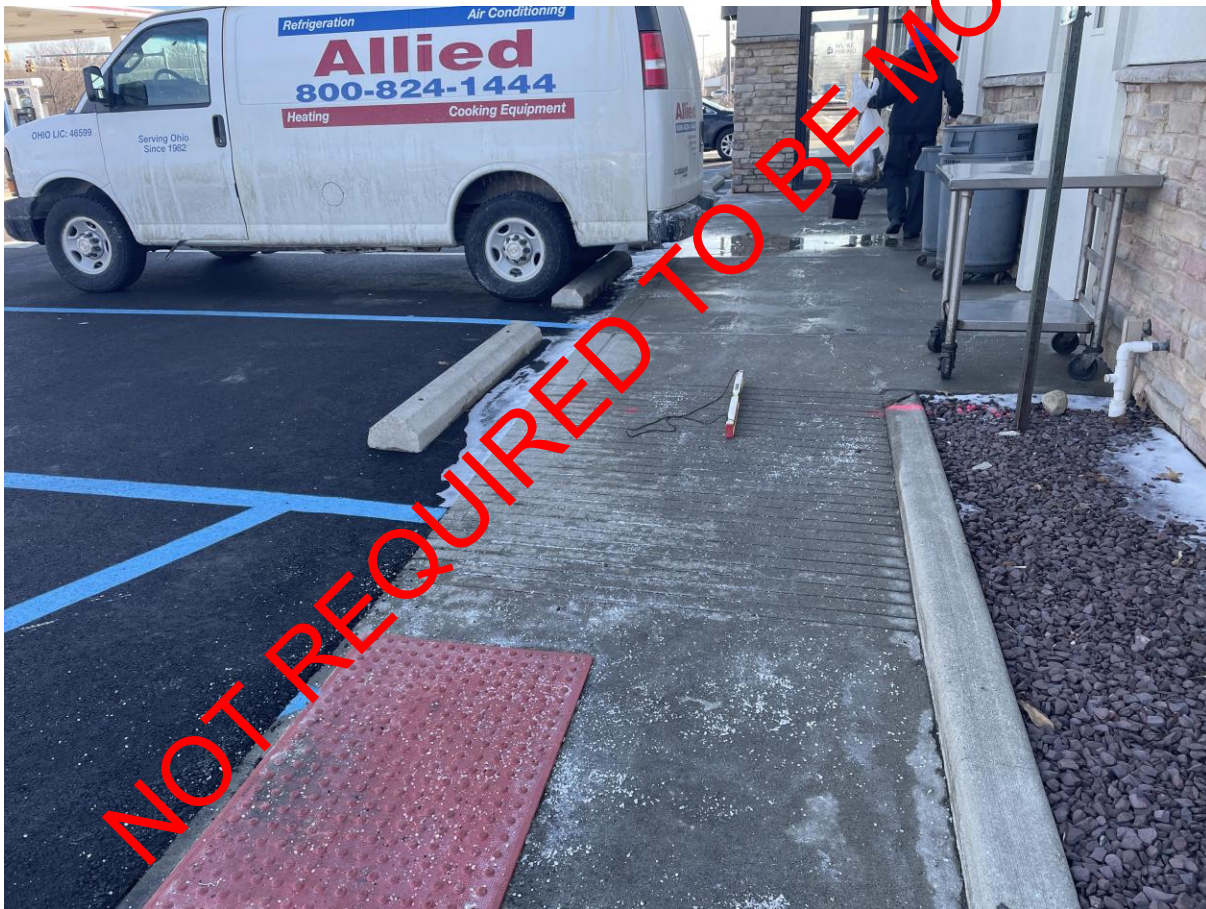
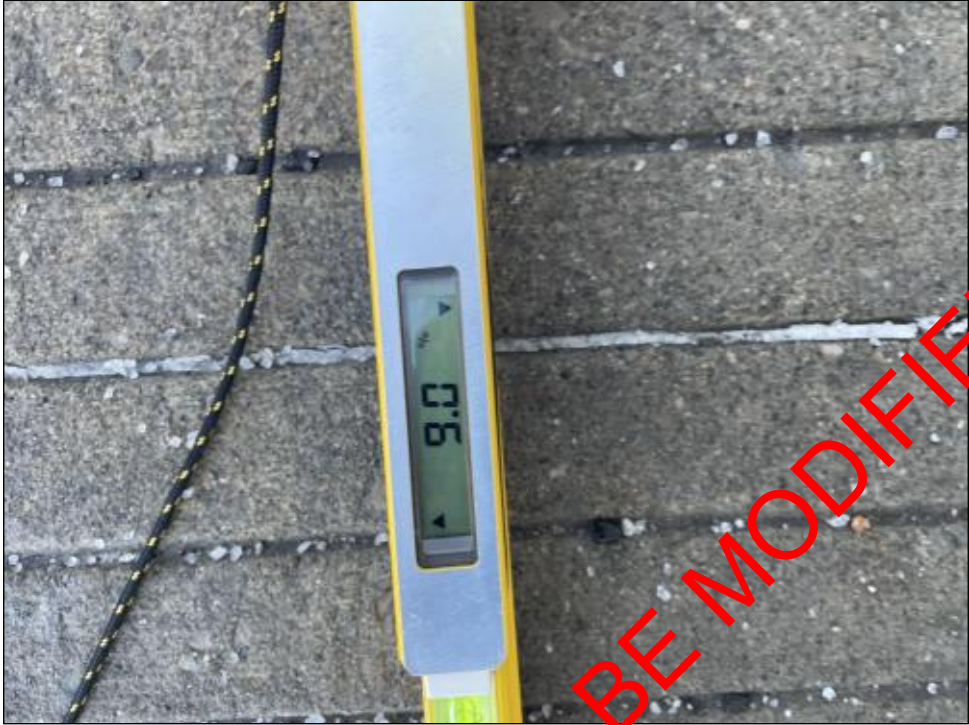
### Finding: 11

The curb ramp exceeds the maximum running slope (parallel to the direction of travel) allowable of 8.33%.

Curb ramps should have the least possible slope but in no case more than 8.33% (1:12).

9.0%

**WITHIN REASONABLE CONSTRUCTION TOLERANCE**

NOT REQUIRED TO BE MODIFIED

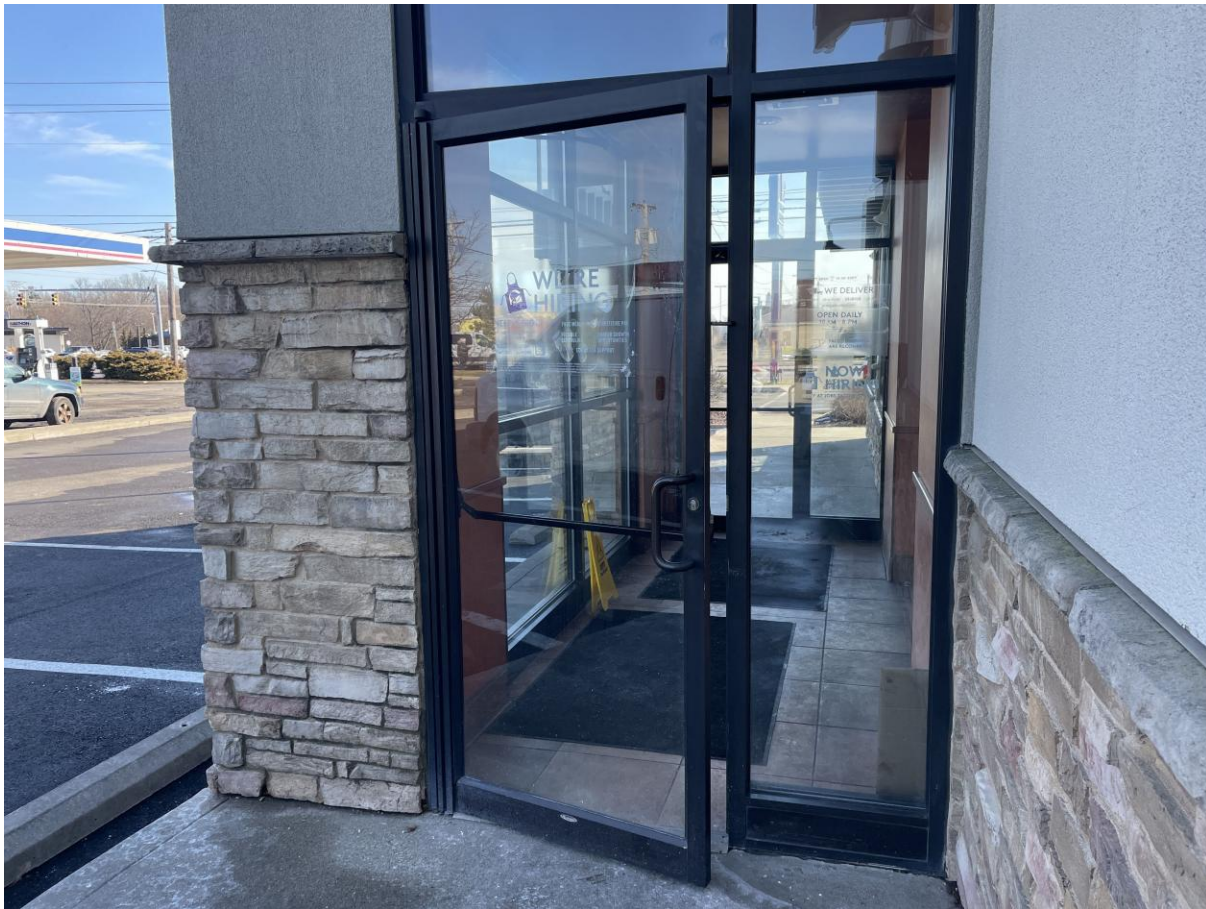
### **Finding: 12**

The door exceeds the maximum pressure to open the door.

Exterior hinged doors shall be designed so that such doors can be pushed or pulled open with a force not exceeding 8.5 pounds.

11 lbs
