# Site Accessibility Evaluation

## Americans with Disabilities Act And ANSI A117.1

**Taco Bell Store #015908  
(Pre)**

**Pre Inspection**

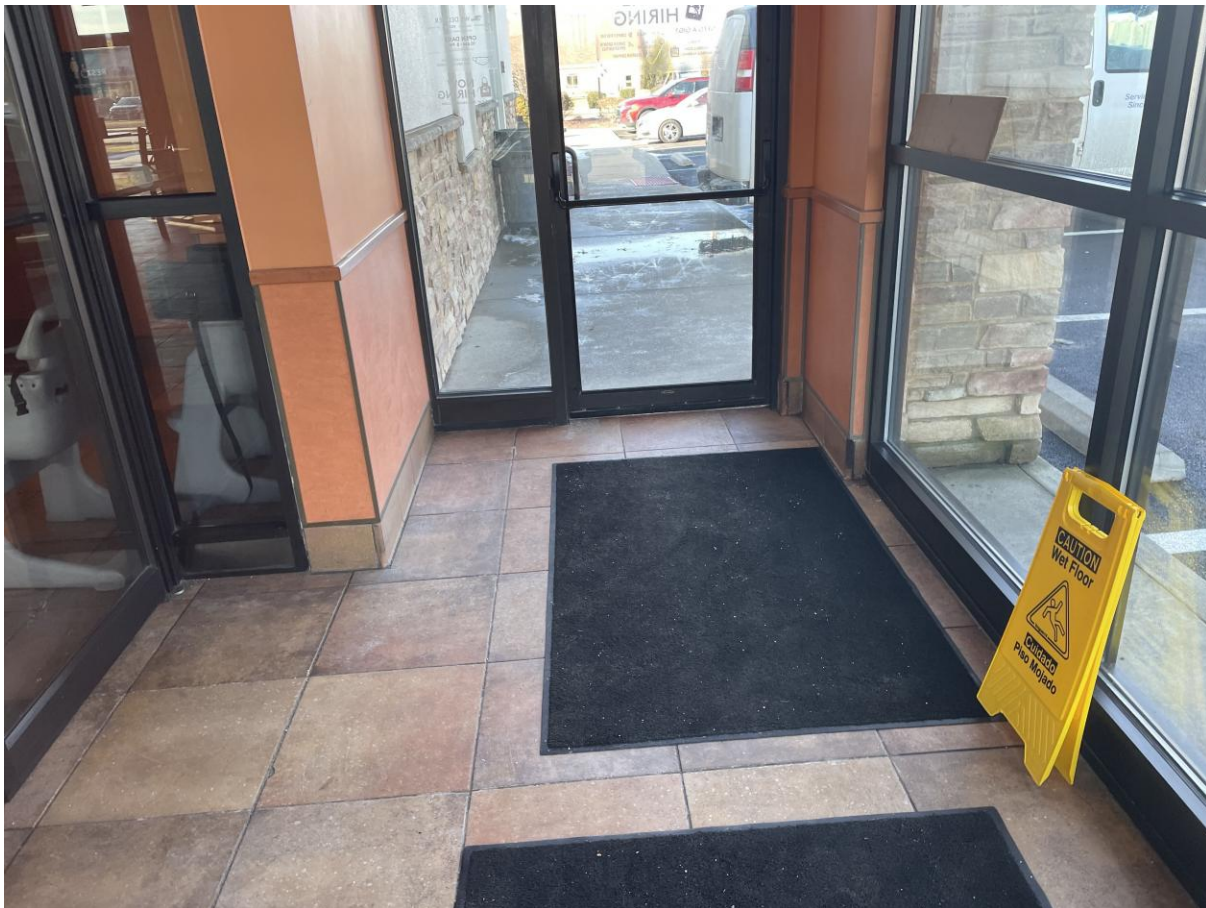
### **Finding: 13**

The floor mat at the door is not secured in place.

If carpet or carpet tile is used on a ground or floor surface, then it shall be securely attached; have a firm cushion, pad or backing or no cushion or pad; and have a level loop, textured loop, level-cut pile or level-cut/uncut pile texture. The maximum pile height shall be 1/2 inch. Exposed edges of carpet shall be fastened to floor surfaces and have trim along the entire length of the exposed edge. Recessed doormats shall be adequately anchored to prevent interference with wheelchair traffic.

Not secured

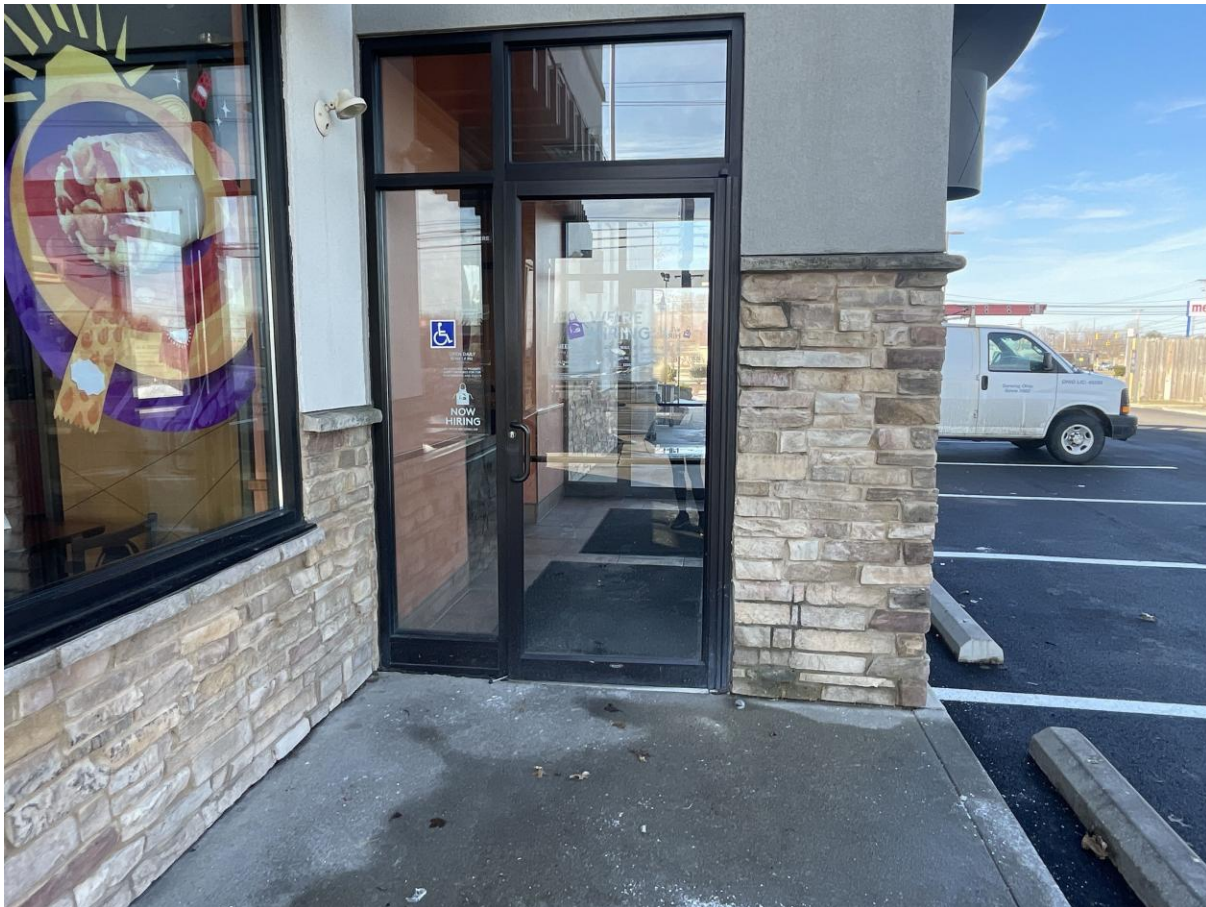
### **Finding: 14**

The door exceeds the maximum pressure to open the door.

Exterior hinged doors shall be designed so that such doors can be pushed or pulled open with a force not exceeding 8.5 pounds.

**10 lbs**

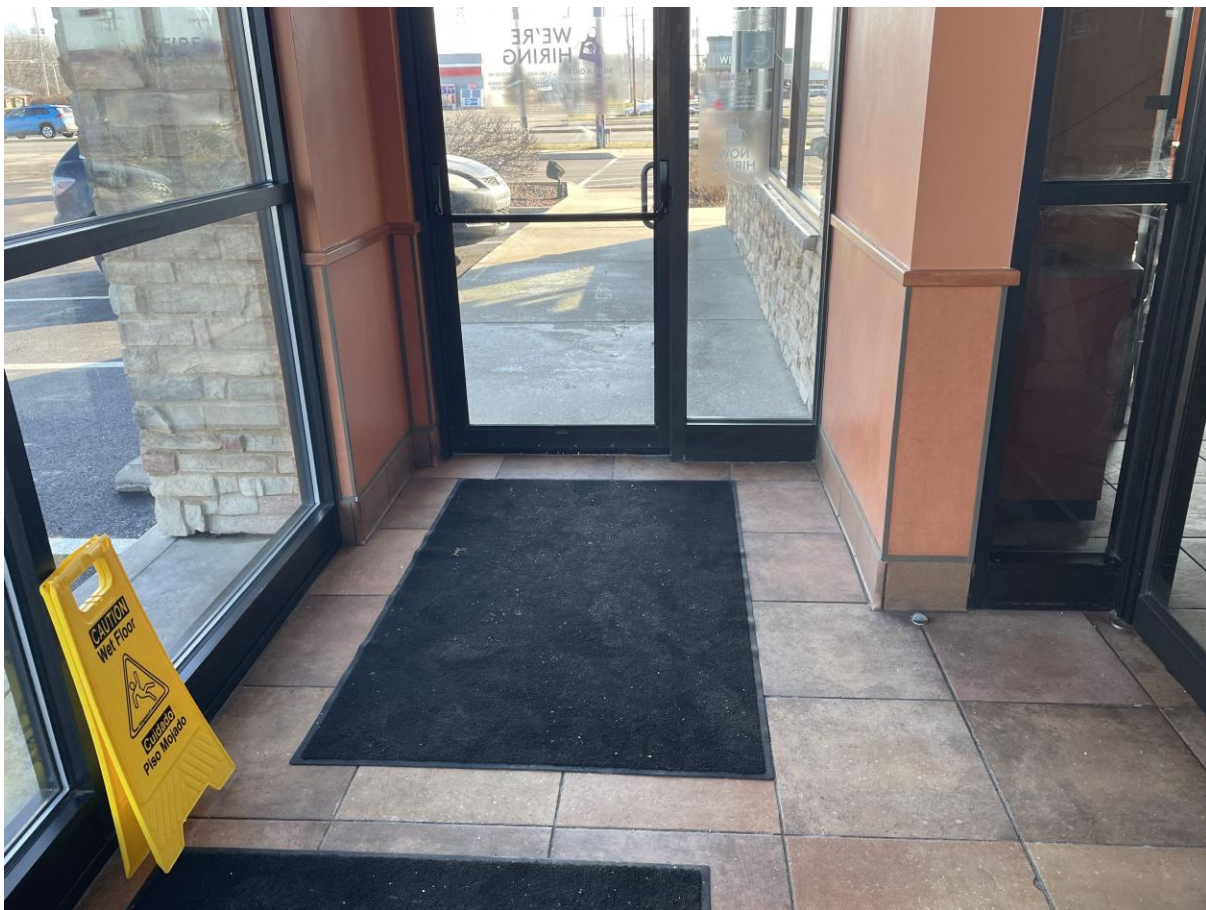
### **Finding: 15**

The floor mat at the door is not secured in place.

If carpet or carpet tile is used on a ground or floor surface, then it shall be securely attached; have a firm cushion, pad or backing or no cushion or pad; and have a level loop, textured loop, level-cut pile or level-cut/uncut pile texture. The maximum pile height shall be 1/2 inch. Exposed edges of carpet shall be fastened to floor surfaces and have trim along the entire length of the exposed edge. Recessed doormats shall be adequately anchored to prevent interference with wheelchair traffic.

Not secured

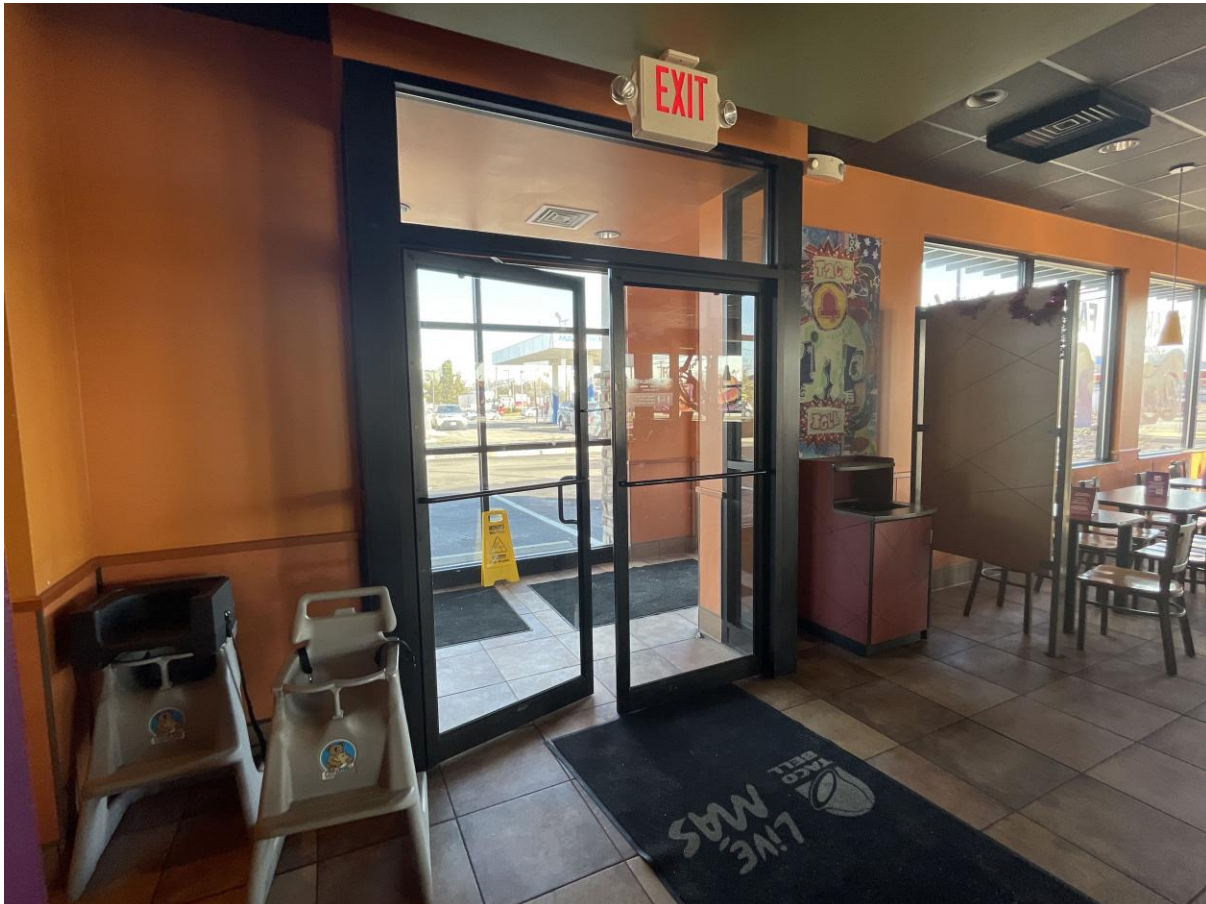
### **Finding: 16**

The door exceeds the maximum allowable opening force.

Interior doors shall have a maximum opening force of 5 pounds.

9 lbs

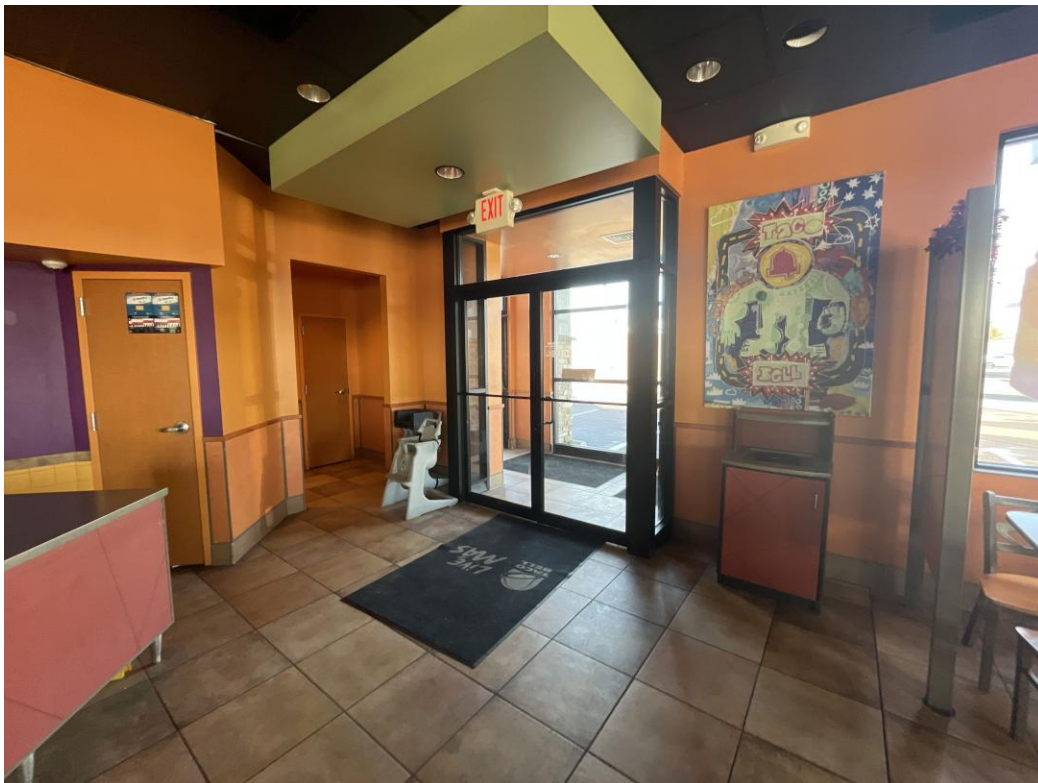
### **Finding: 17**

The tactile EXIT sign is missing at the door.

Wall signs identifying exits shall have characters raised 1/32 inch minimum and shall be uppercase characters a minimum of 5/8 inch and a maximum of 2 inches high. Braille shall be placed directly below the tactile characters; flush left or centered. Signs shall be located a minimum of 48 inches above the floor, measured from the baseline of the lowest tactile characters and 60 inches maximum above the finish floor or ground surface, measured from the baseline of the highest tactile characters.

Missing

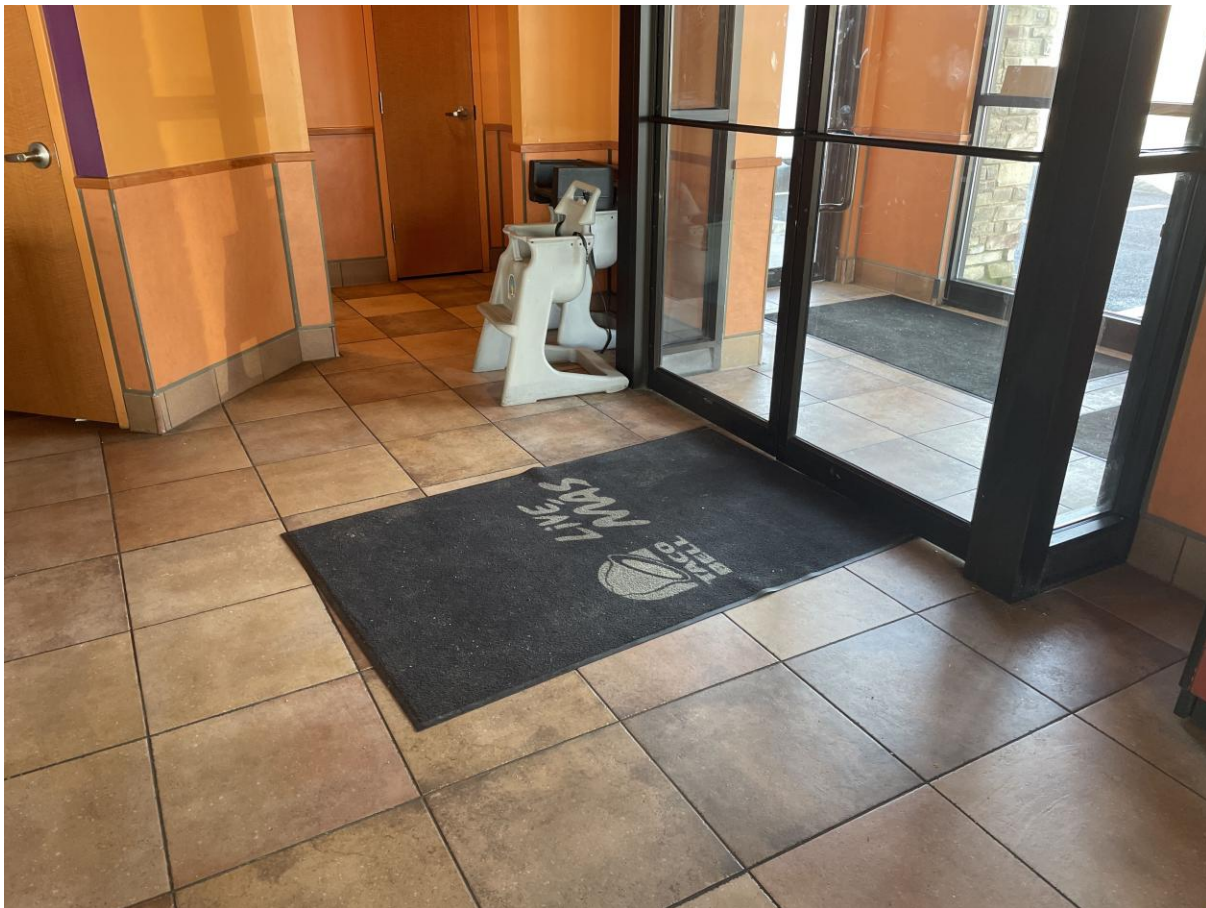
### **Finding: 18**

The floor mat at the door is not secured in place.

If carpet or carpet tile is used on a ground or floor surface, then it shall be securely attached; have a firm cushion, pad or backing or no cushion or pad; and have a level loop, textured loop, level-cut pile or level-cut/uncut pile texture. The maximum pile height shall be 1/2 inch. Exposed edges of carpet shall be fastened to floor surfaces and have trim along the entire length of the exposed edge. Recessed doormats shall be adequately anchored to prevent interference with wheelchair traffic.

Not secured

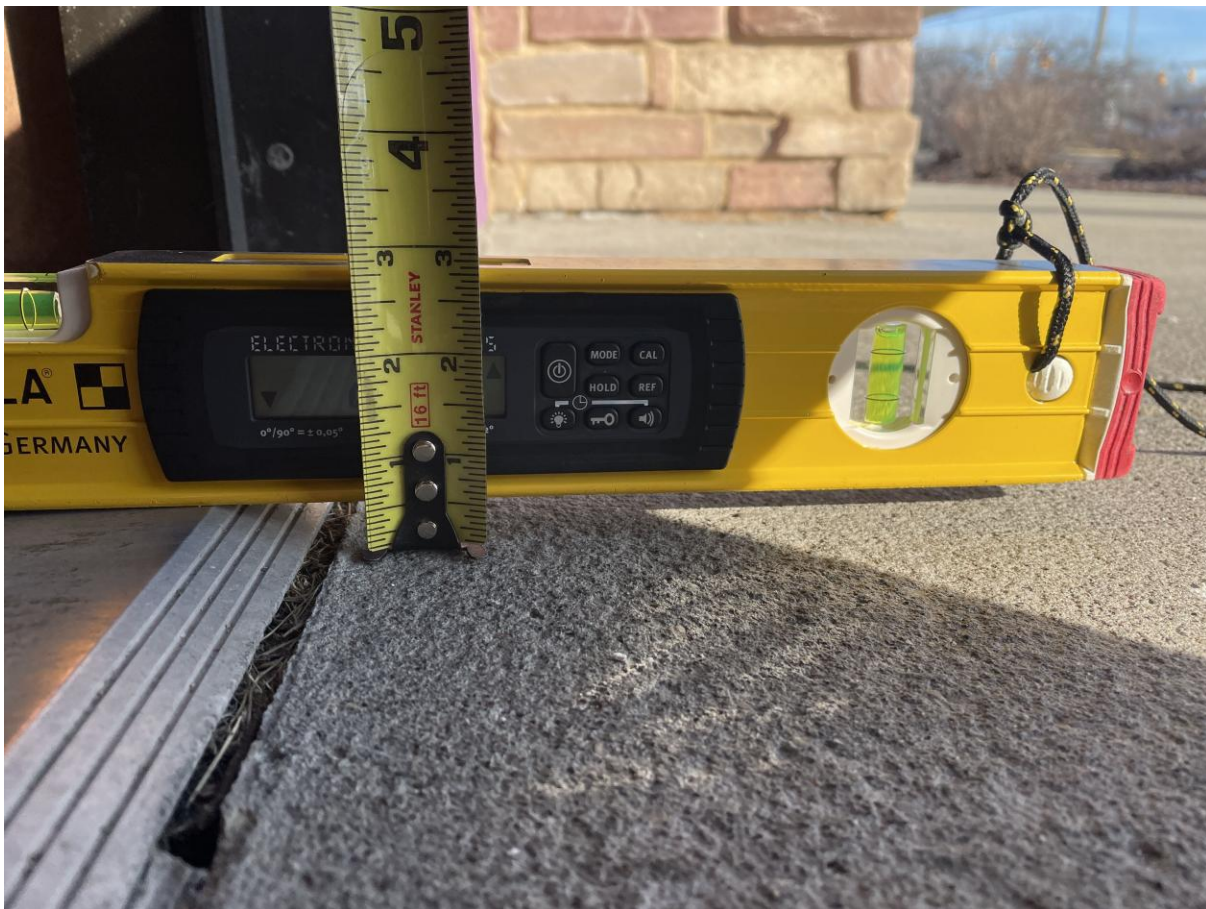
### **Finding: 19**

The threshold is greater than 1/2 inch high.

The threshold at a doorway shall be no higher than 1/2 inch. Changes in level between 1/4 inch and 1/2 inch must be beveled at 1:2 or less. 1/4 inch is the maximum vertical rise.

3/4" (lifted)

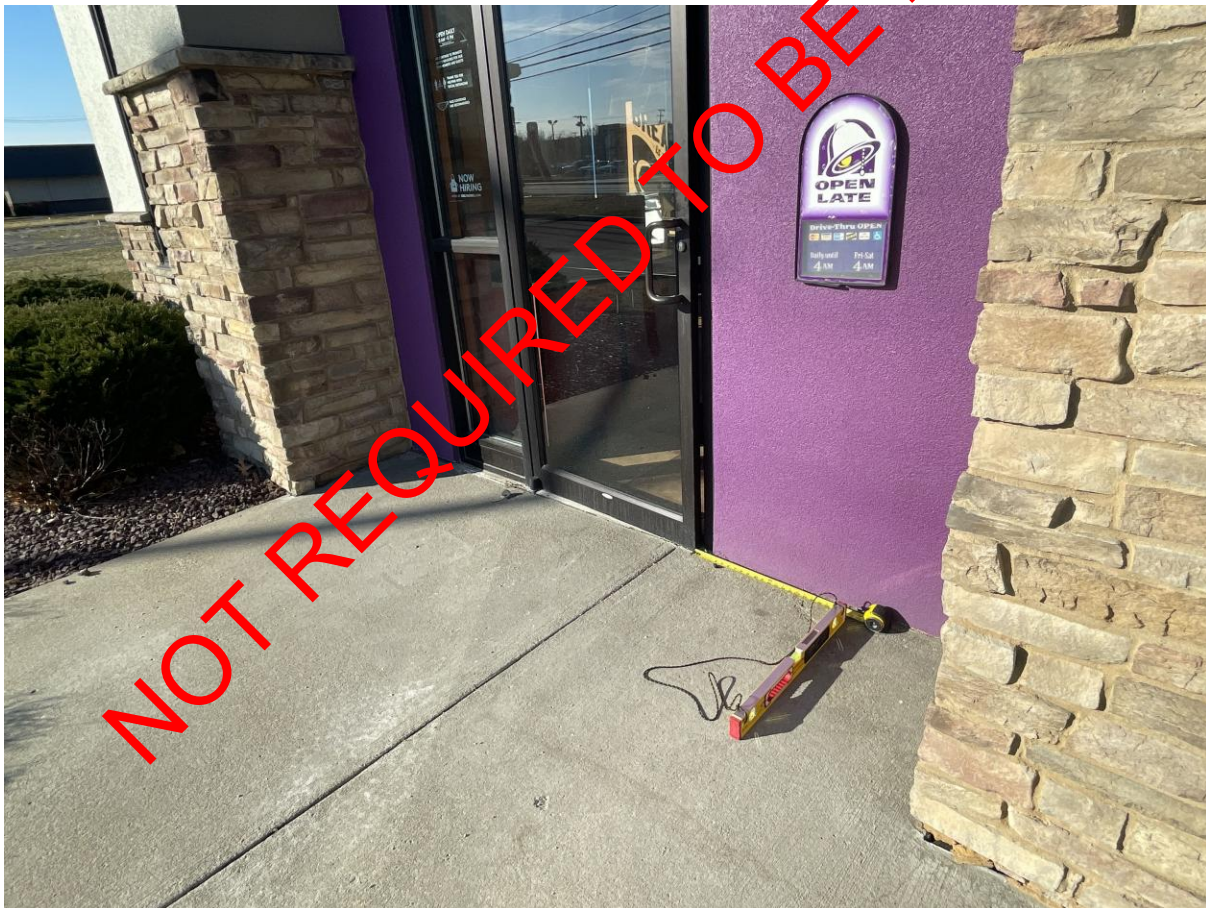
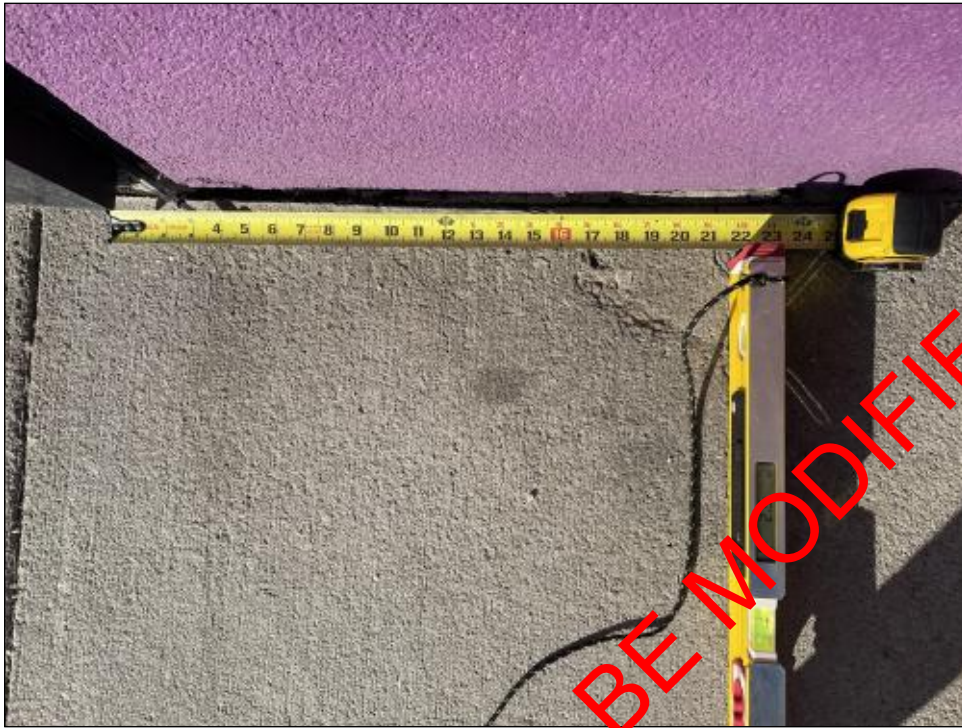
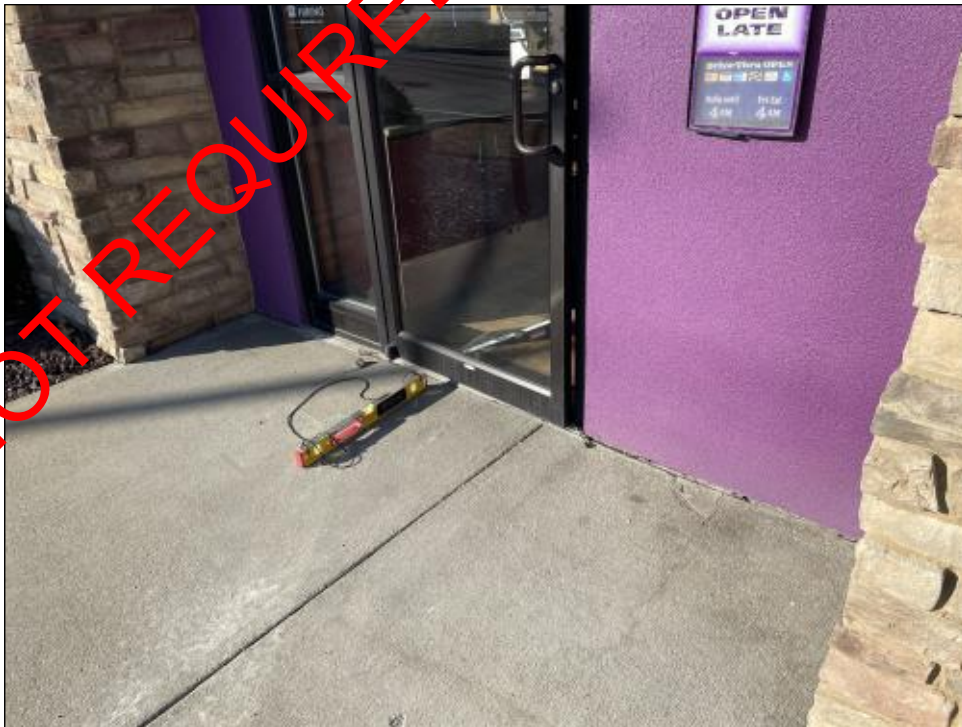
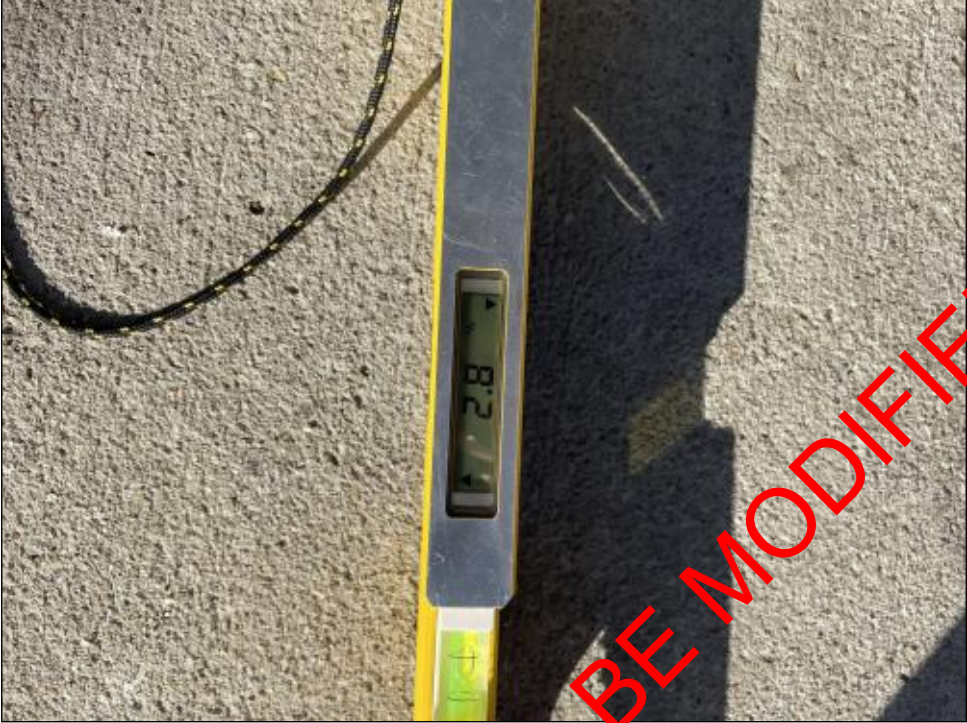
### Finding: 20

The maneuvering clearance at the entrance door exceeds 2% slope.

Exterior doors with a front approach must have a landing on the pull side that is a minimum of 60 inches in depth perpendicular to the door in a close position by a minimum width dimension of 18 inches plus the door width. The additional 18 inches must extend past the door on the latch side. The entire maneuvering clearance must be free of obstructions and must be flat (2% max. slope is considered flat in any direction).

2.5%-2.8%

WITHIN REASONABLE CONSTRUCTION TOLERANCE

NOT REQUIRED TO BE MODIFIED

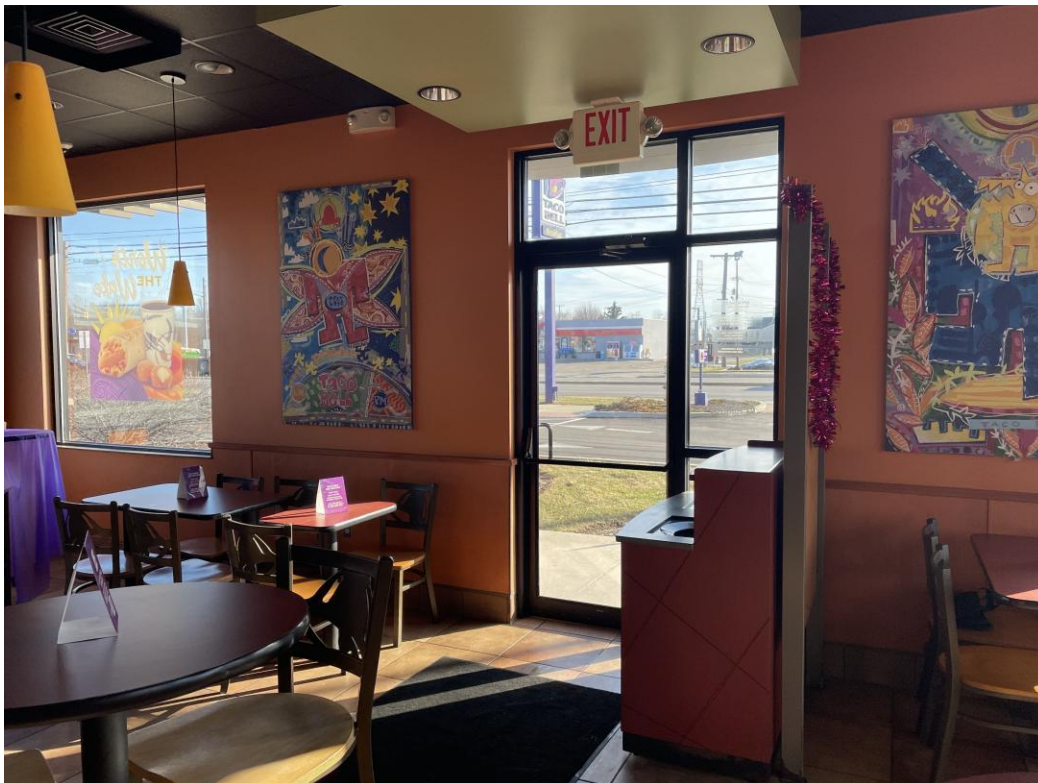
### **Finding: 21**

The tactile EXIT sign is missing at the door.

Wall signs identifying exits shall have characters raised 1/32 inch minimum and shall be uppercase characters a minimum of 5/8 inch and a maximum of 2 inches high. Braille shall be placed directly below the tactile characters; flush left or centered. Signs shall be located a minimum of 48 inches above the floor, measured from the baseline of the lowest tactile characters and 60 inches maximum above the finish floor or ground surface, measured from the baseline of the highest tactile characters.

Missing

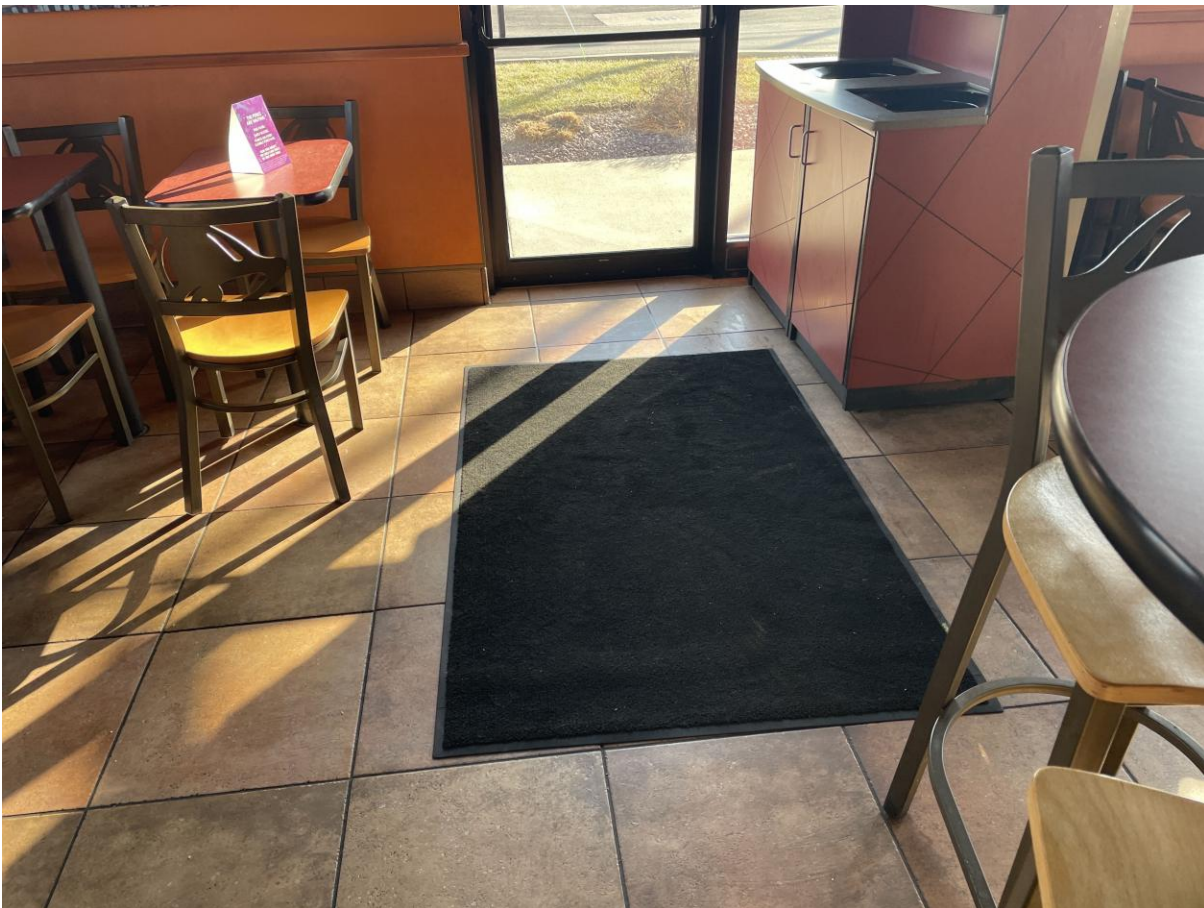
### **Finding: 22**

The floor mat at the door is not secured in place.

If carpet or carpet tile is used on a ground or floor surface, then it shall be securely attached; have a firm cushion, pad or backing or no cushion or pad; and have a level loop, textured loop, level-cut pile or level-cut/uncut pile texture. The maximum pile height shall be 1/2 inch. Exposed edges of carpet shall be fastened to floor surfaces and have trim along the entire length of the exposed edge. Recessed doormats shall be adequately anchored to prevent interference with wheelchair traffic.

Not secured

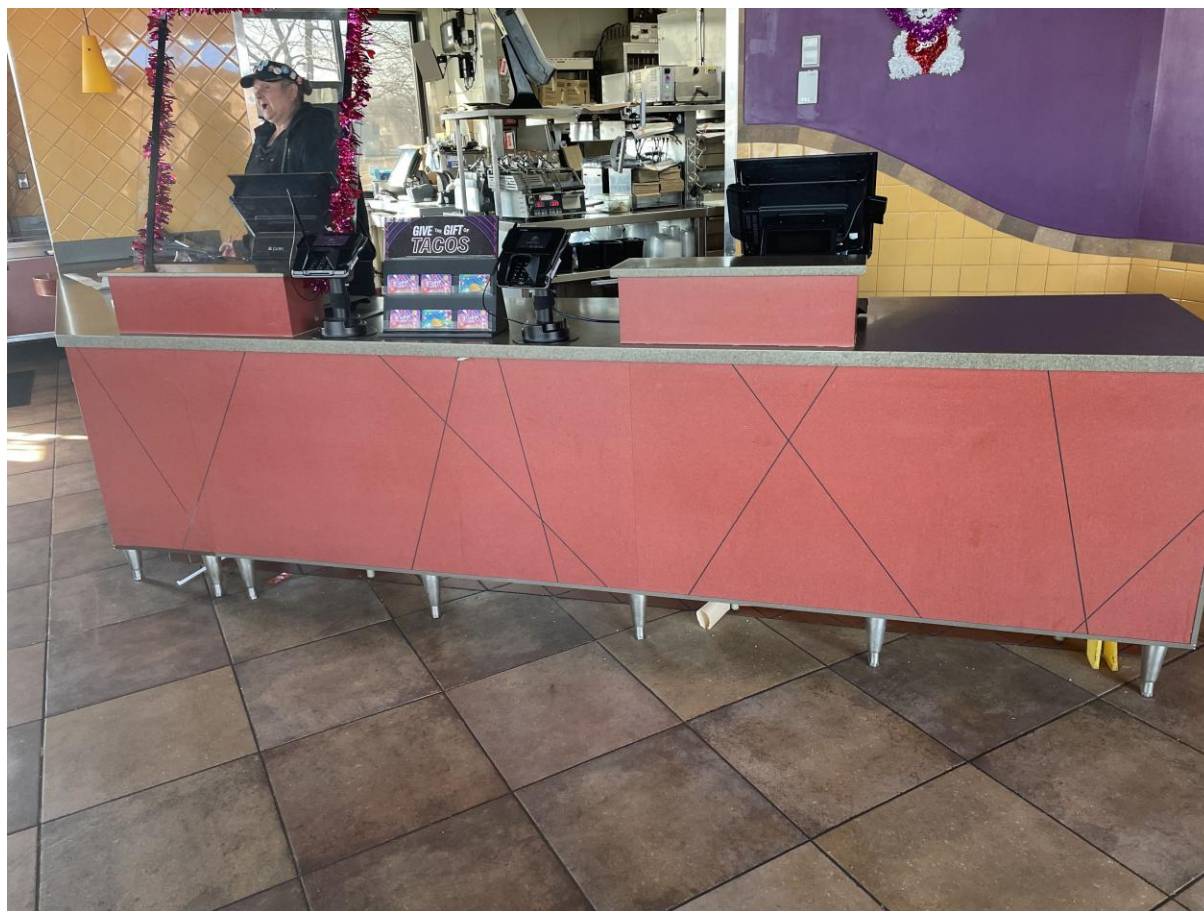
### Finding: 23

A front counter sign stating: "Please Ask if You Need Assistance" in a visible location for customers has not been installed.

Missing

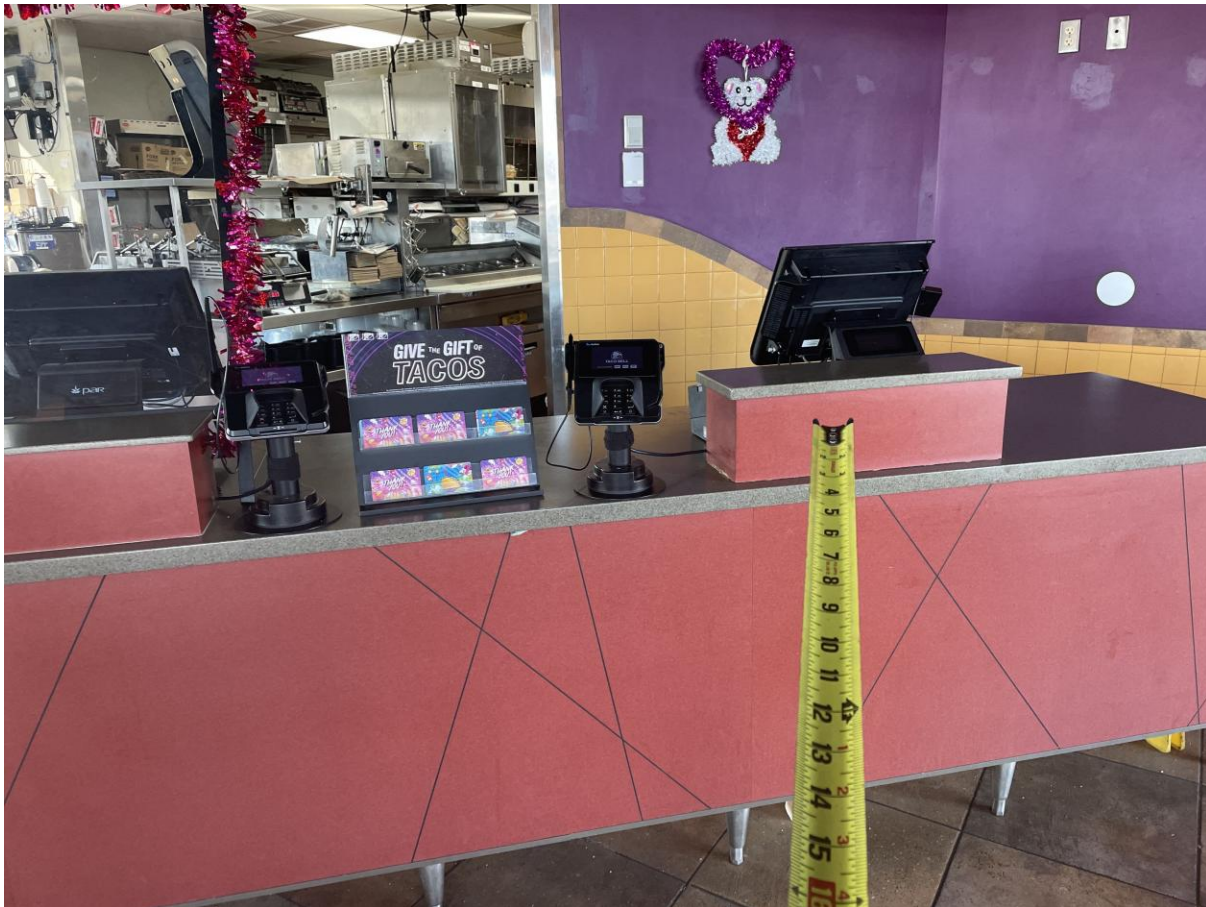
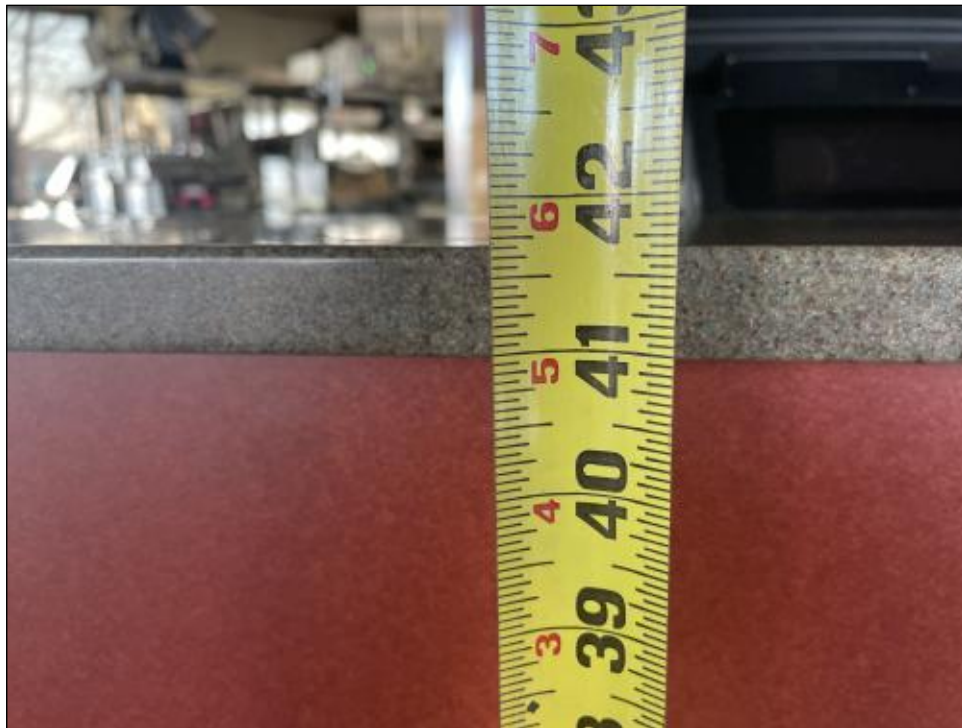
### Finding: 24

The counter is too high.

A portion of the counter surface that is 30 inches long minimum and 36 inches high maximum shall be provided. Knee and toe space shall be provided under the counter. A clear floor or ground space shall be positioned for a forward approach to the counter.

40 1/4" (to partitions)

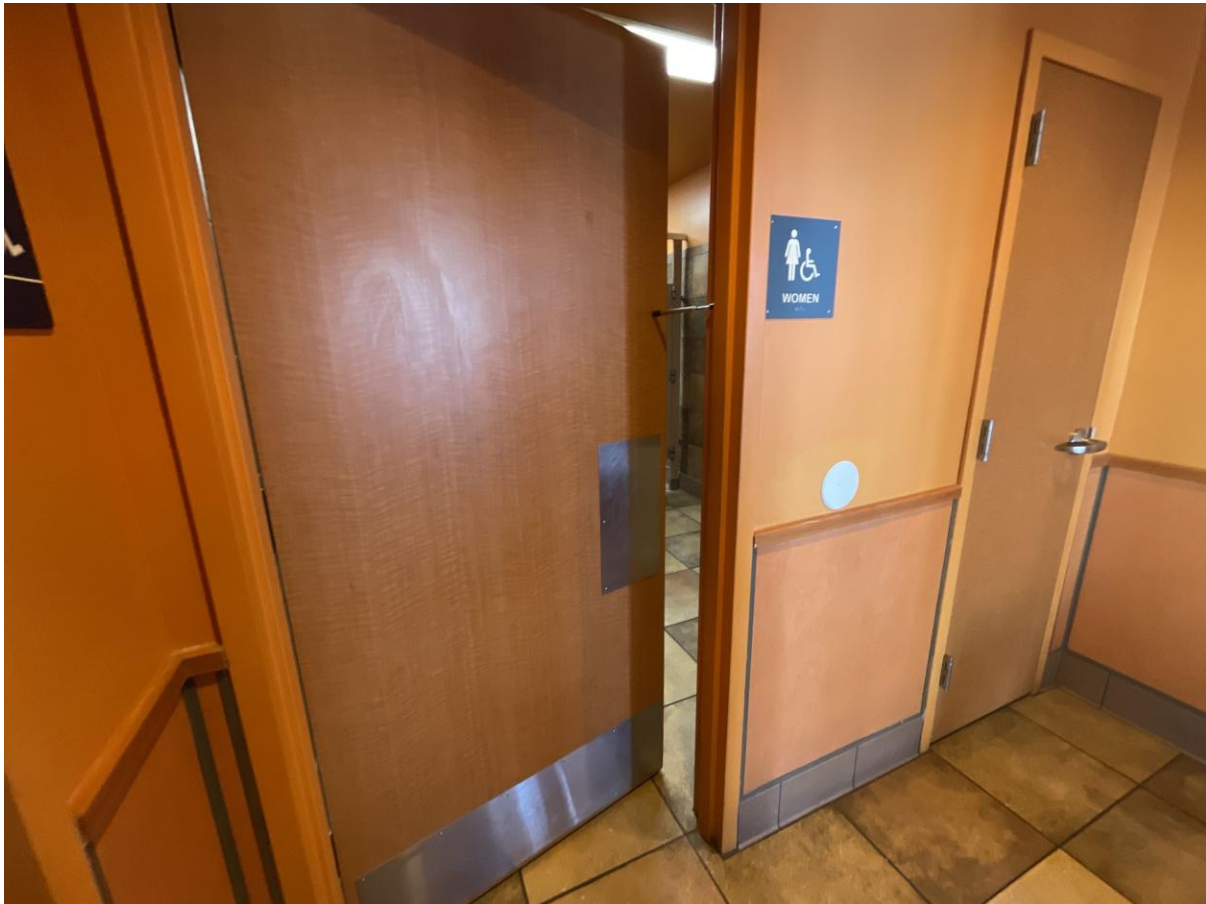
### **Finding: 25**

The door exceeds the maximum allowable opening force.

Interior doors shall have a maximum opening force of 5 pounds.

10 lbs

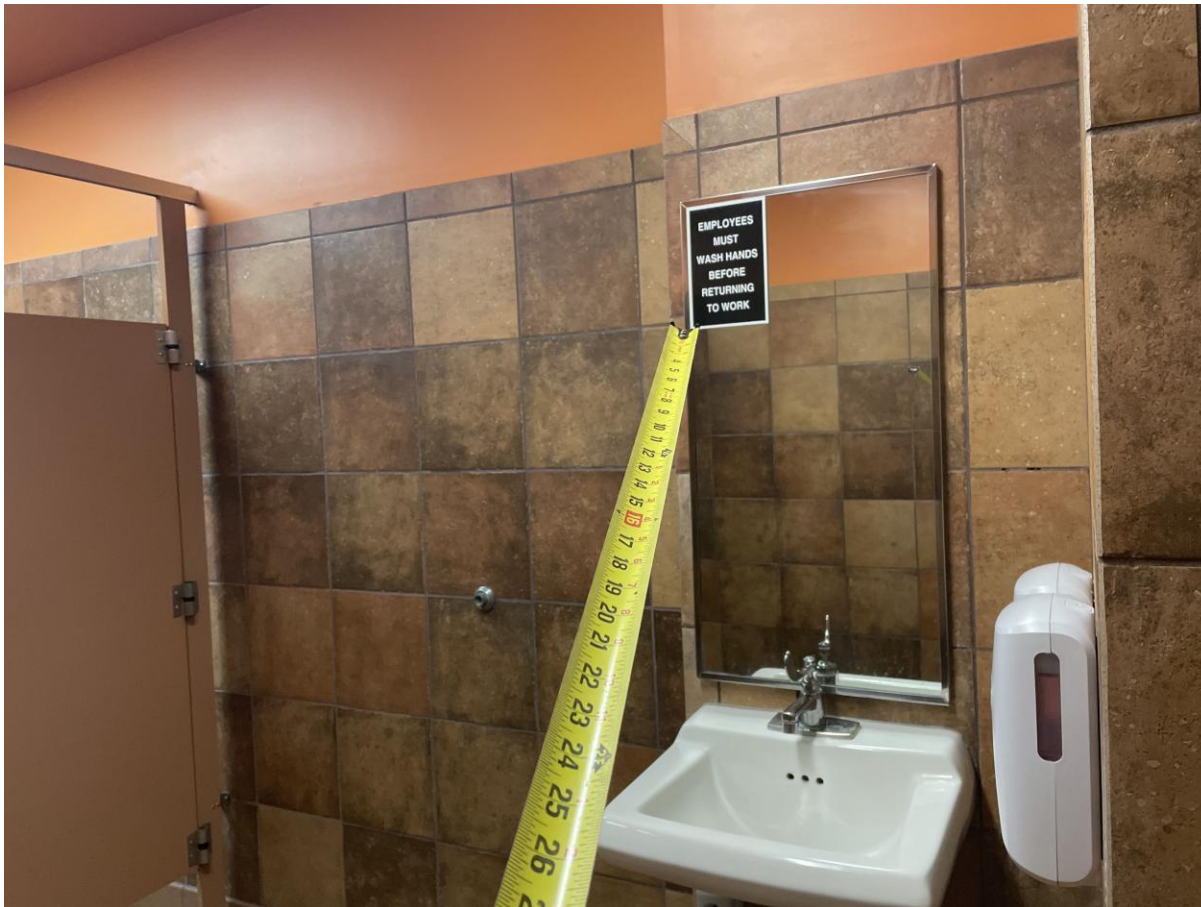
### **Finding: 26**

The employee sign is installed on the mirror which obstructs the reflecting surface.

Mirrors must have the bottom edge of the reflecting surface a maximum of 40 inches above the floor if above a sink or counter. Mirrors not located above lavatories or countertops shall be installed with the bottom edge of the reflecting surface 35 inches maximum above the finish floor or ground.

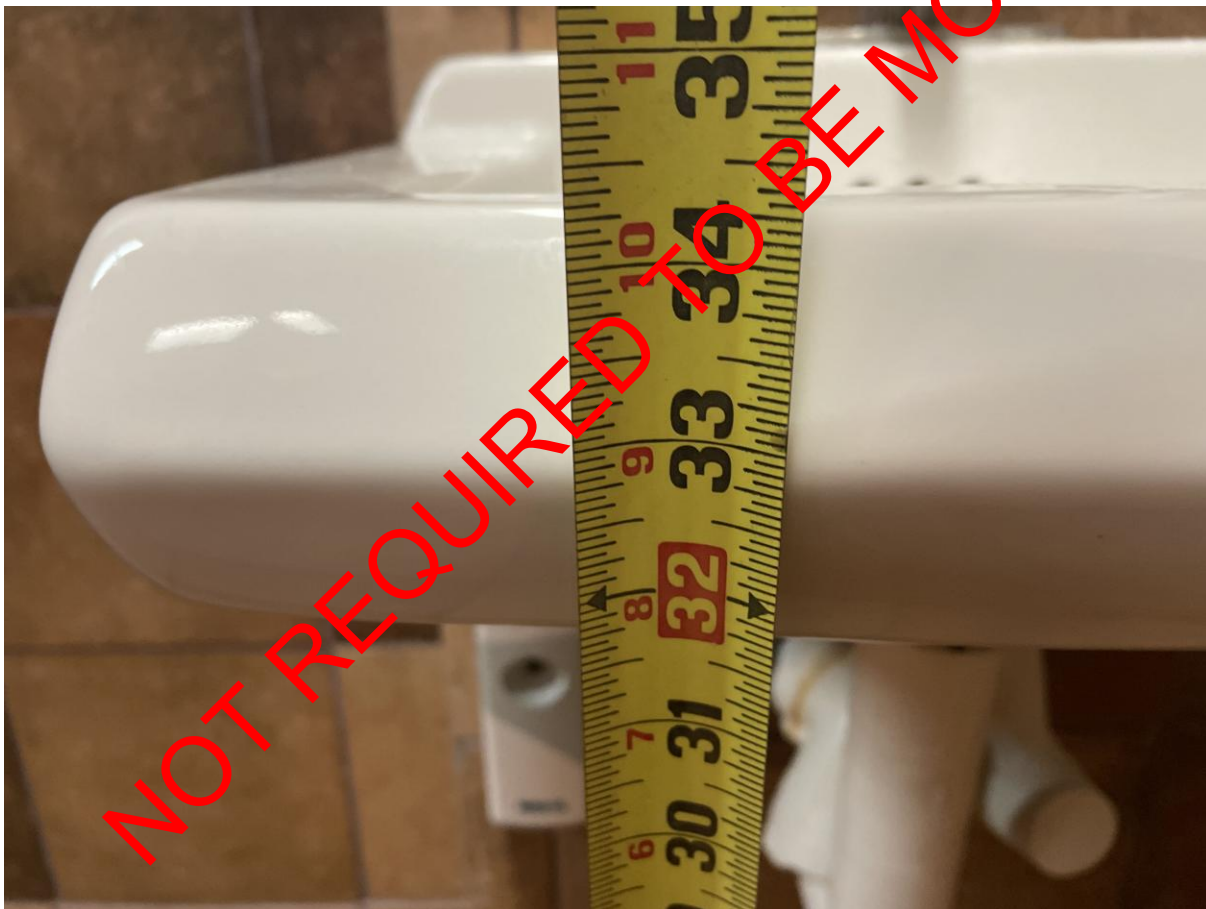
### Finding: 27

The top rim of the lavatory is too high.

All lavatories that are designated to be accessible shall be a minimum 17 inches in horizontal depth and mounted with the rim or counter edge no higher than 34 inches above the finished floor.

34 1/4"

WITHIN REASONABLE CONSTRUCTION TOLERANCE

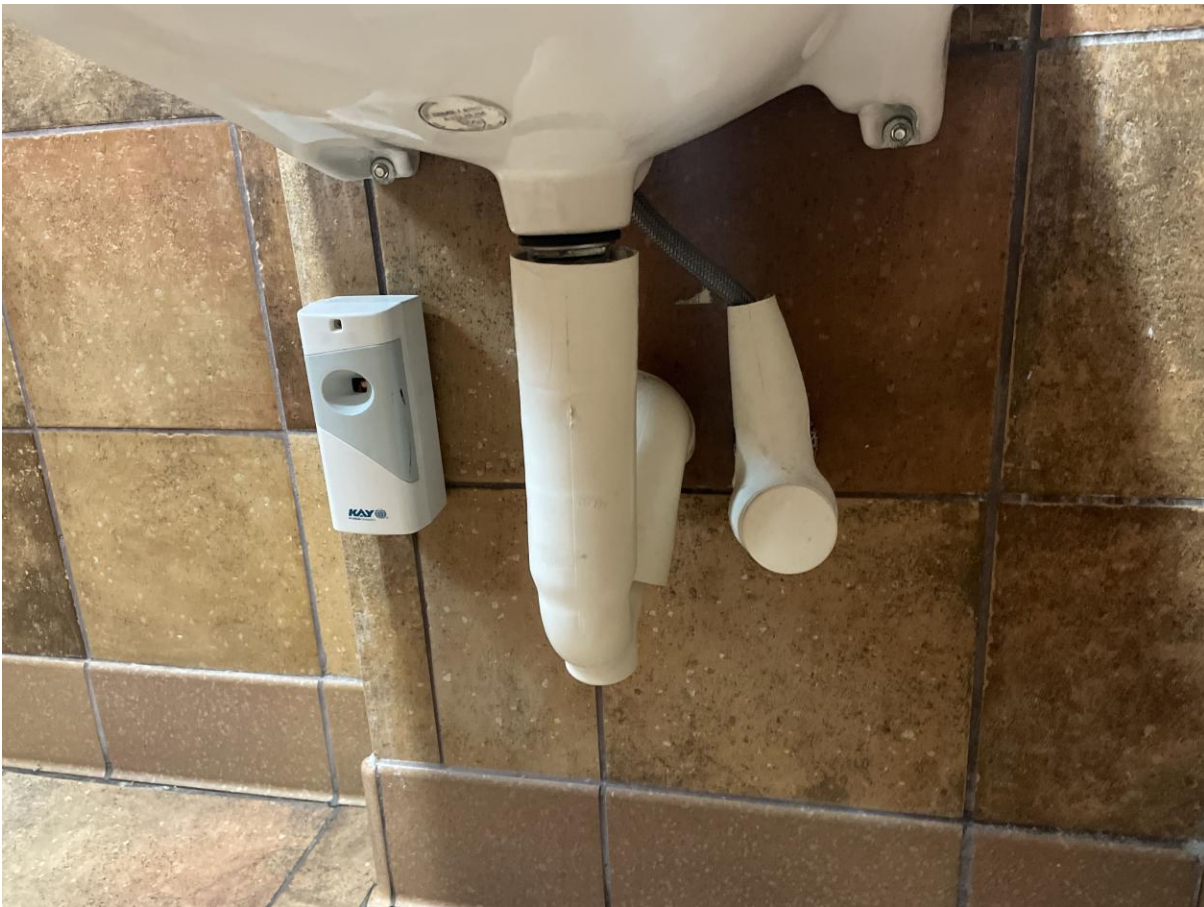
### **Finding: 28**

The water and drain pipes under the lavatory are not adequately insulated.

Water supply and drain pipes under lavatories and sinks shall be insulated or otherwise configured to protect against contact. There shall be no sharp or abrasive surfaces under lavatories and sinks.

Partial
