# Site Accessibility Evaluation

## Americans with Disabilities Act And ANSI A117.1

**Taco Bell Store #015908  
(Pre)**

**Pre Inspection**

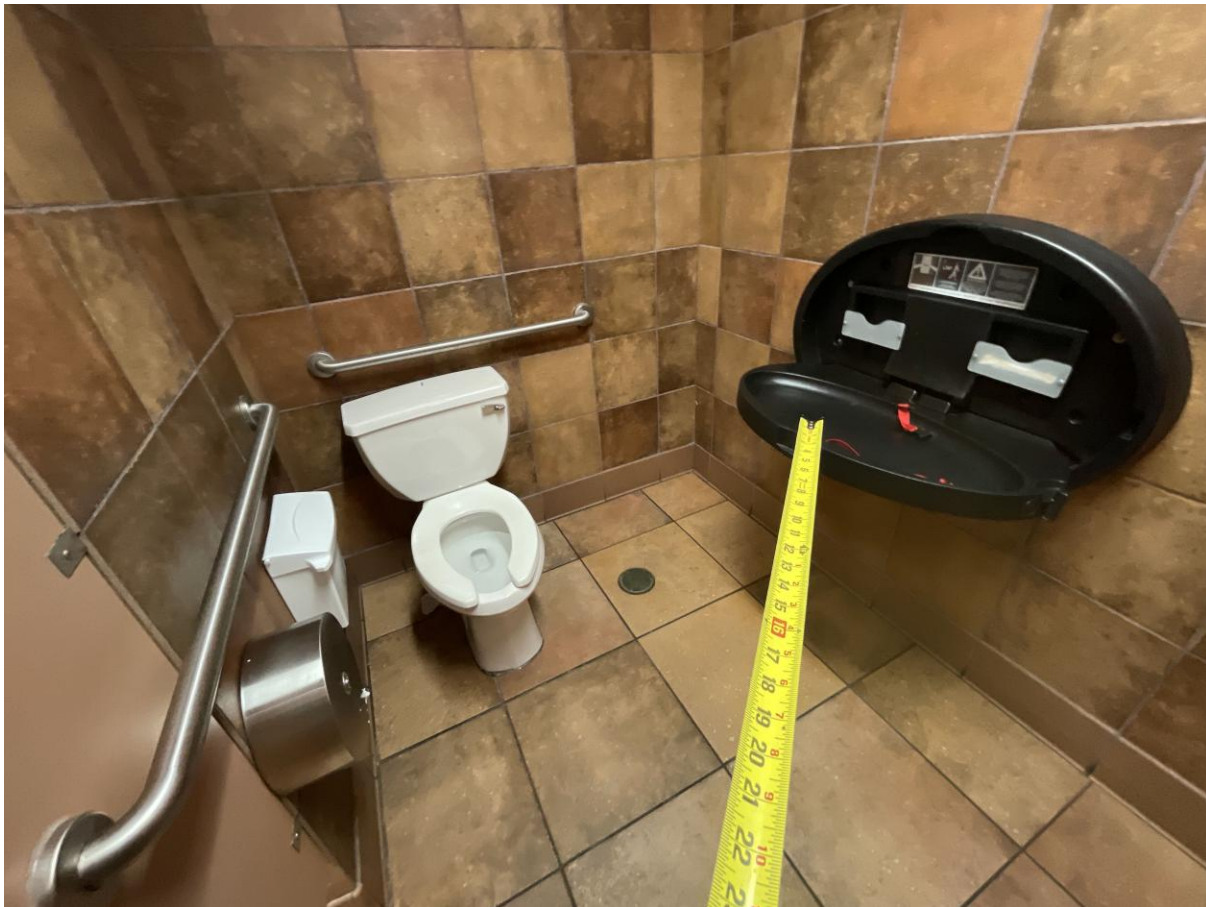
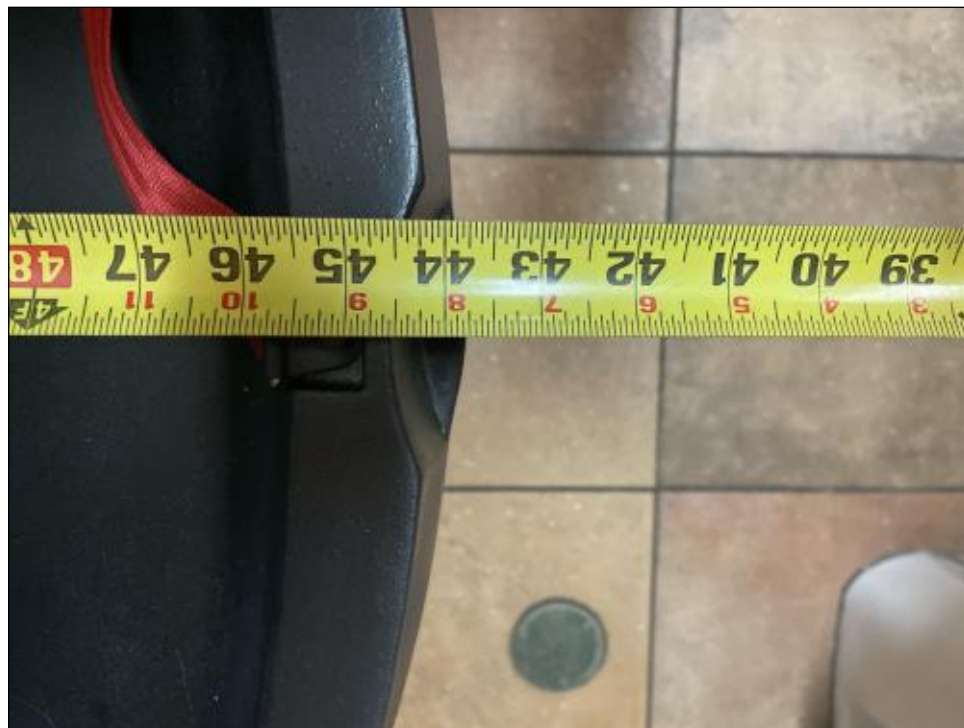
### Finding: 29

The toilet compartment is not wide enough.

Wheelchair accessible compartments shall be 60 inches wide minimum measured perpendicular to the side wall, and 56 inches deep minimum for wall hung water closets and 59 inches deep minimum for floor mounted water closets measured perpendicular to the rear wall.

Obstructed by  
changing table

**THE CHANGING TABLE SHOULD BE REMOVED**

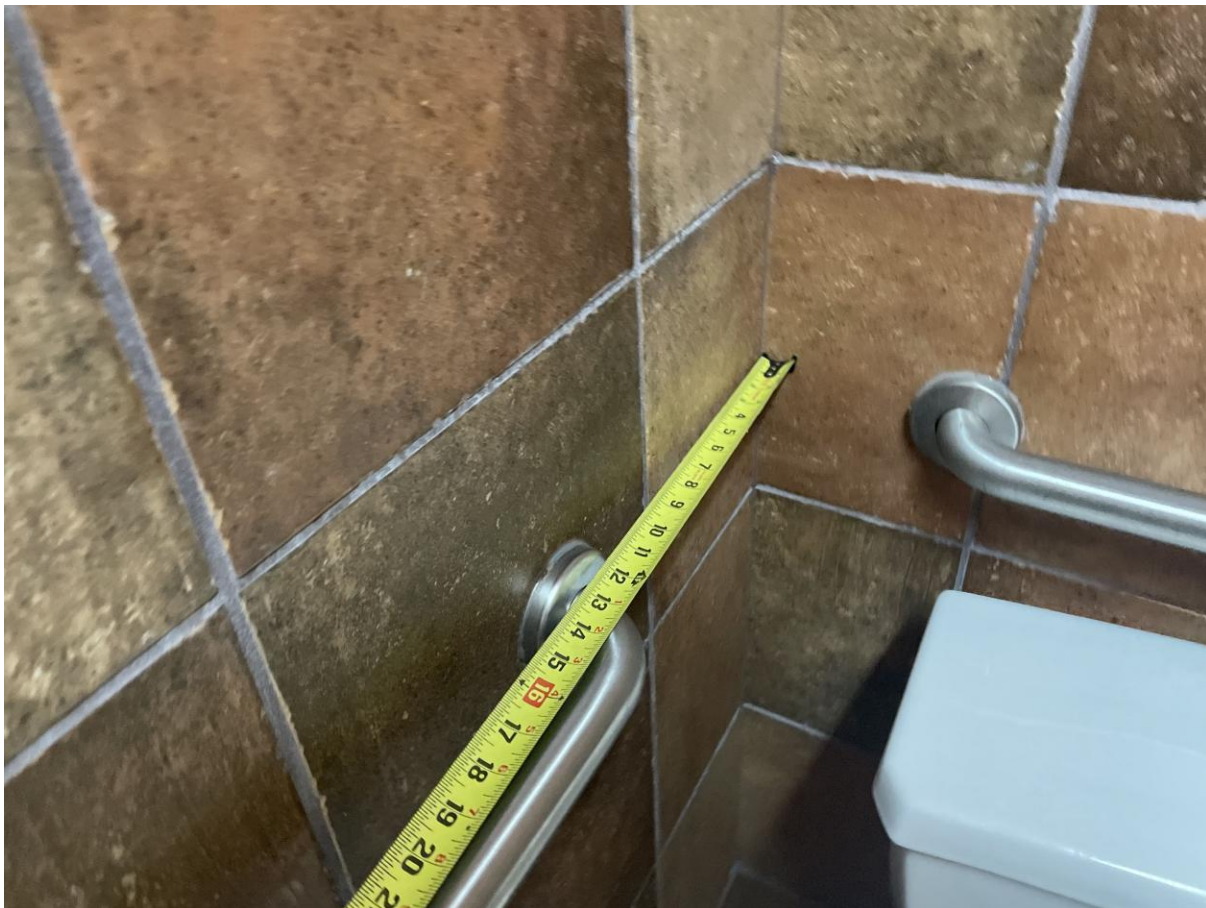
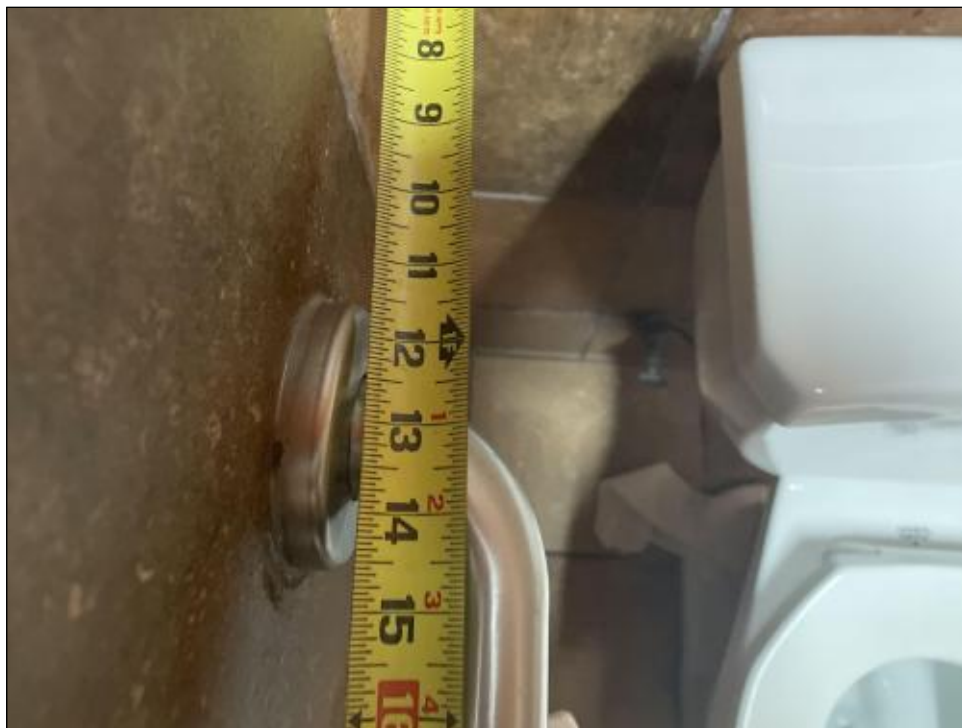
### **Finding: 30**

The side grab bar is located greater than 12 inches from the rear wall.

The side grab bar must extend at least 54 inches minimum beyond the rear wall and start a maximum of 12 inches from the rear wall. A 42 inch grab bar installed the maximum distance from the rear wall (12 inches) will leave the leading end 54 inches from the rear wall. Grab bars shall be installed in a horizontal position, 33 inches minimum and 36 inches maximum above the finish floor measured to the top of the gripping surface.

13"

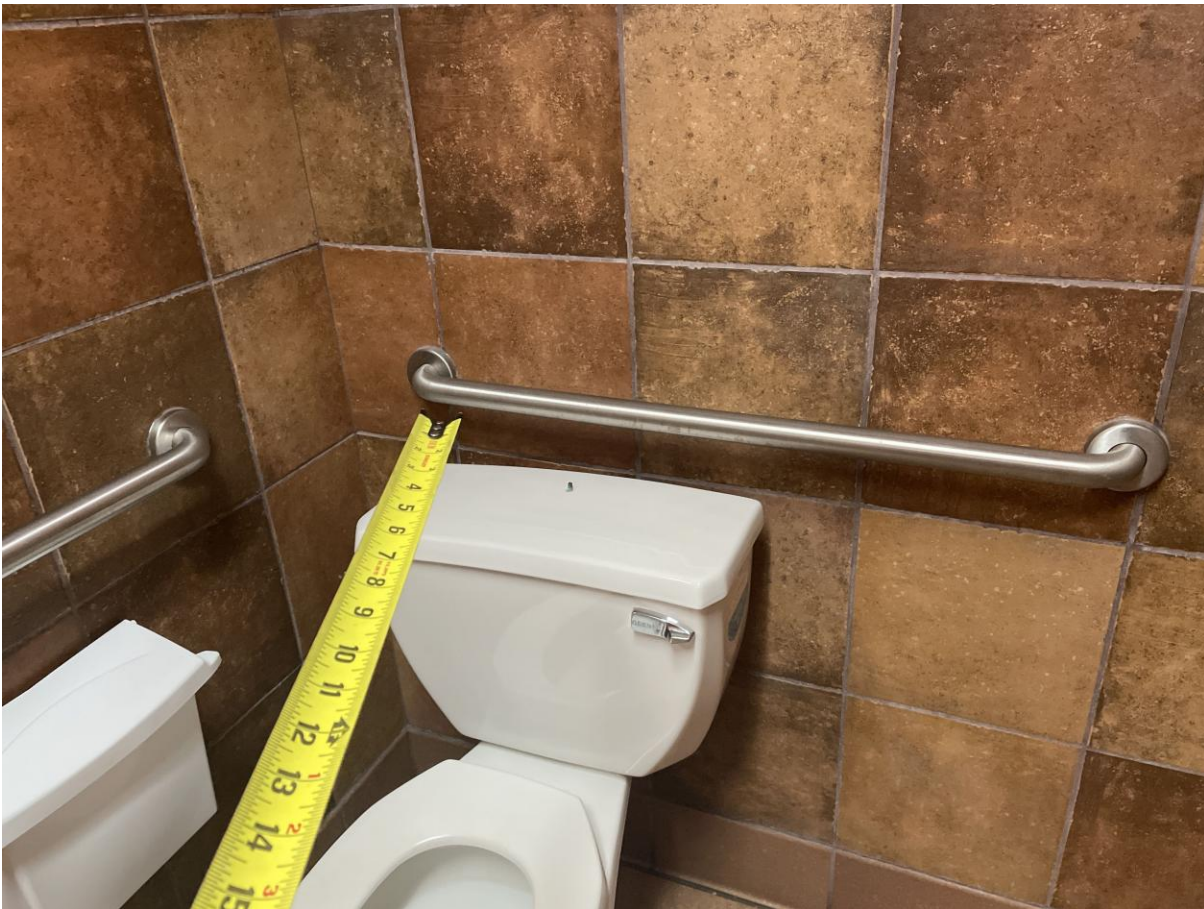
### **Finding: 31**

The rear grab bar does not extend adequately past the centerline of the toilet on the wall side.

The rear grab bar must be a minimum of 36 inches long and extend from the centerline of the toilet 12 inches minimum on one side and 24 inches minimum on the other side.

11"

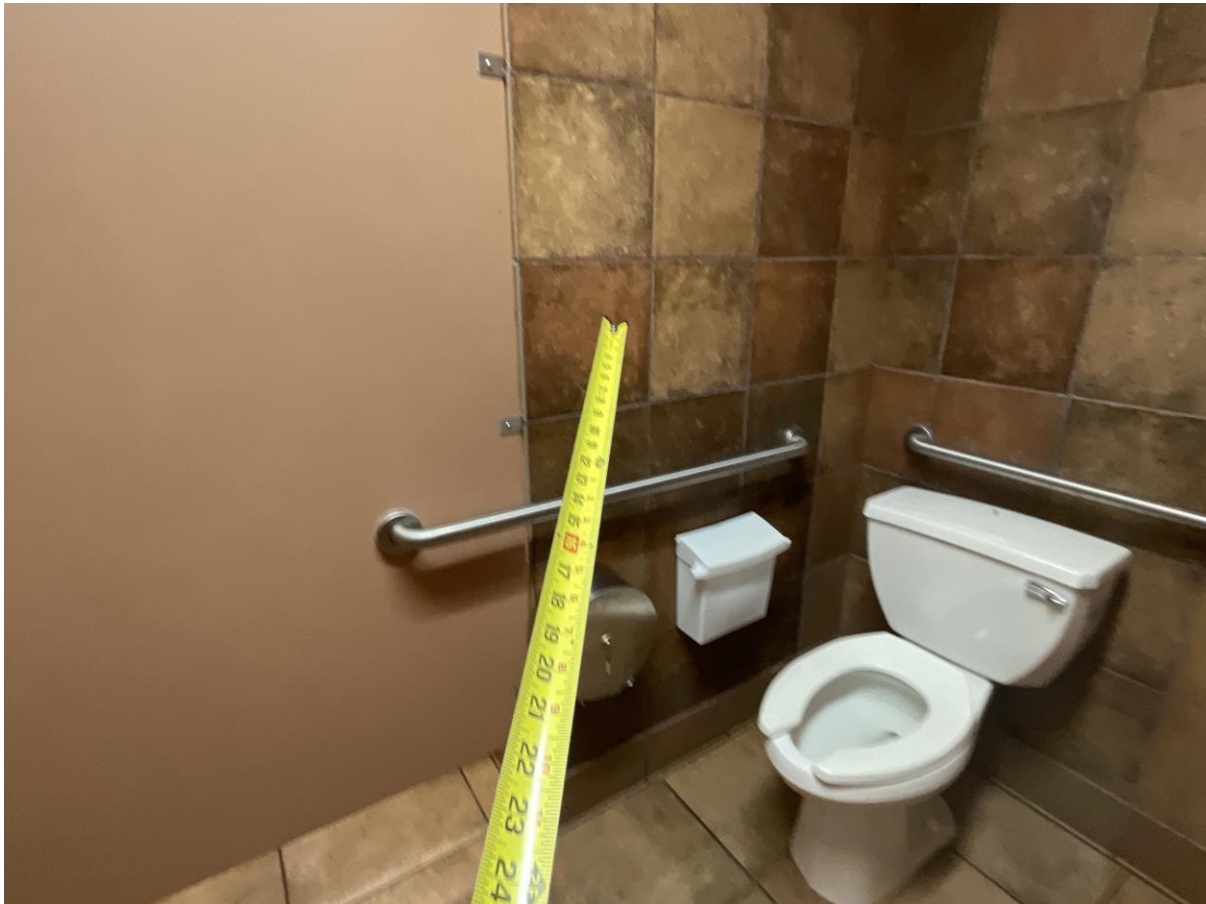
### **Finding: 32**

The vertical grab bar missing.

Fixed sidewall grab bars shall be 42 inches minimum in length, located 12 inches maximum from the rear wall and extending 54 inches minimum from the rear wall.

In addition, a vertical grab bar 18 inches minimum in length shall be mounted with the bottom of the bar located between 39 inches and 41 inches above the floor, and with the center line of the bar located between 39 inches and 41 inches from the rear wall.

Missing

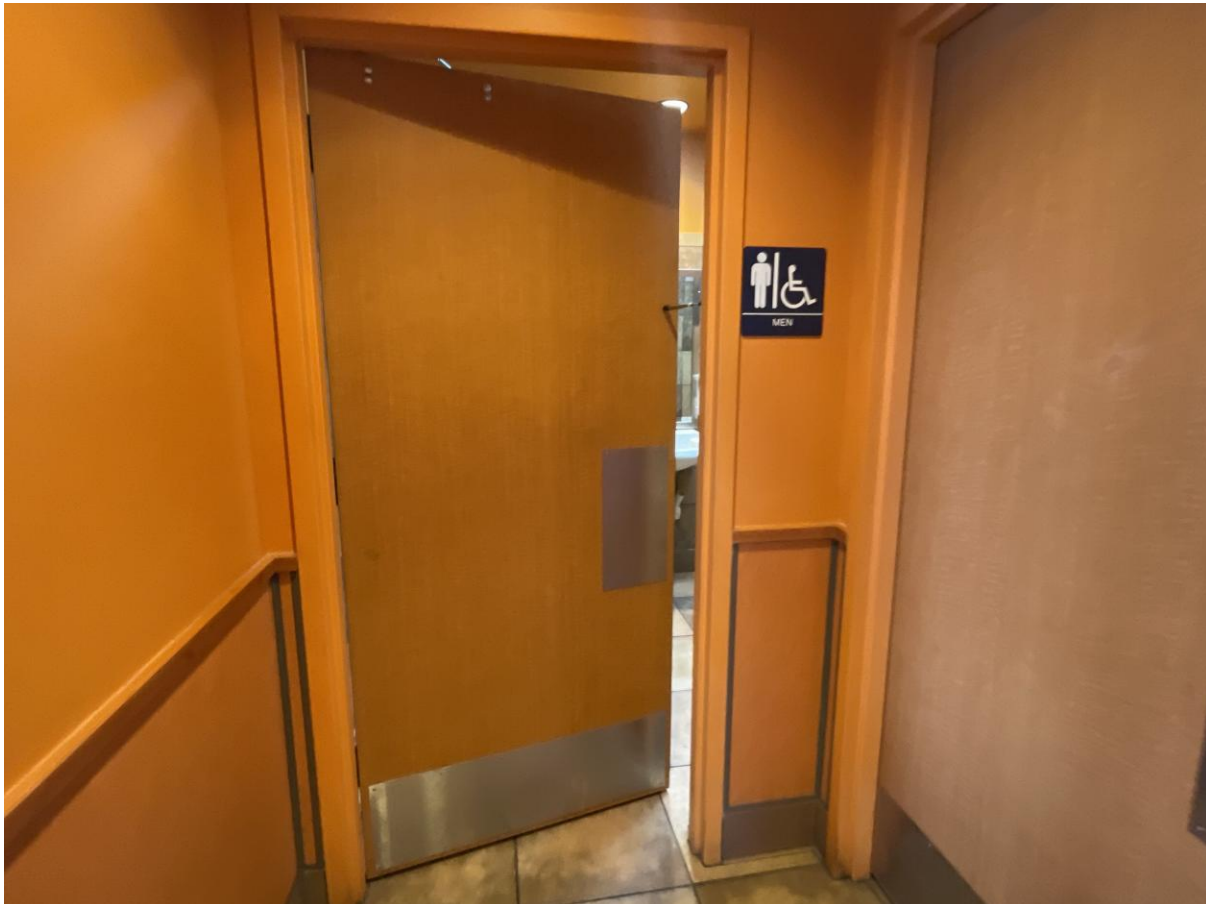
### **Finding: 33**

The door exceeds the maximum allowable opening force.

Interior doors shall have a maximum opening force of 5 pounds.

13 lbs

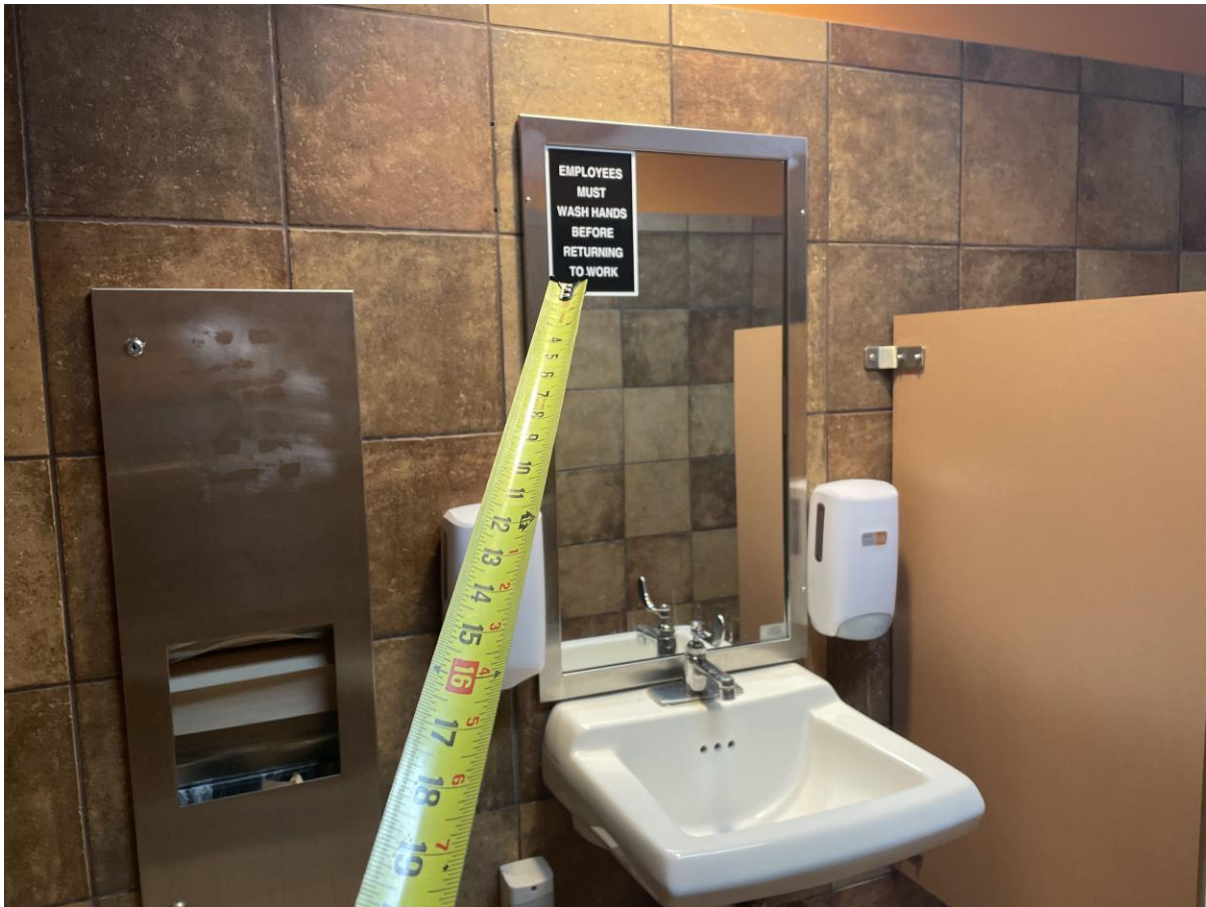
### **Finding: 34**

The employee sign is installed on the mirror which obstructs the reflecting surface.

Mirrors must have the bottom edge of the reflecting surface a maximum of 40 inches above the floor if above a sink or counter. Mirrors not located above lavatories or countertops shall be installed with the bottom edge of the reflecting surface 35 inches maximum above the finish floor or ground.

Mirror Sticker

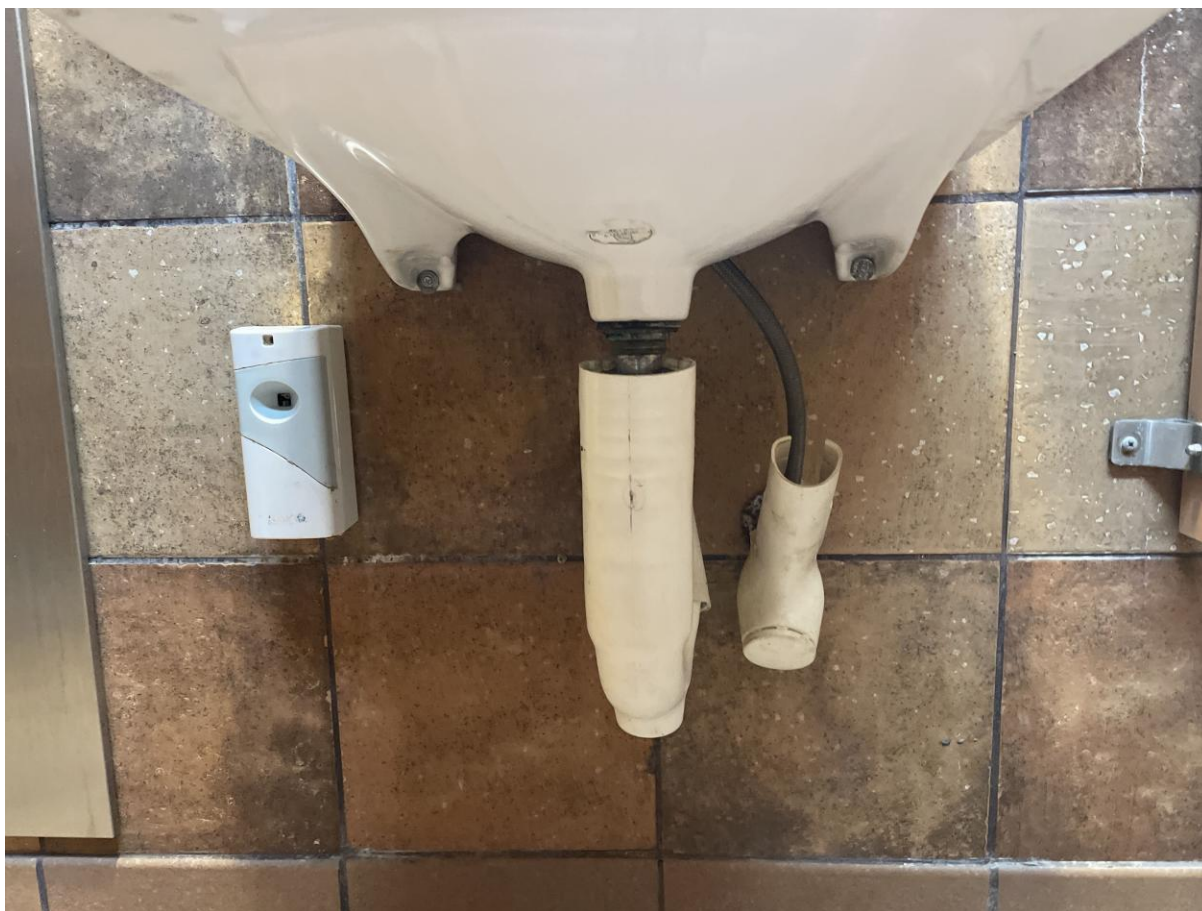
### **Finding: 35**

The water and drain pipes under the lavatory are not adequately insulated.

Water supply and drain pipes under lavatories and sinks shall be insulated or otherwise configured to protect against contact. There shall be no sharp or abrasive surfaces under lavatories and sinks.

Partial

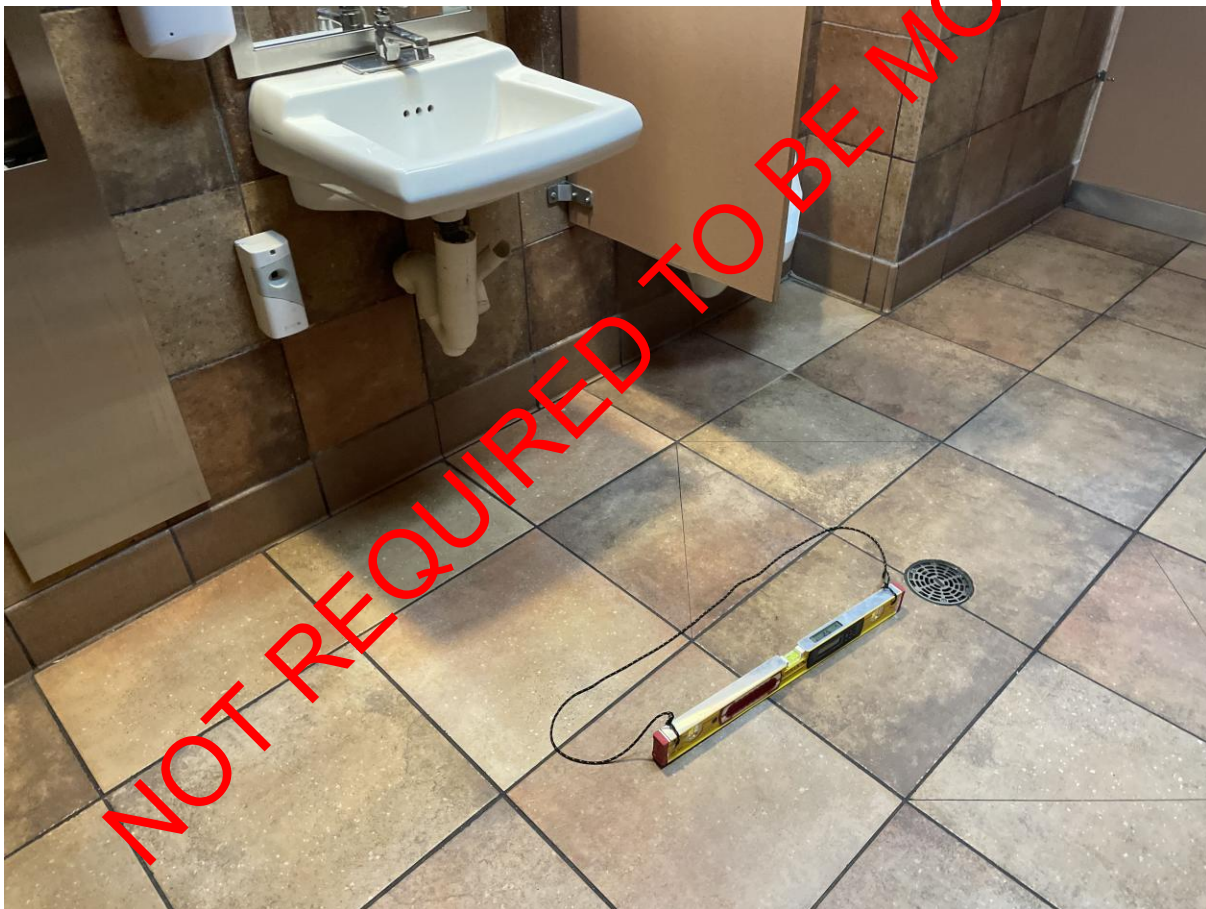
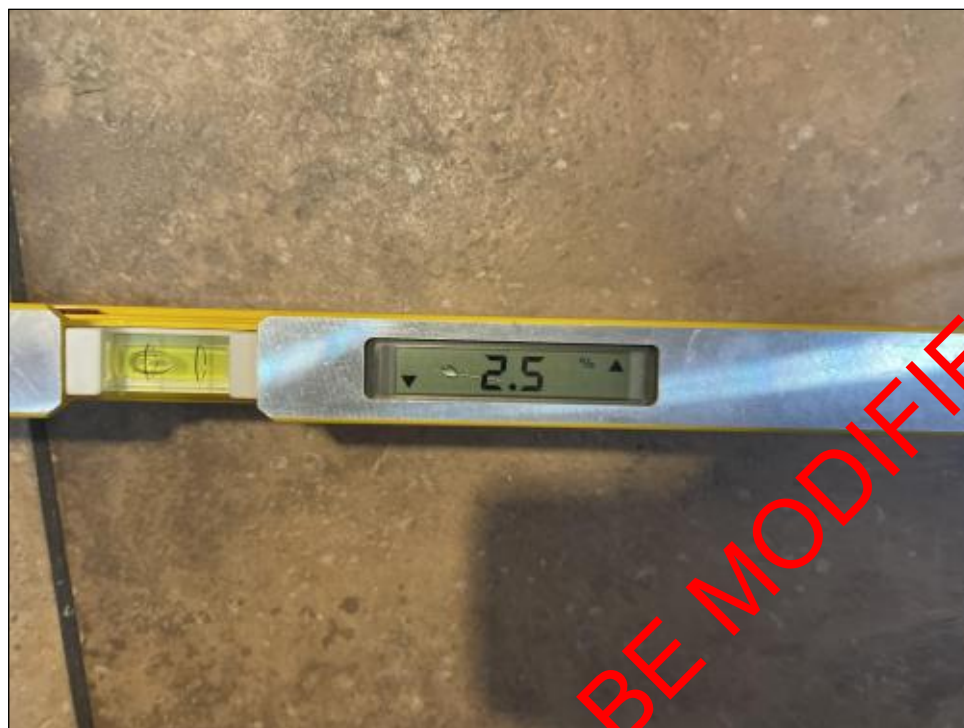
### Finding: 36

The clear floor space required at the element is not flat (2% or 1:48 maximum slope) in all directions.

Changes in level are not permitted at required clear floor or ground space except that slopes not steeper than 1:48 shall be permitted.

2.5% (floor drain)

**WITHIN REASONABLE CONSTRUCTION TOLERANCE**

NOT REQUIRED TO BE MODIFIED

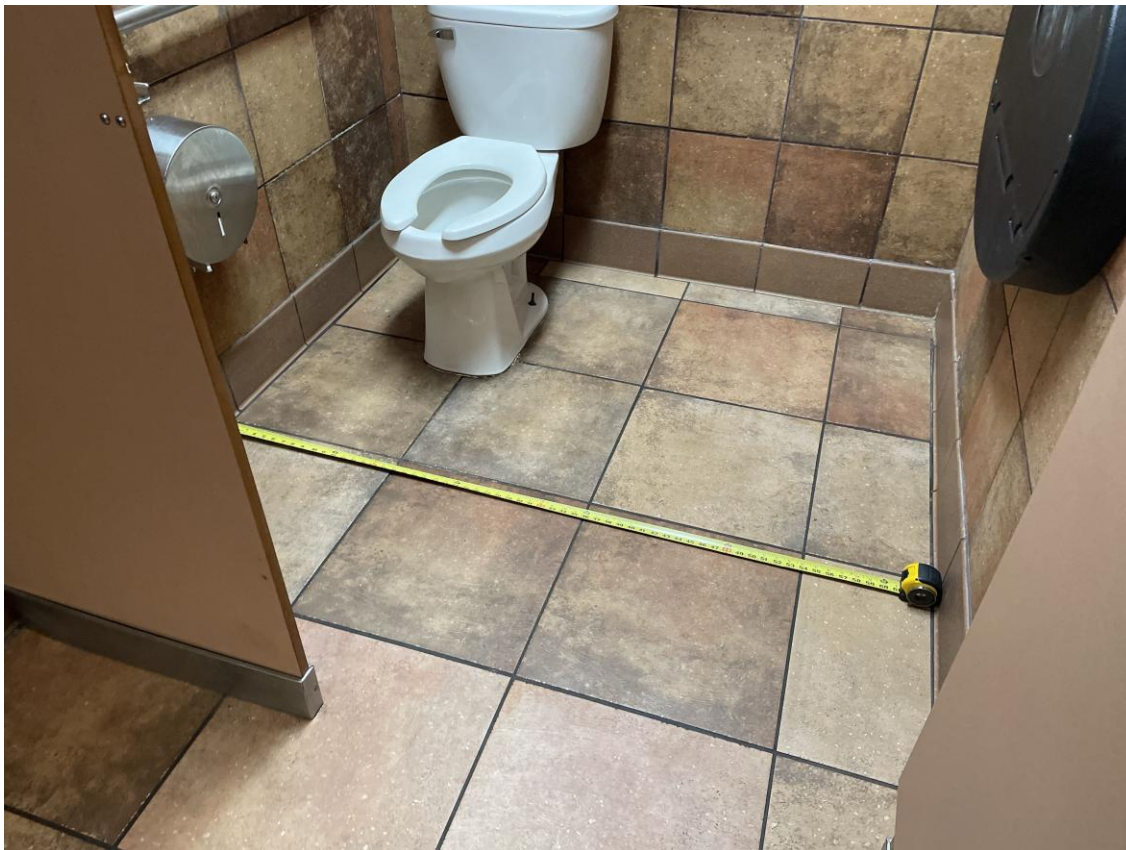
### **Finding: 37**

Missing (63" wide stall)

**NOTE: IF THIS COMPARTMENT WAS ORIGINALLY CONSTRUCTED PRIOR TO MARCH 2010, IT CAN REMAIN AS-IS. OTHERWISE, THE COMPARTMENT WILL NEED TO BE MODIFIED TO CONFORM TO CURRENT ADA STANDARDS.**

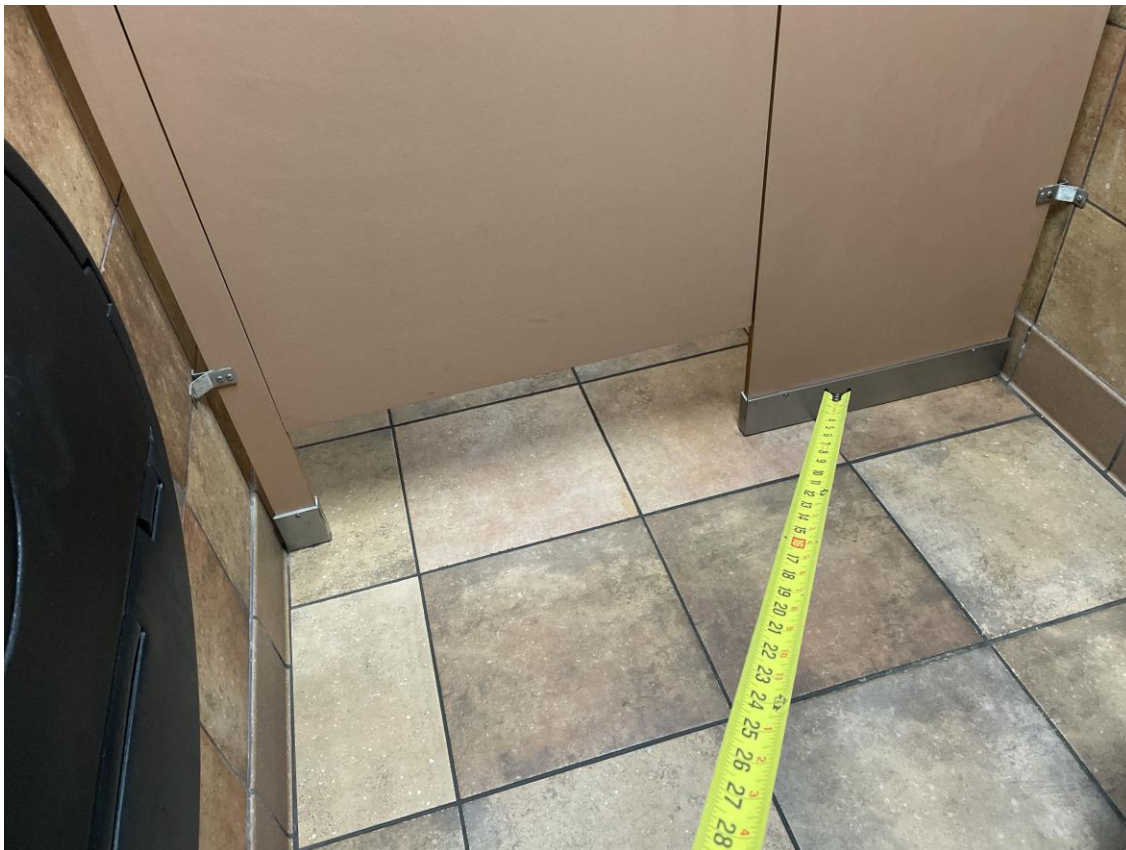
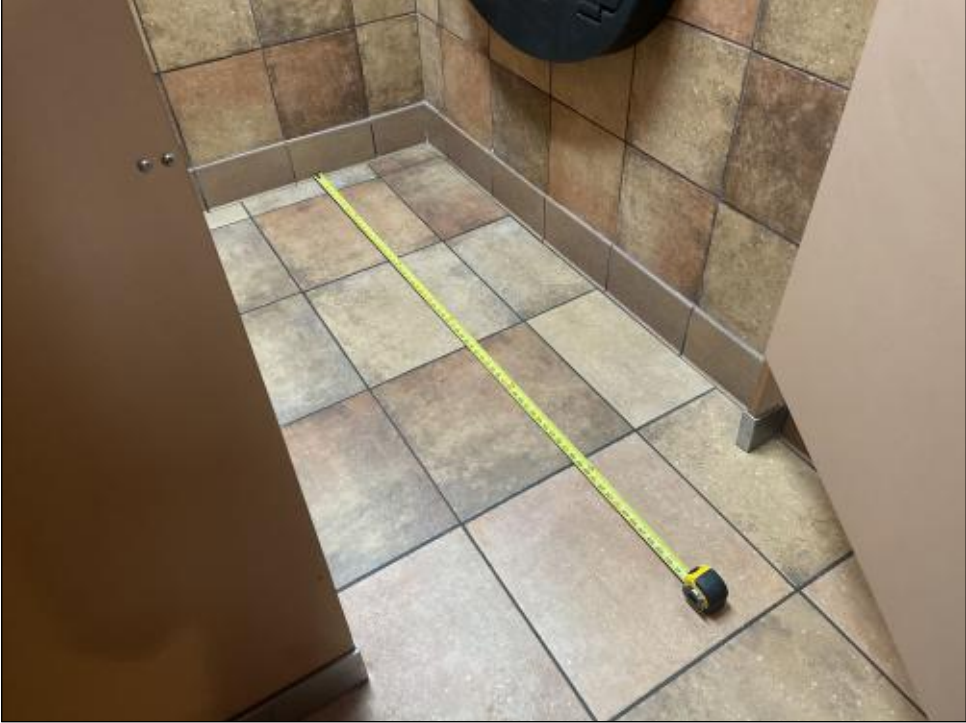
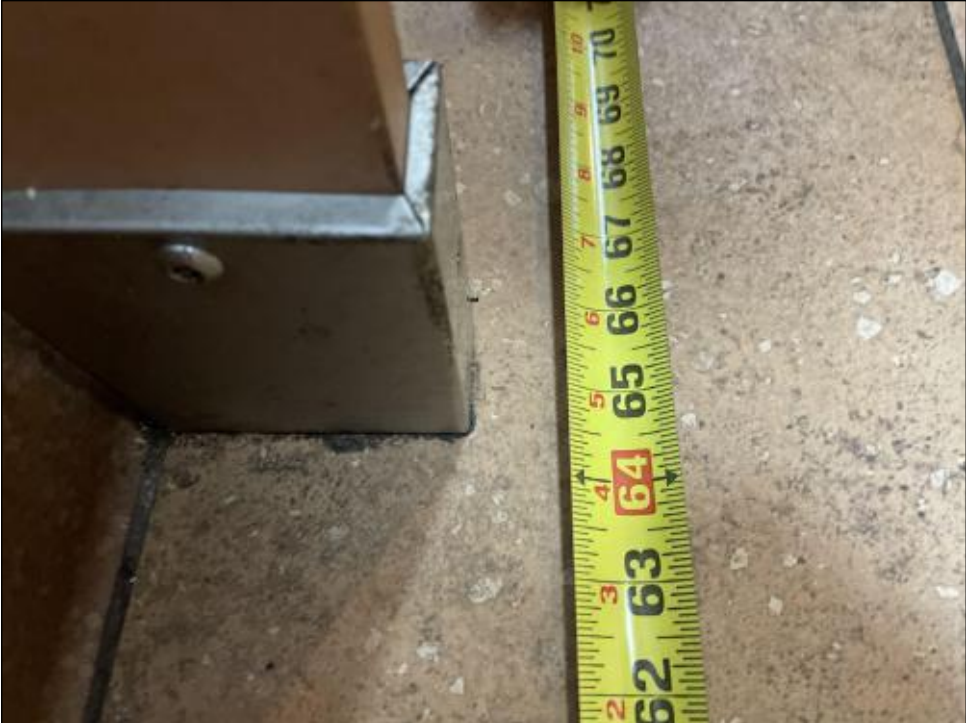
### **Finding: 38**

Partial, 64 1/2" deep

**NOTE: IF THIS COMPARTMENT WAS ORIGINALLY CONSTRUCTED PRIOR TO MARCH 2010, IT CAN REMAIN AS-IS. OTHERWISE, THE COMPARTMENT WILL NEED TO BE MODIFIED TO CONFORM TO CURRENT ADA STANDARDS.**

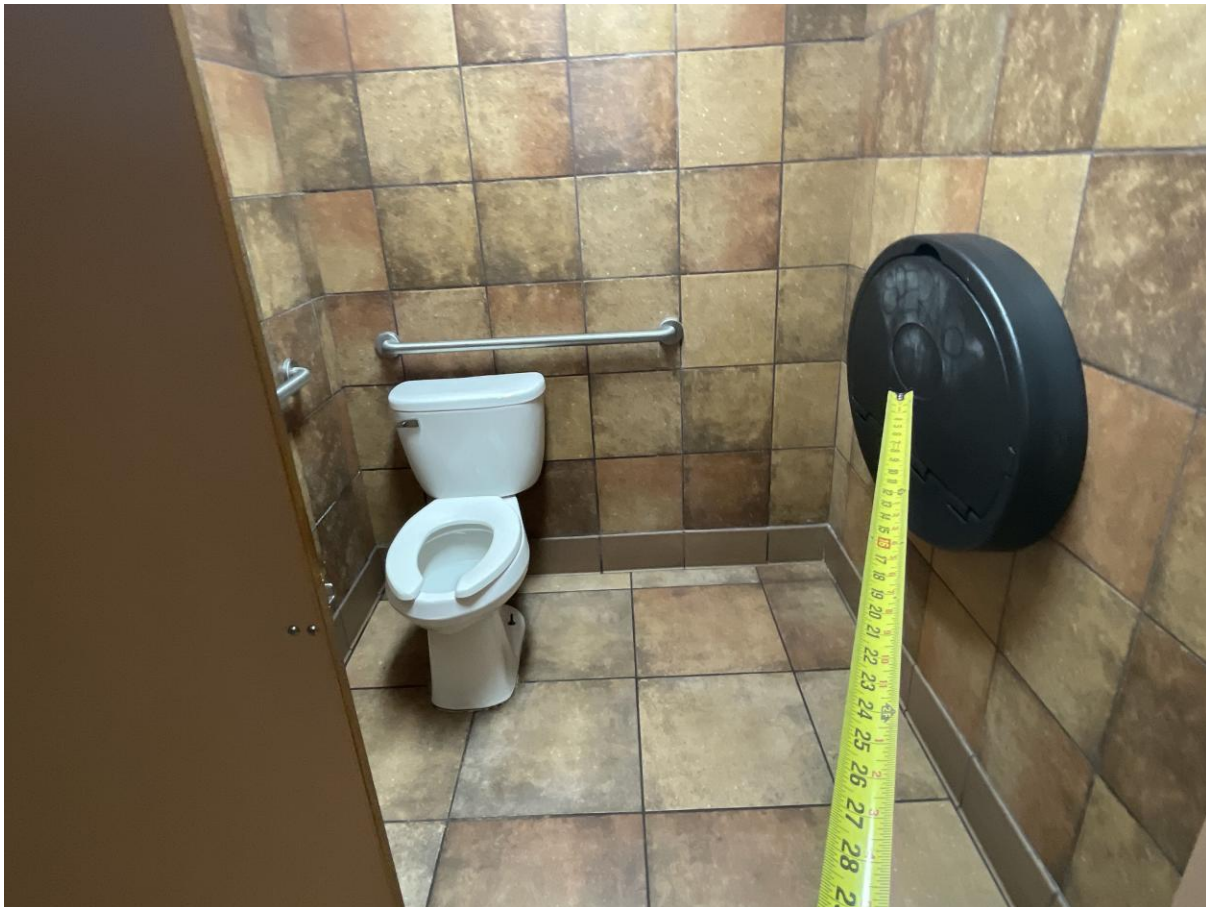
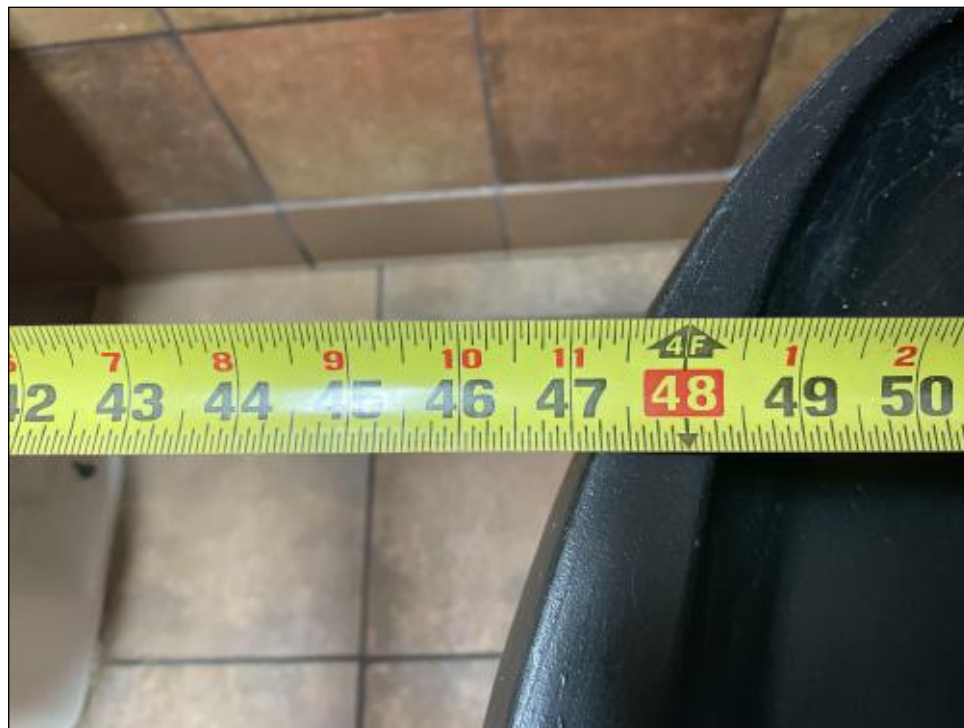
### Finding: 39

Obstructed by  
changing table

**THE CHANGING TABLE SHOULD BE REMOVED**

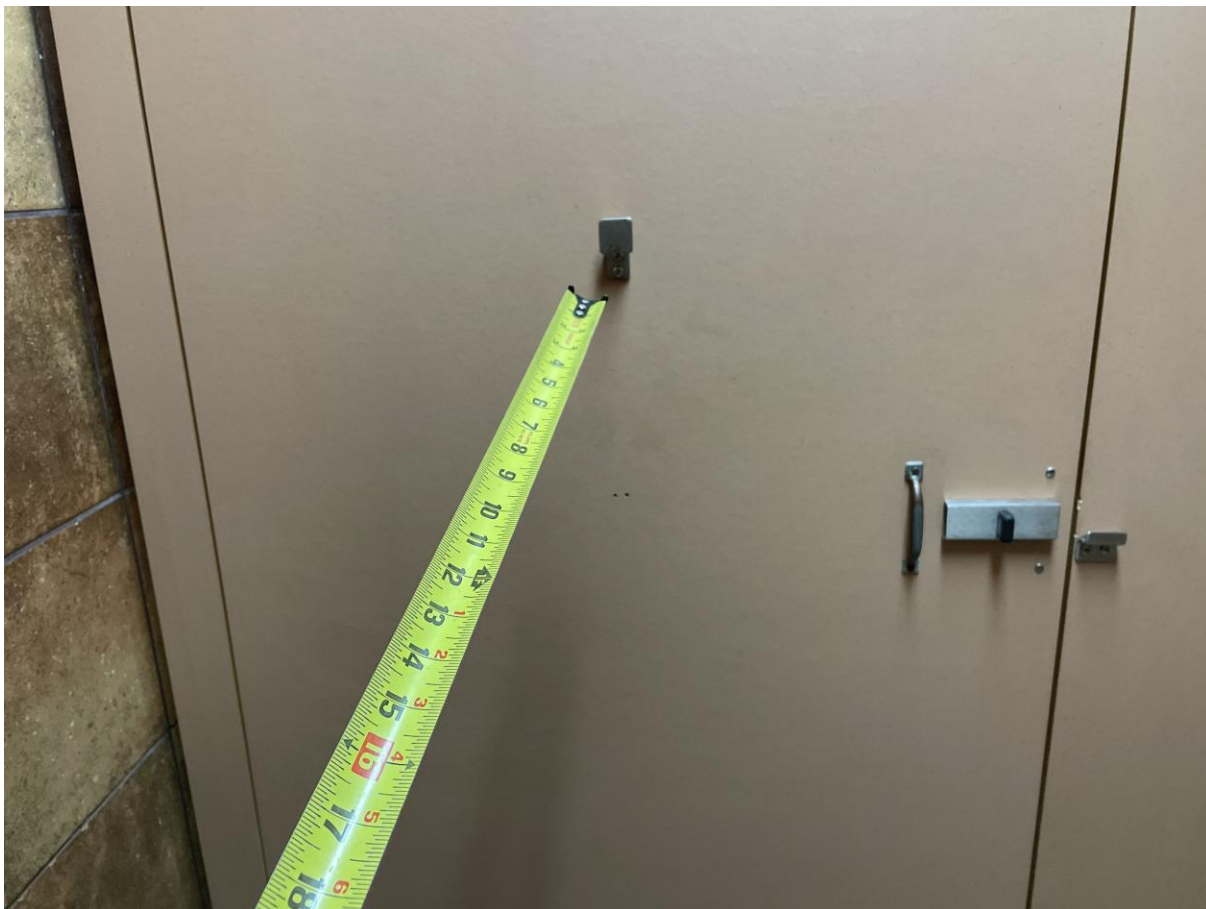
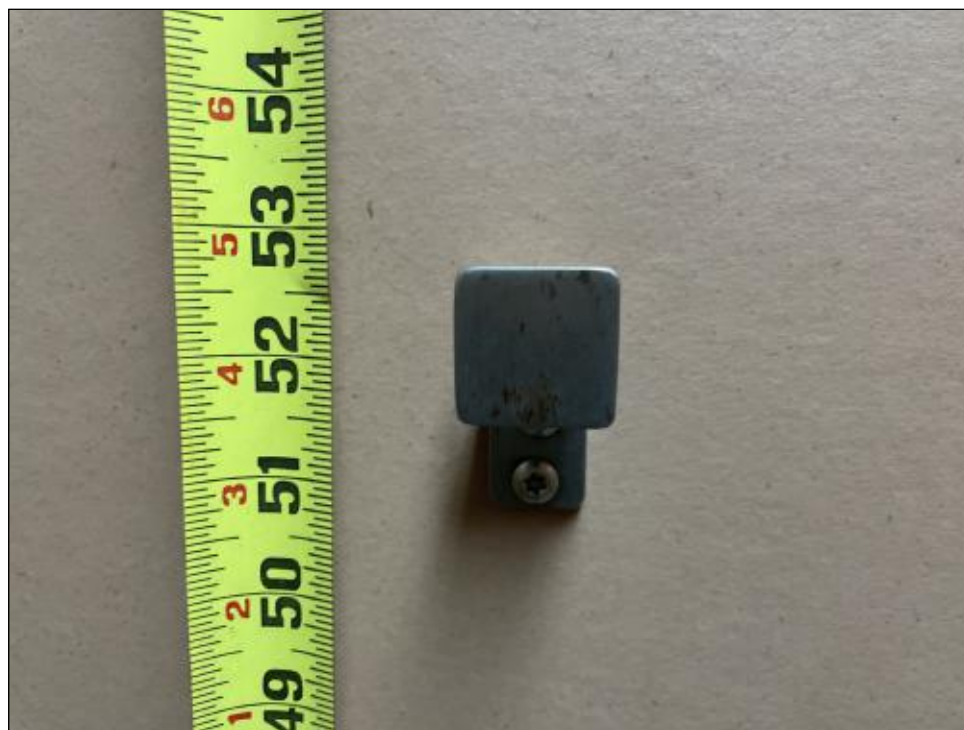
### **Finding: 40**

52 1/2"

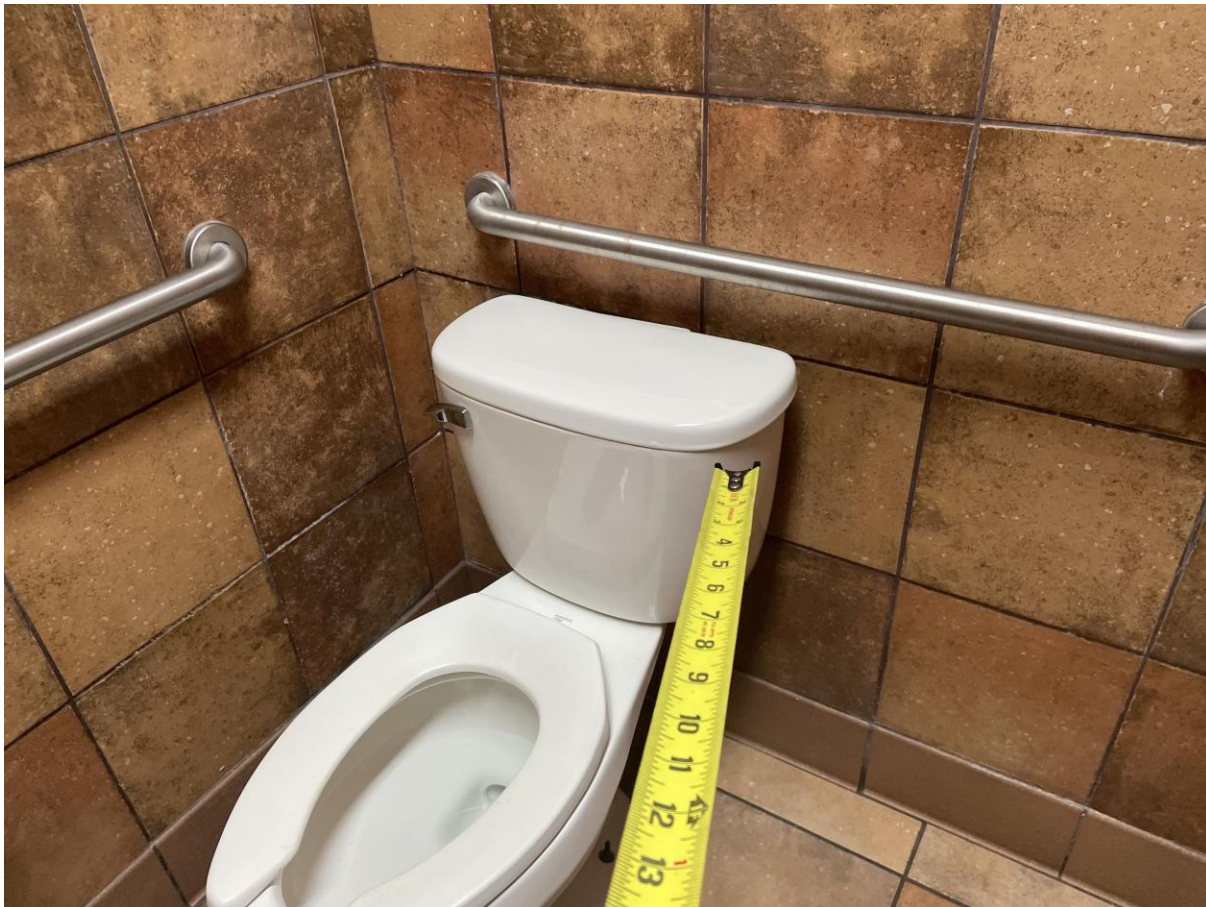
### Finding: 41

Relocate

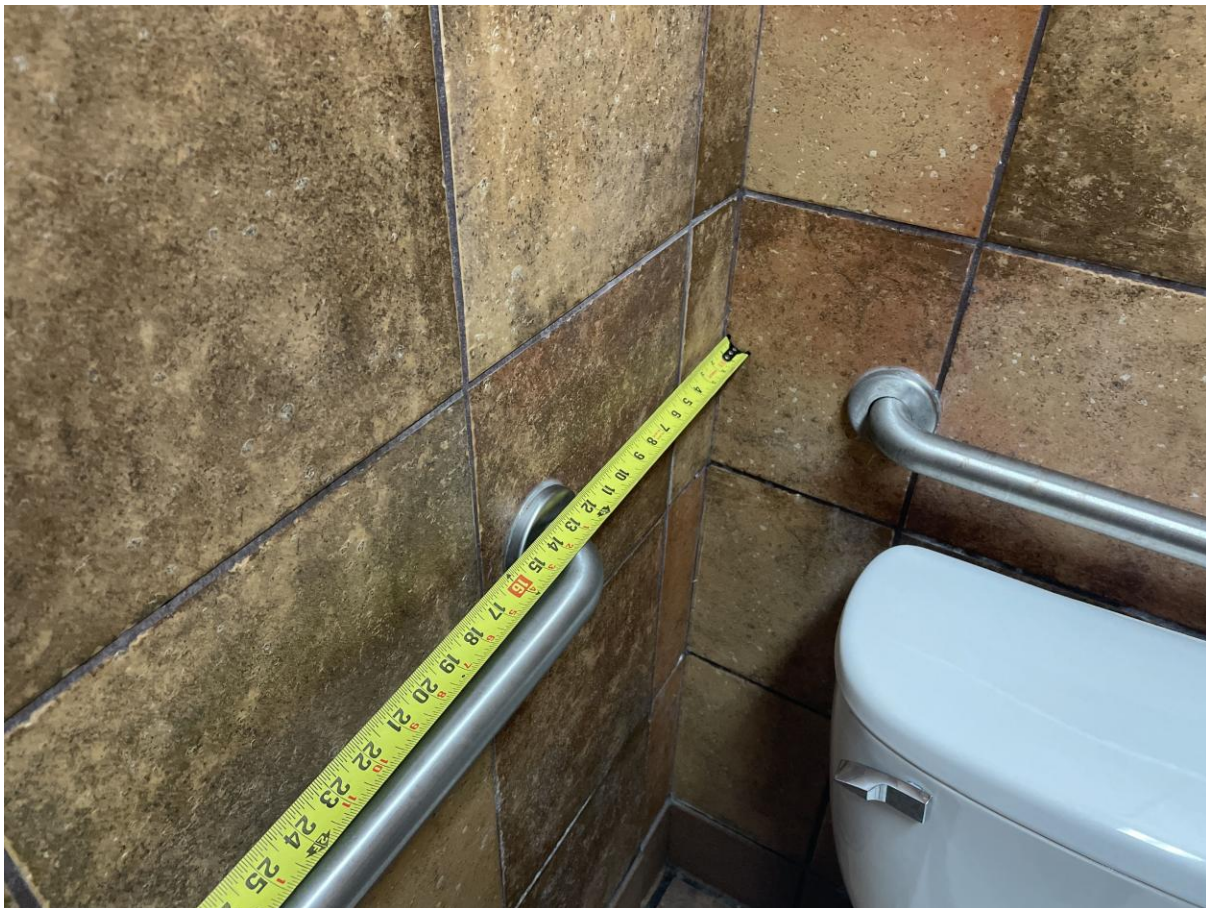
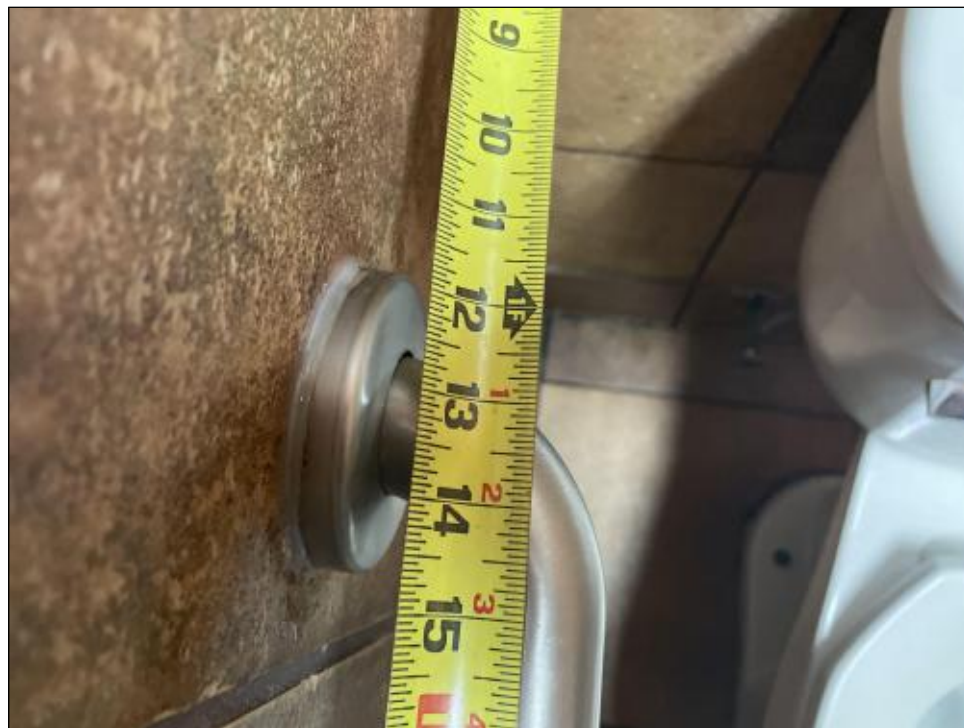
### **Finding: 42**

13 1/4"

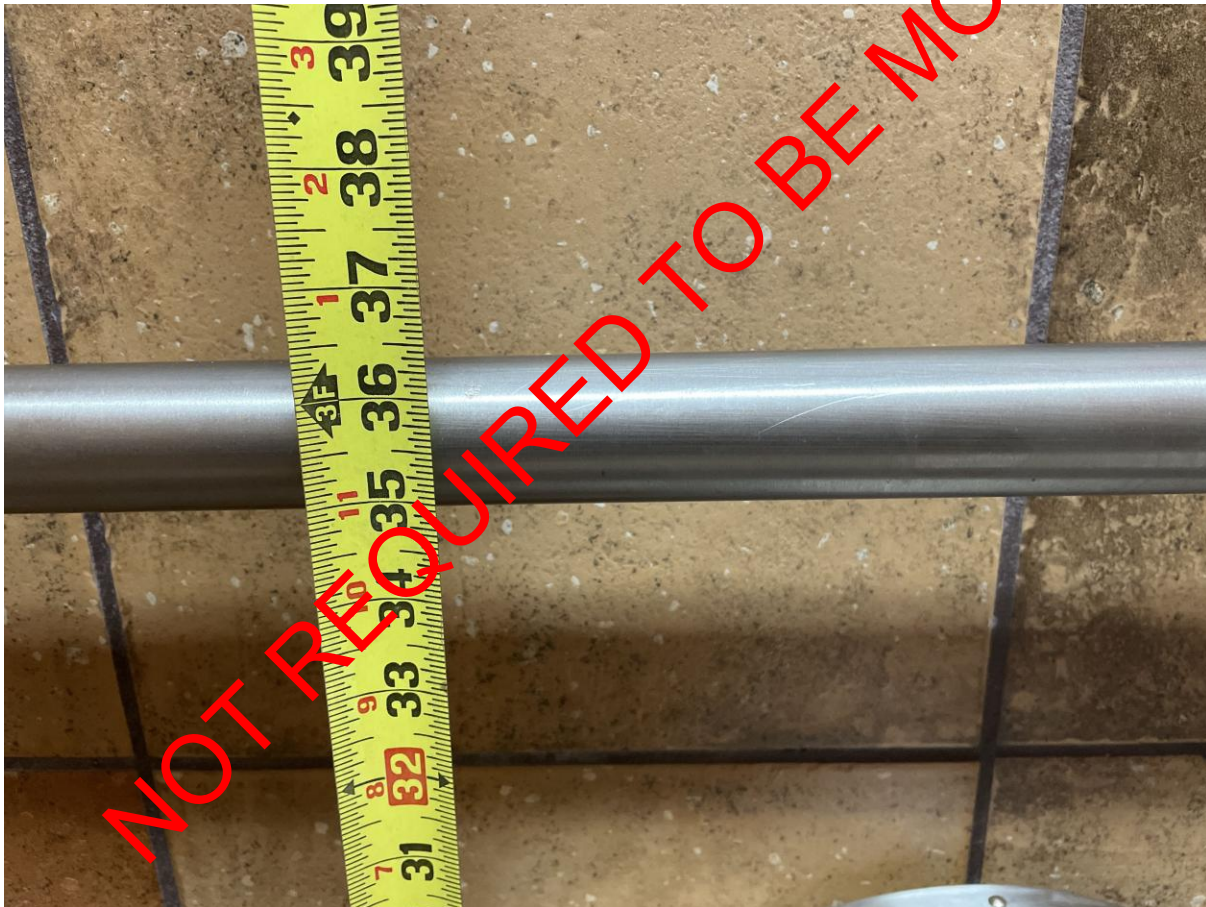
### Finding: 43

36 1/4"

**WITHIN REASONABLE CONSTRUCTION TOLERANCE**
