# Site Accessibility Evaluation

## Americans with Disabilities Act And ANSI A117.1

**Taco Bell Store #015908  
(Pre)**

**Pre Inspection**

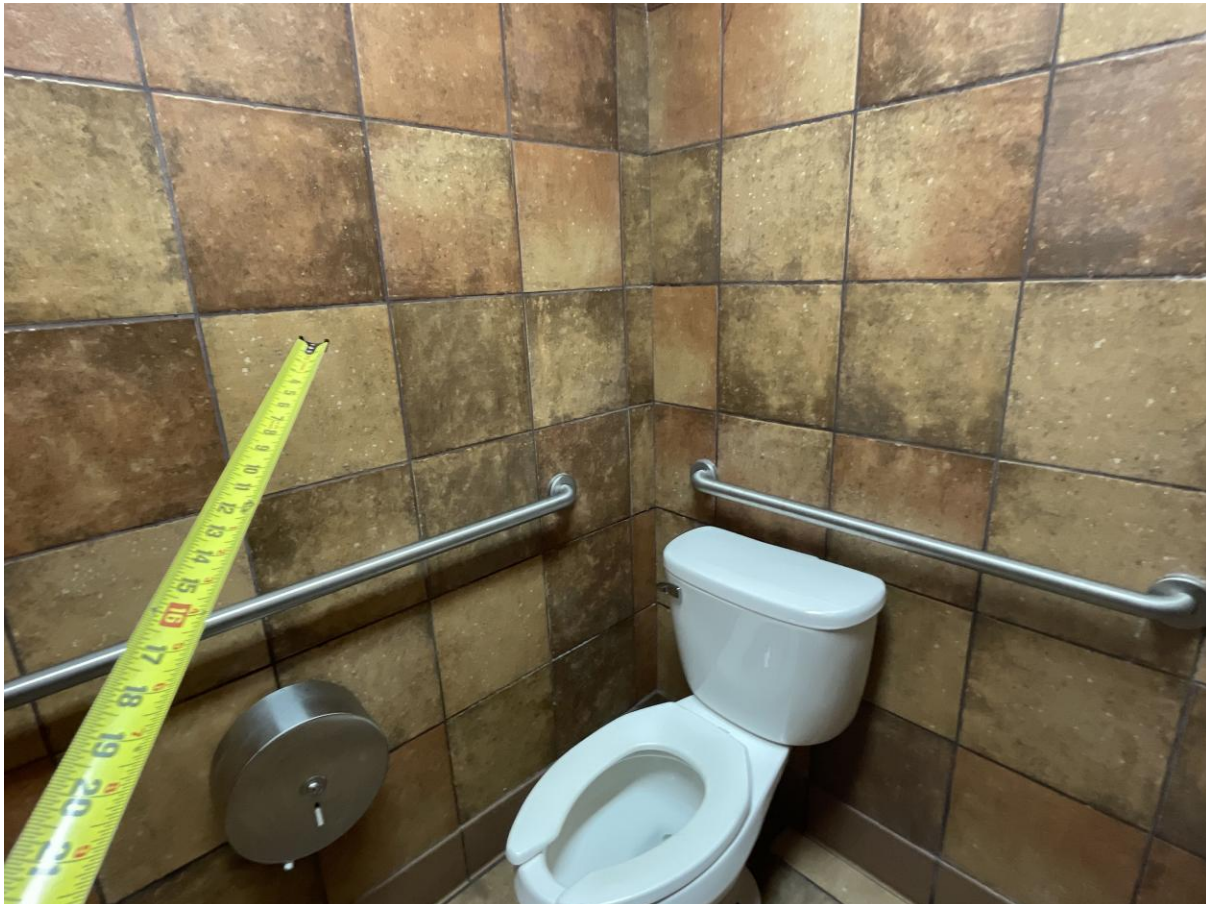
The vertical grab bar missing.

Missing

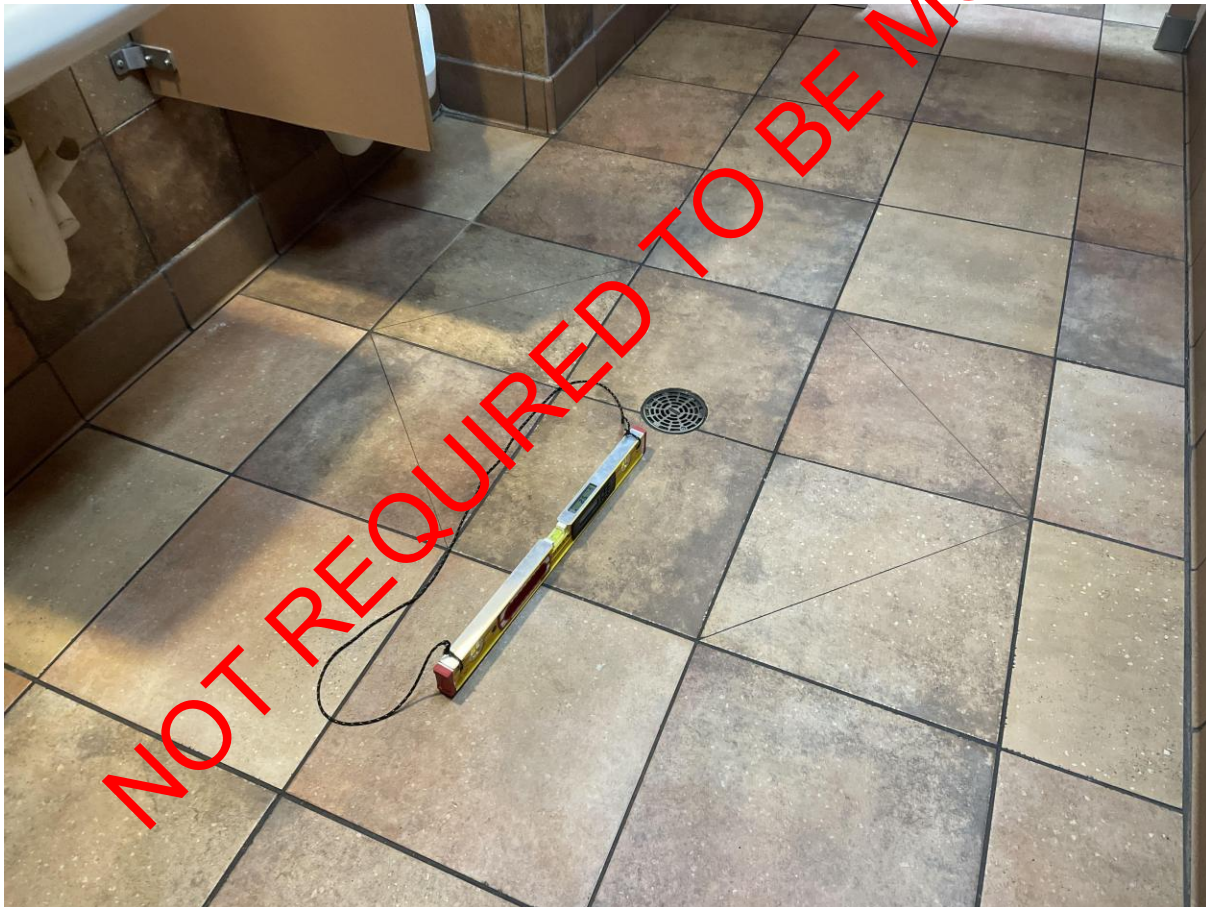
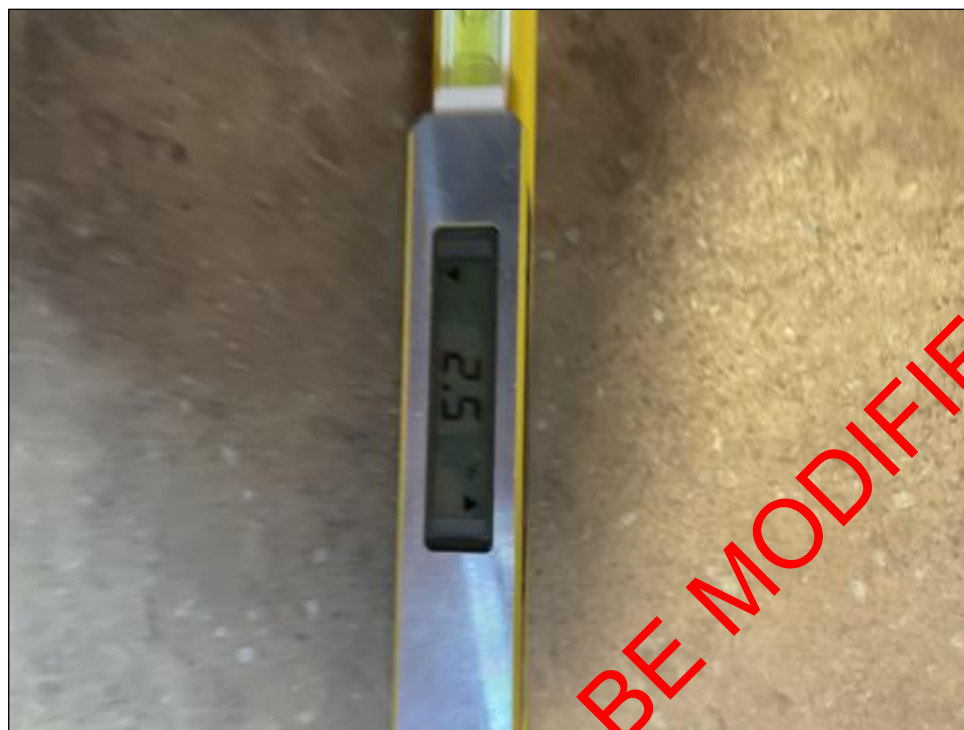
### Finding: 45

The floor drain is set too low in the floor which causes a slope over 2 percent.

2.5%

**WITHIN REASONABLE CONSTRUCTION TOLERANCE**

NOT REQUIRED TO BE MODIFIED
