Site Accessibility Evaluation

**Taco Bell Store #024598
(Pre)**

**7246 Central Ave
Toledo, OH 43617**

Pre Inspection

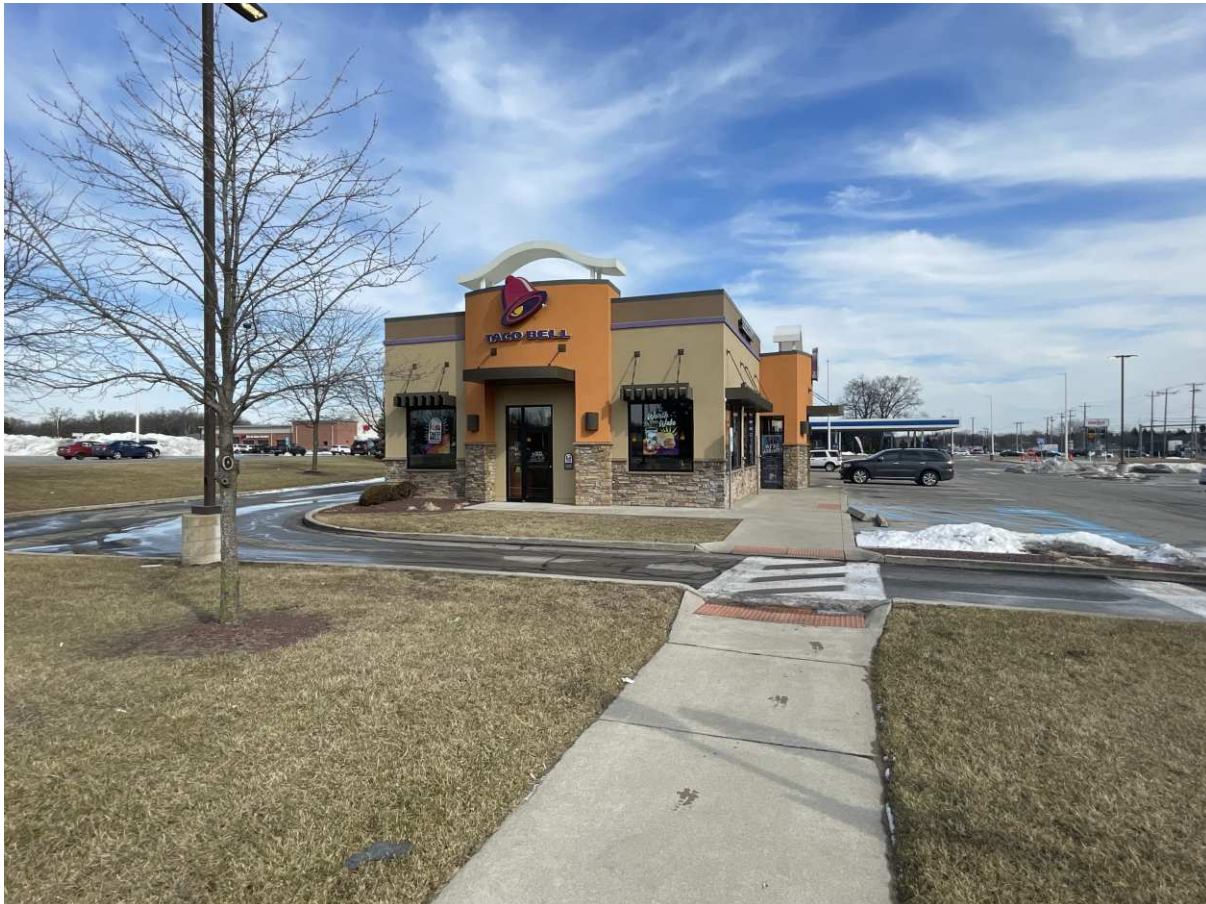
Finding: 1

At least 60% of all public entrances must be accessible and on an accessible route to the public way.

Based on the number of ground floor exits provided for the building (2), at least (2) of the existing exit doors (if used as a public entrance) are required to be brought up to compliance if readily achievable to do so. This would include an accessible path of travel which is currently out of compliance for slope and cross slopes between the entrances, accessible parking stalls and public way.

N/A

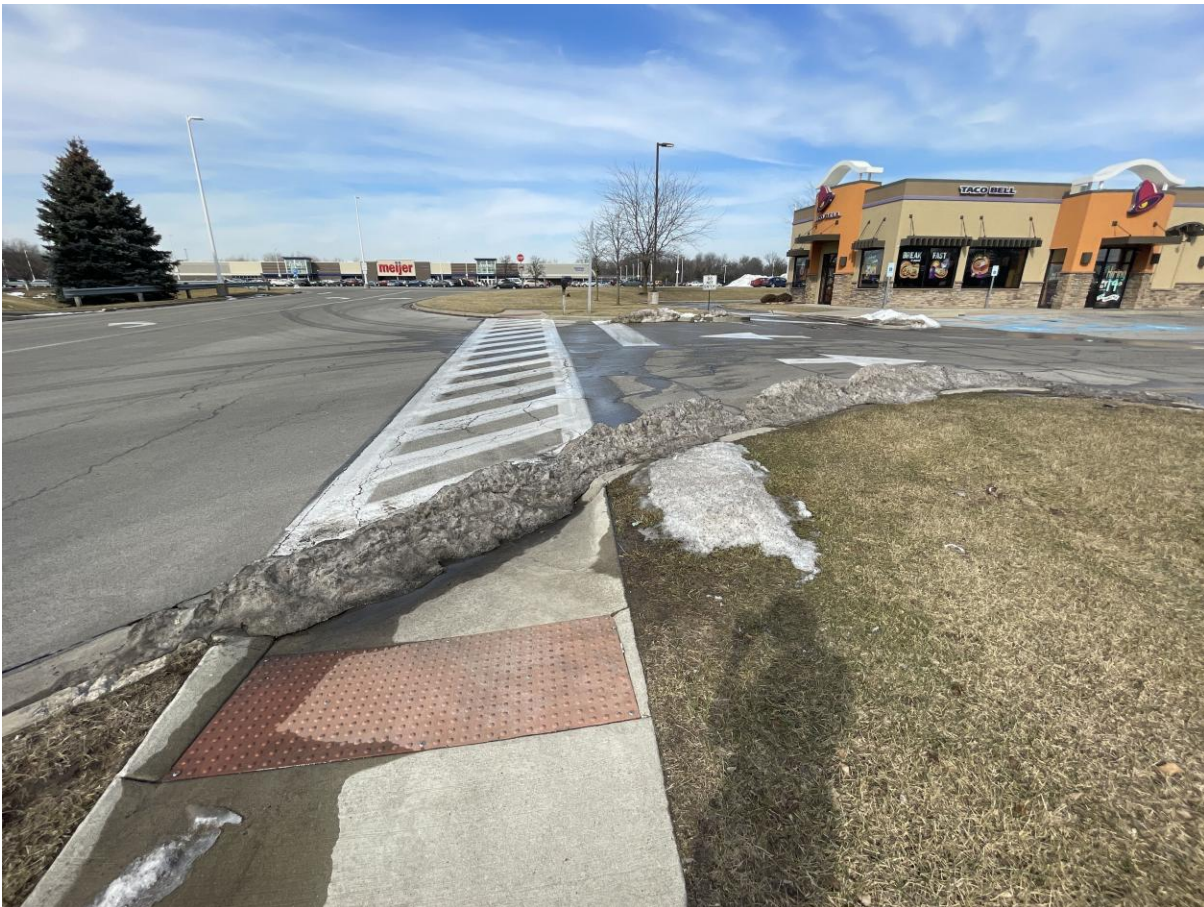
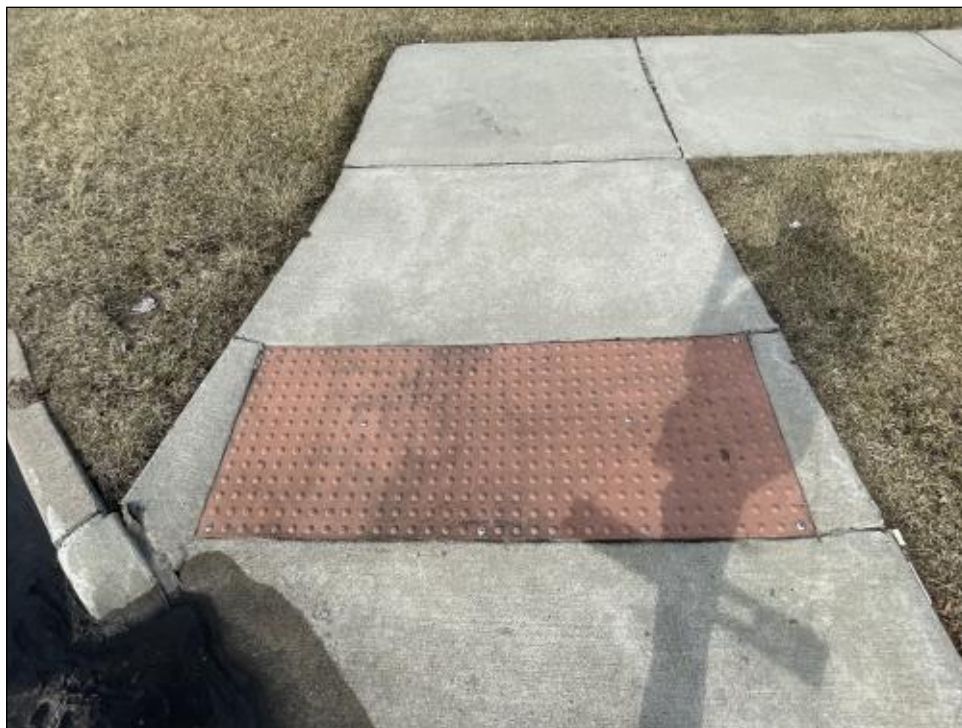
Finding: 2

The accessible route of travel contains detectable warnings (truncated domes) which are not currently required by the 2010 ADAS or ANSI A117.1 for this location.

Due to the ongoing development of guidelines and lack of adopted standards and/or regulations pertaining to the installation of detectable warnings, it is recommended that detectable warnings not be installed until such time that the standards and/or regulations require them. Please confirm with the local AHJ.

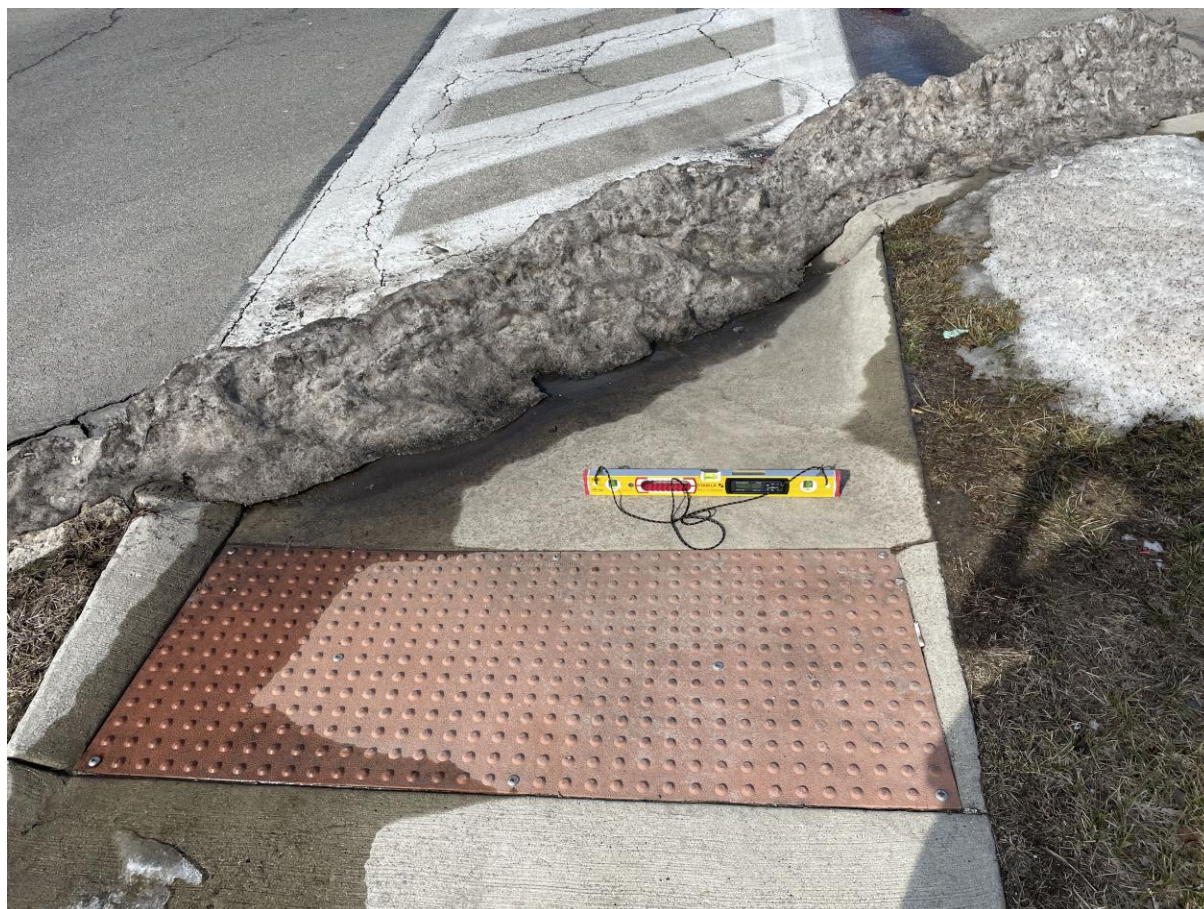
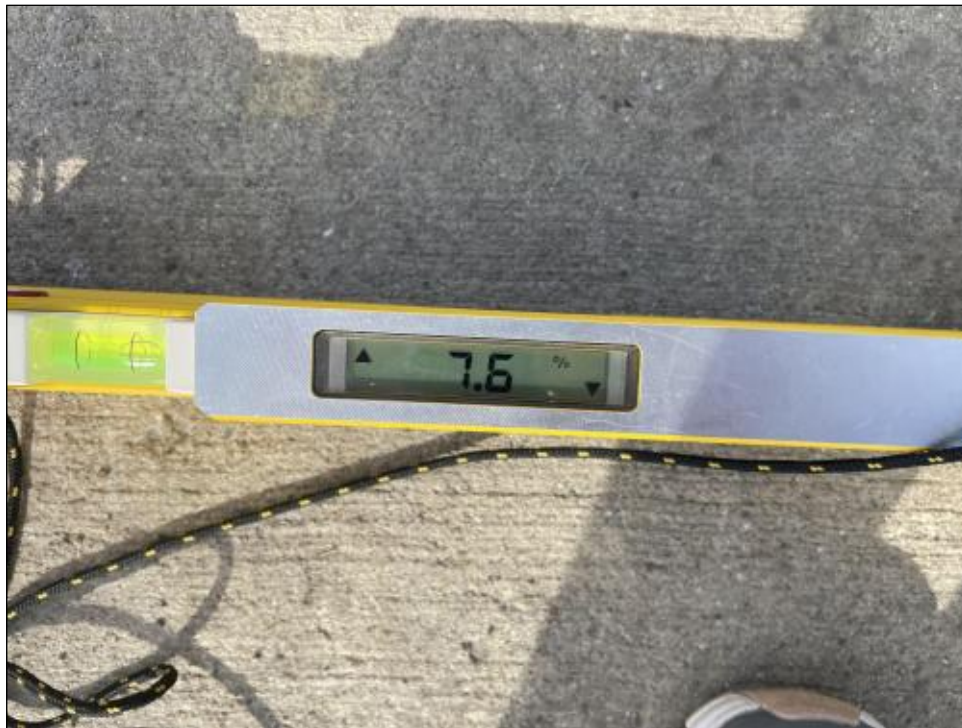
Finding: 3

The curb ramp on the accessible route has cross slopes greater than 2%.

Surface cross slopes shall not exceed one unit vertical in 48 units horizontal (2-percent slope).

7.6%

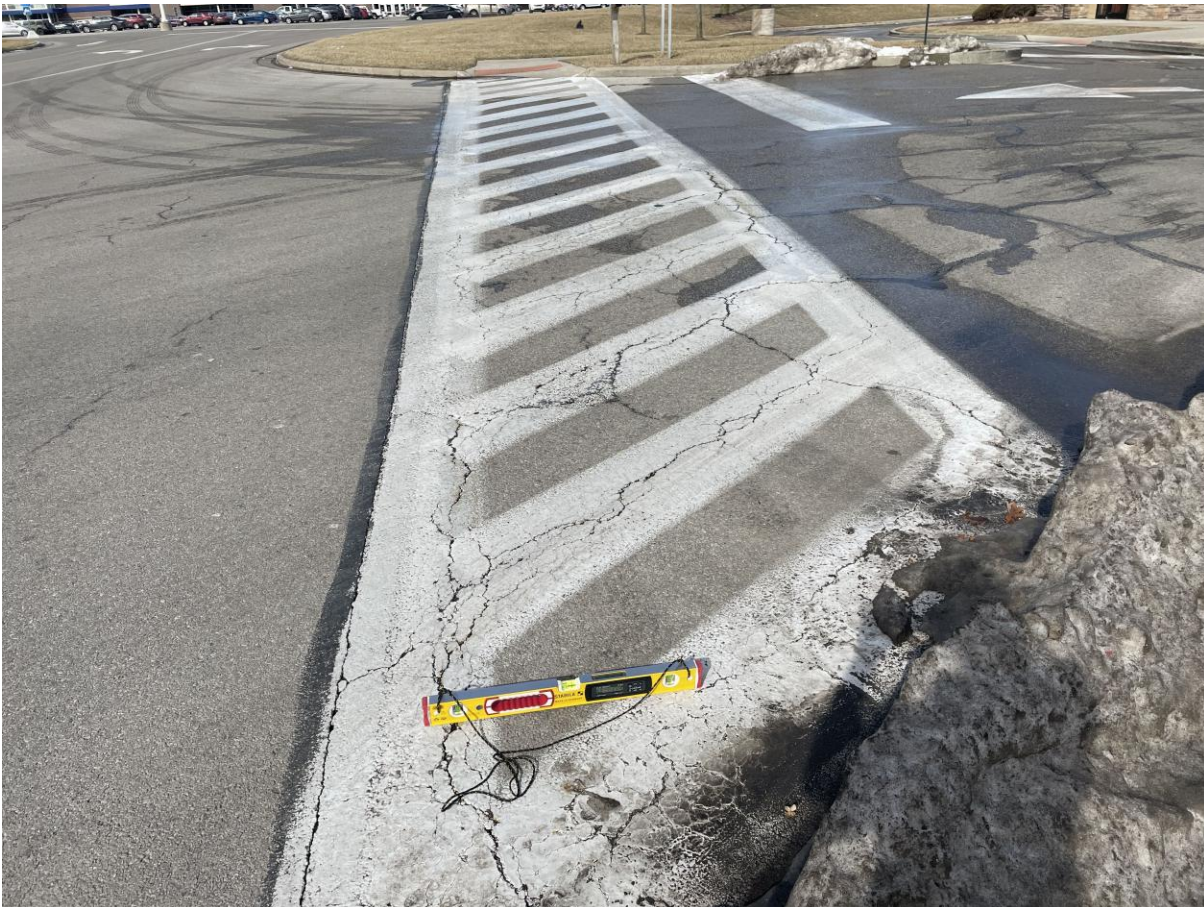
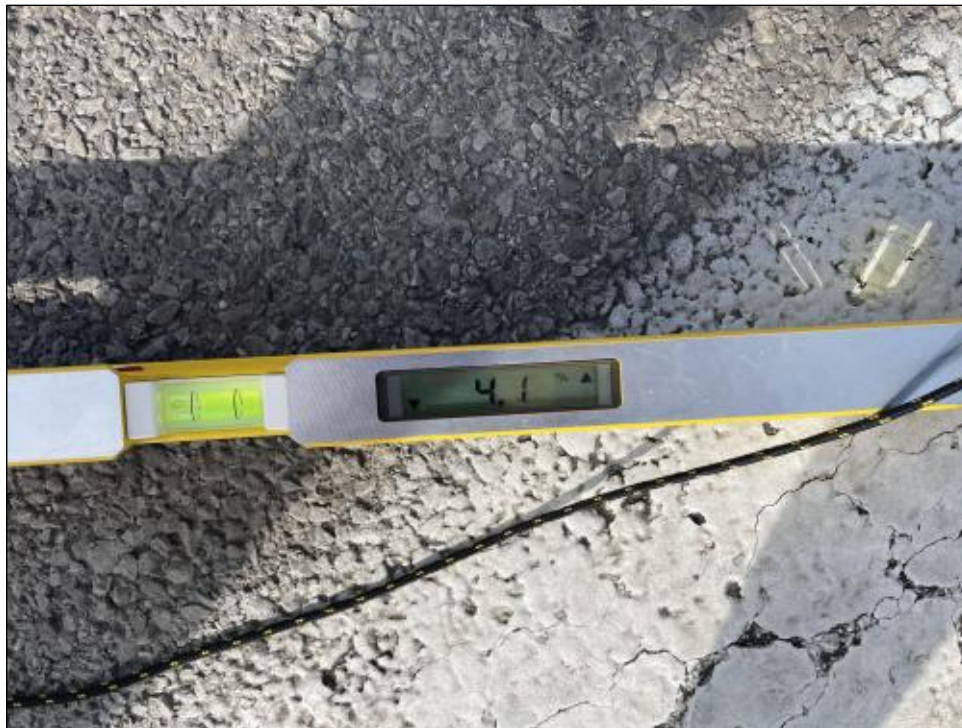
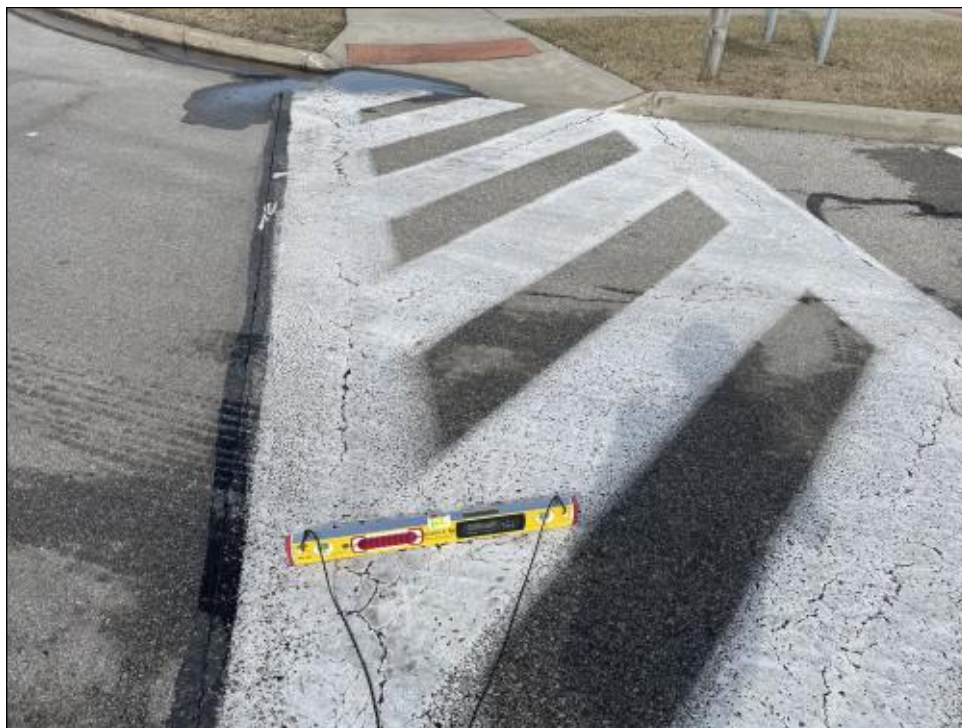
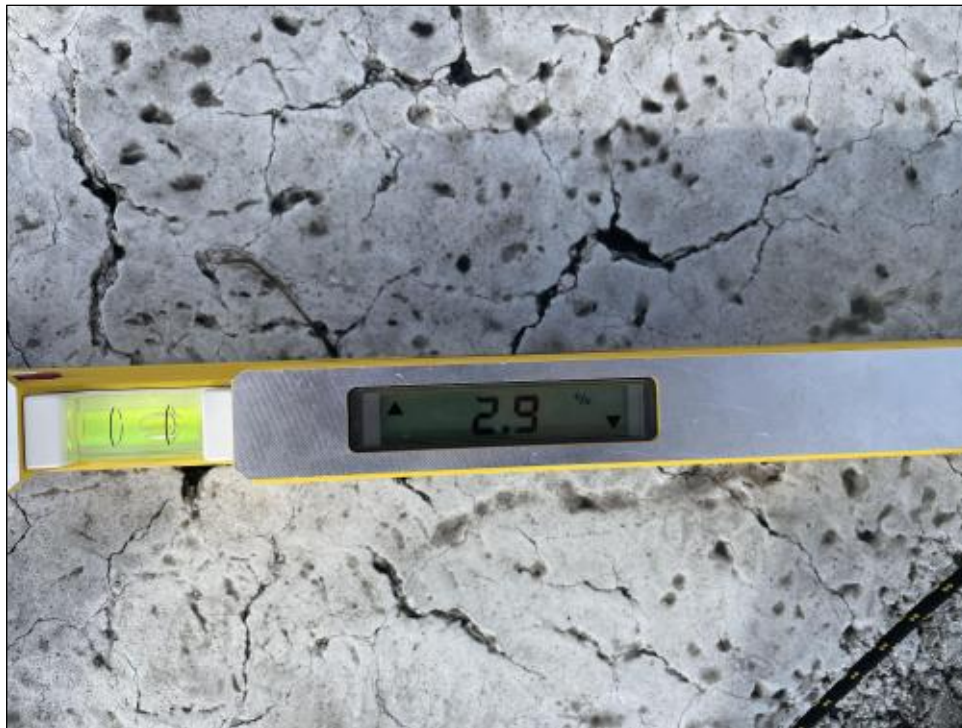
Finding: 4

The accessible path of travel between the building and the public way on the site has cross slopes greater than 2%.

Surface cross slopes shall not exceed one unit vertical in 48 units horizontal (2-percent slope).

2.9%-4.1%

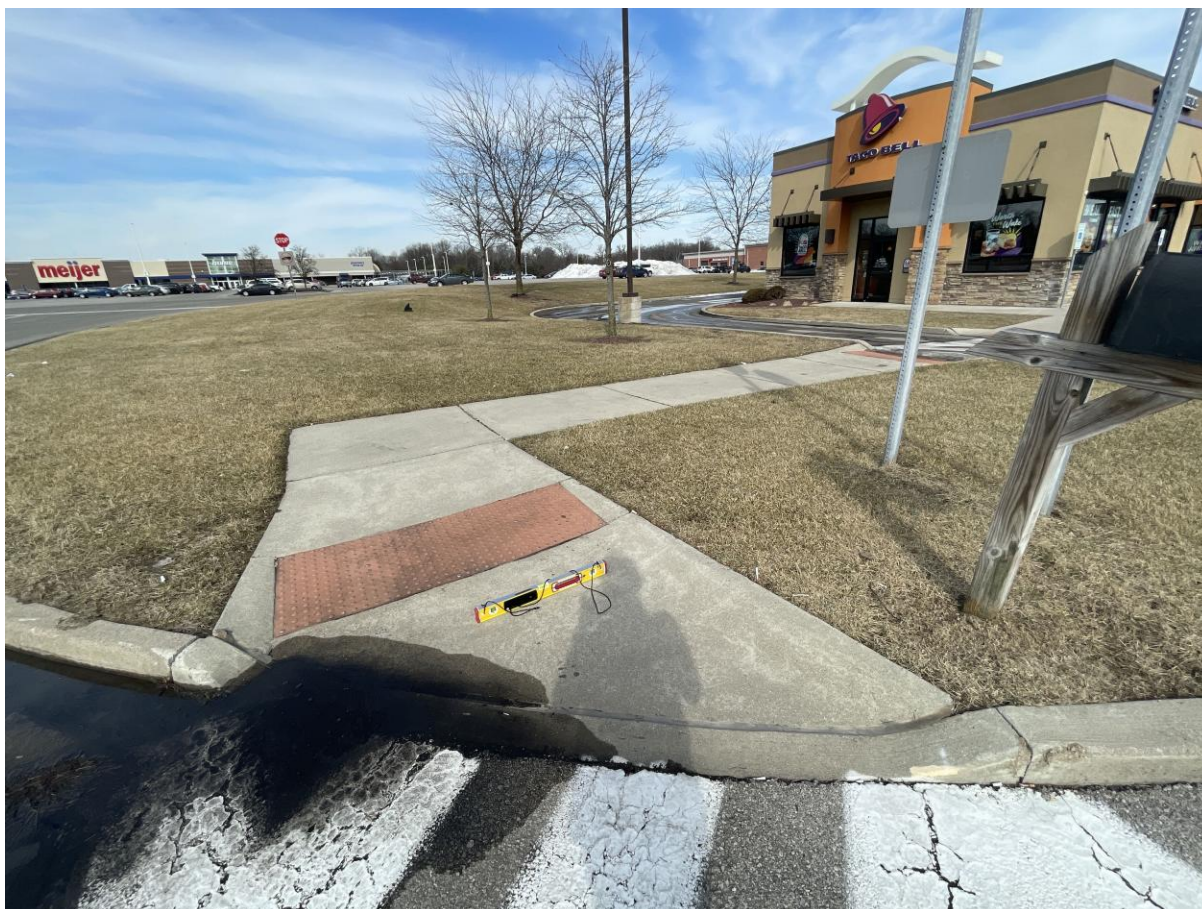
Finding: 5

The curb ramp on the accessible route has cross slopes greater than 2%.

Surface cross slopes shall not exceed one unit vertical in 48 units horizontal (2-percent slope).

4.0%

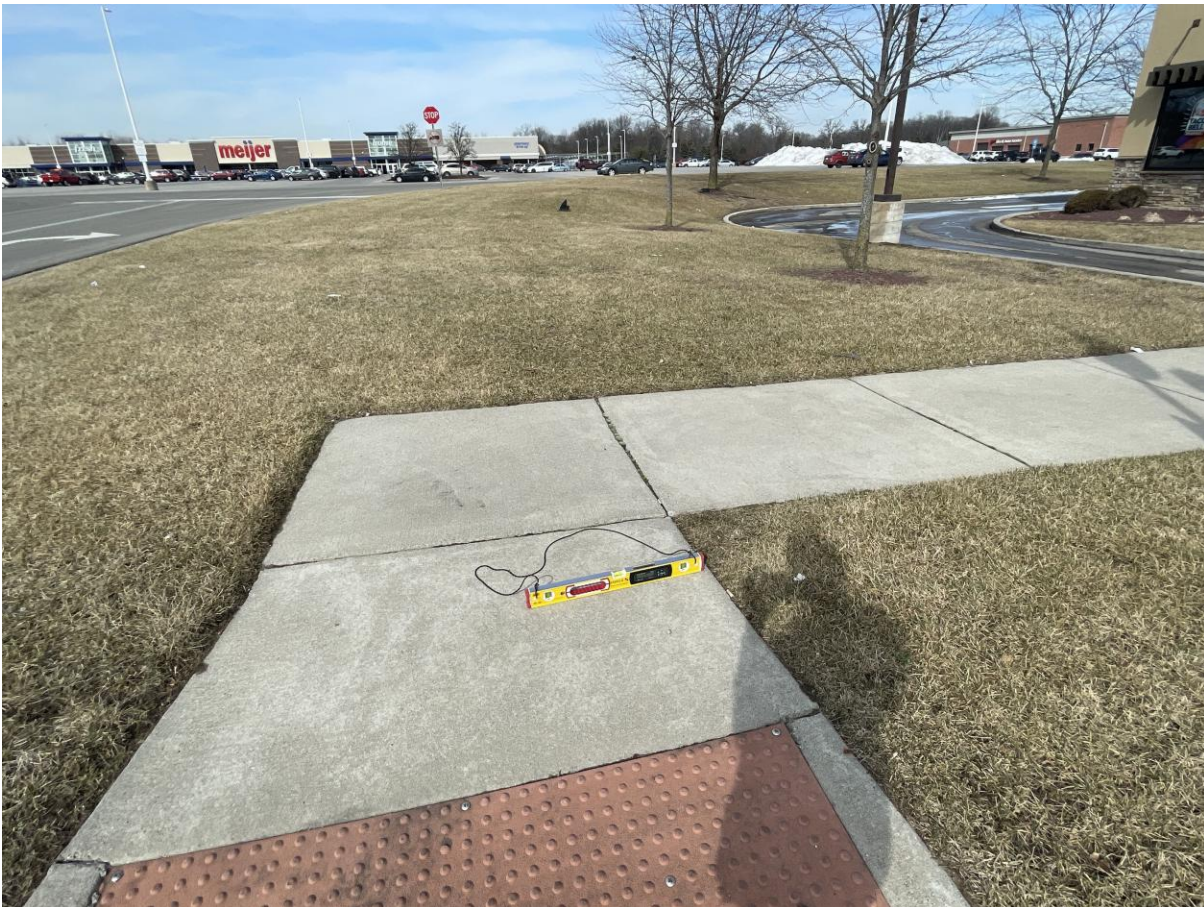
Finding: 6

The accessible path of travel between the building and the public way on the site has cross slopes greater than 2%.

Surface cross slopes shall not exceed one unit vertical in 48 units horizontal (2-percent slope).

3.9%

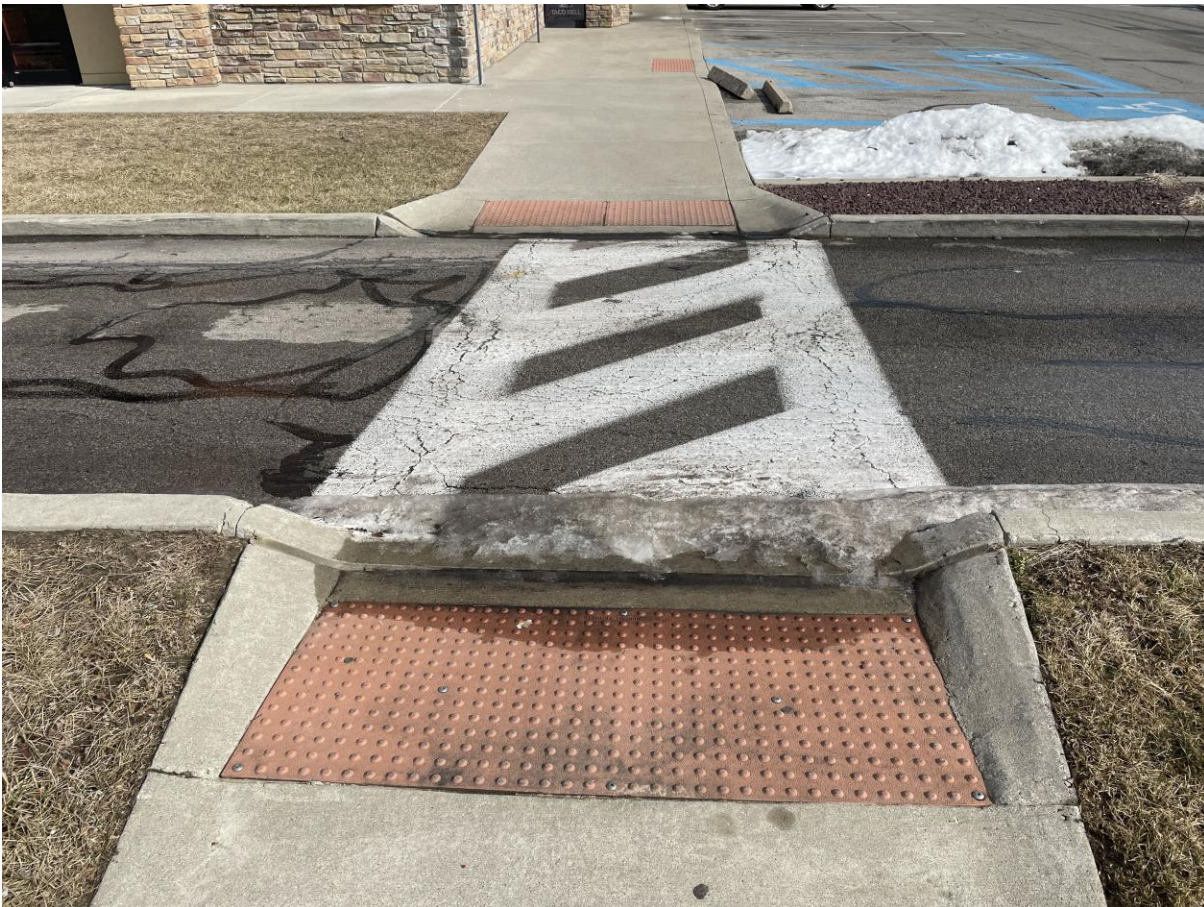
Finding: 7

The accessible route of travel contains detectable warnings (truncated domes) which are not currently required by the 2010 ADAS or ANSI A117.1 for this location.

(Two sets of domes)

Due to the ongoing development of guidelines and lack of adopted standards and/or regulations pertaining to the installation of detectable warnings, it is recommended that detectable warnings not be installed until such time that the standards and/or regulations require them. Please confirm with the local AHJ.

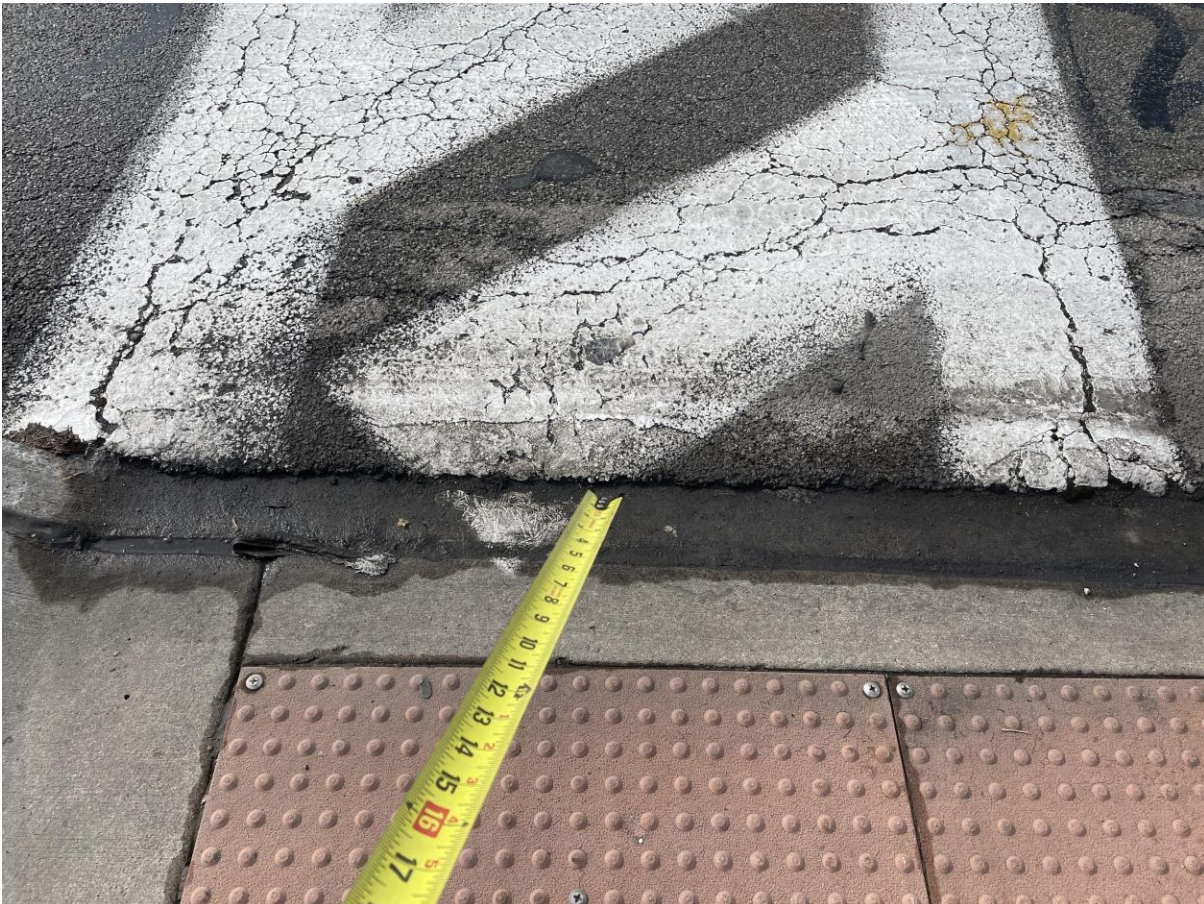
Finding: 8

The walkway contains abrupt vertical edges and/or variations over a 1/2 inch.

1/4 inch is the maximum vertical rise. Changes in level between 1/4 inch and 1/2 inch must be beveled at 1:2 or less.

Changes in level greater than 1/2 inch must be by way of a ramp.

Lifted pavement > 1/2"

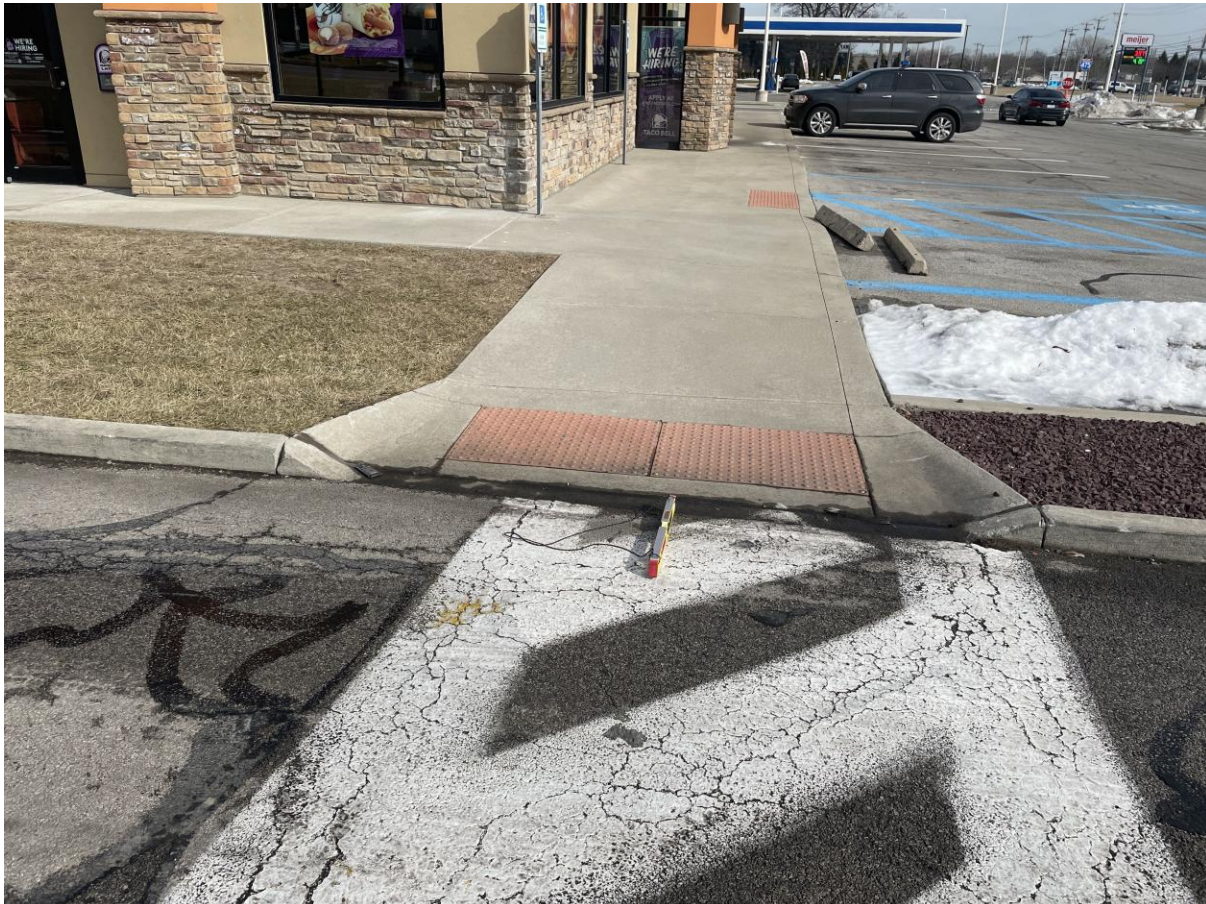
Finding: 9

The accessible route has running slopes greater than 5 percent across the width of the walk and has not been constructed as a ramp (i.e. handrails, edge protection, etc.).

When the slope in the direction of travel of any walk exceeds 1 unit vertical in 20 units horizontal (5-percent slope), it must be constructed as a ramp. Surface cross slopes must not exceed one unit vertical in 48 units horizontal (2-percent slope).

7.5%

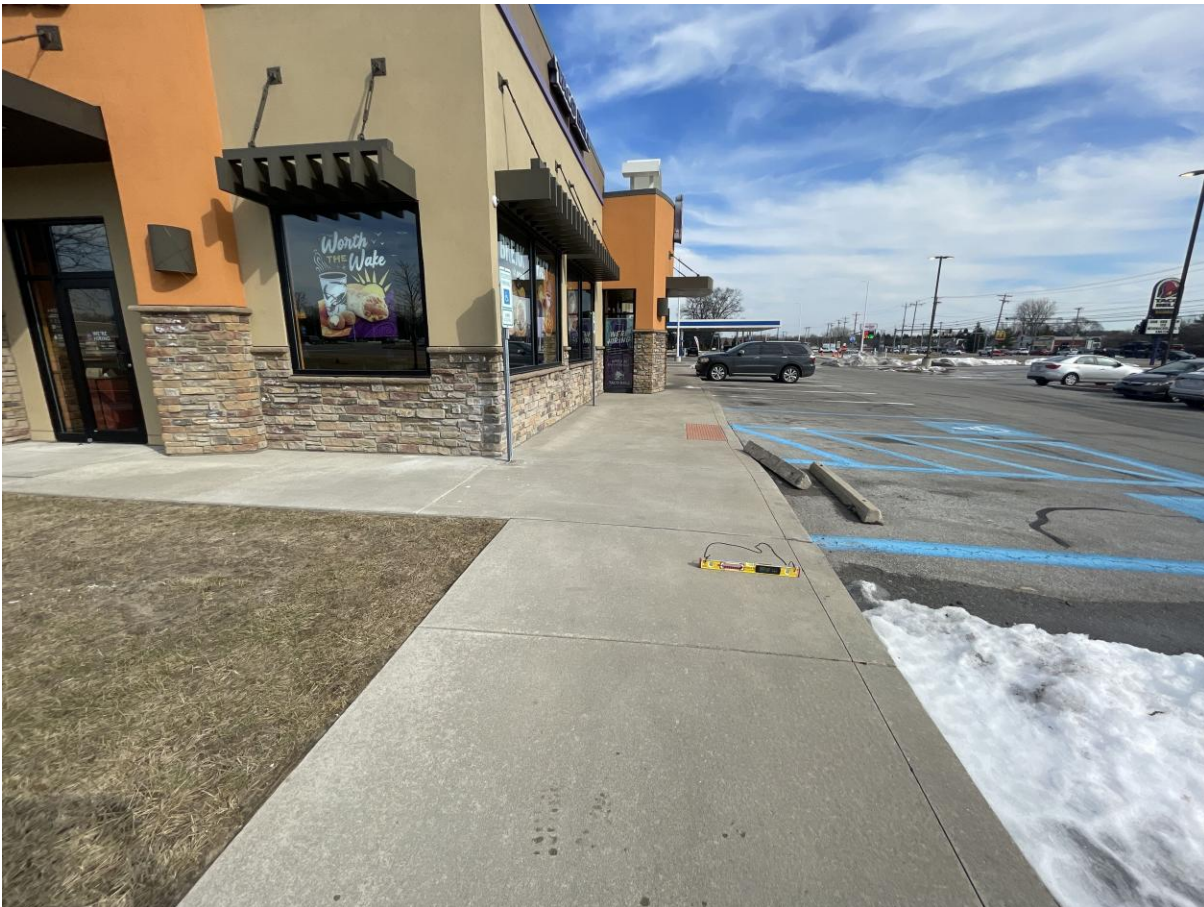
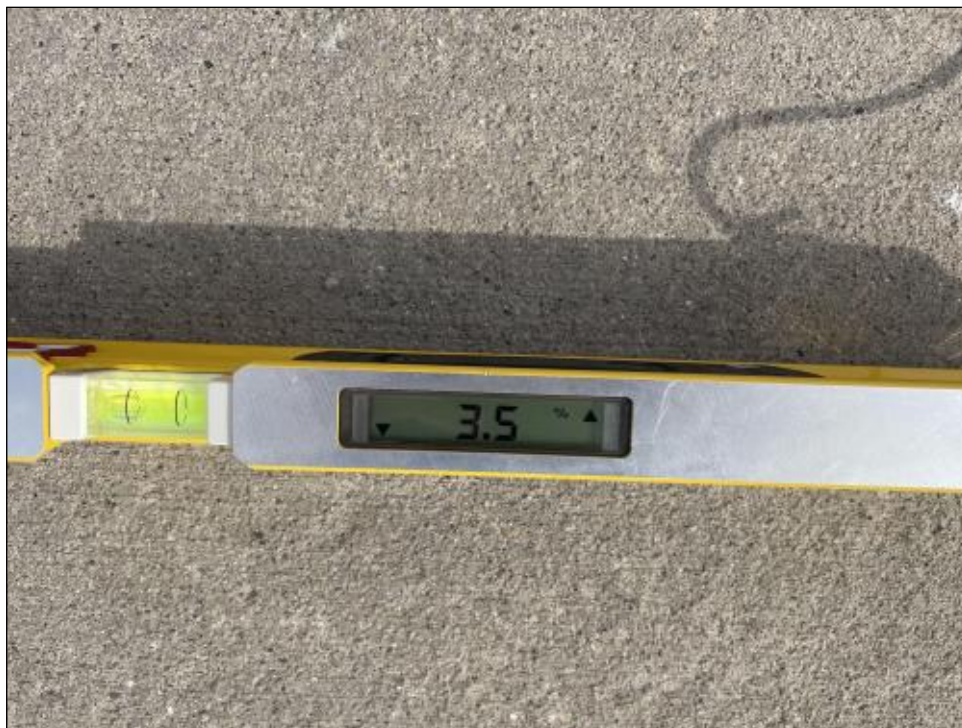
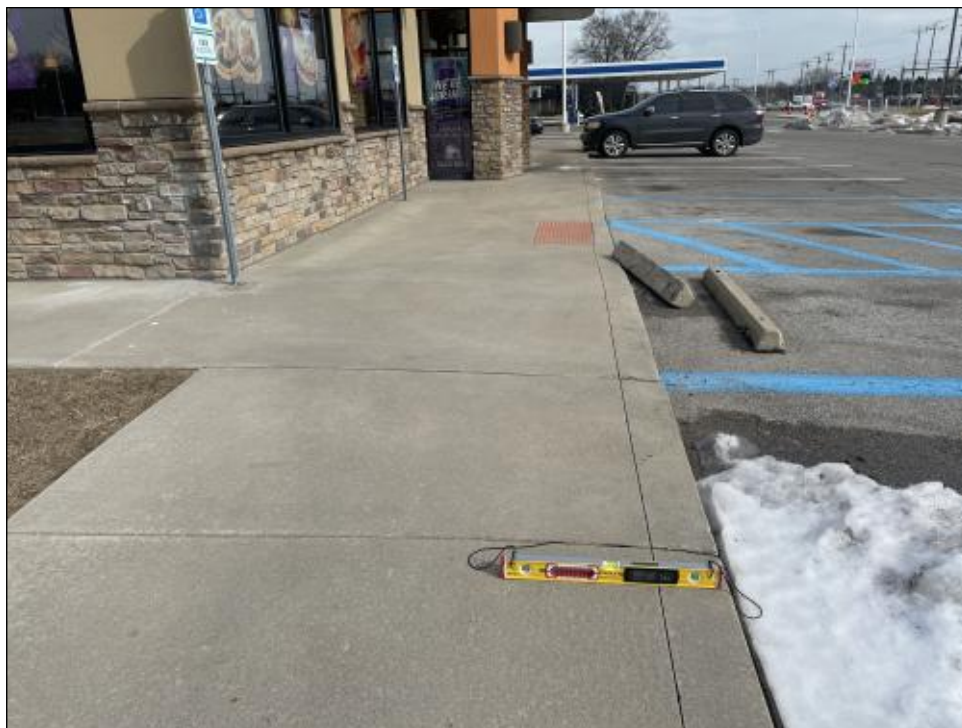
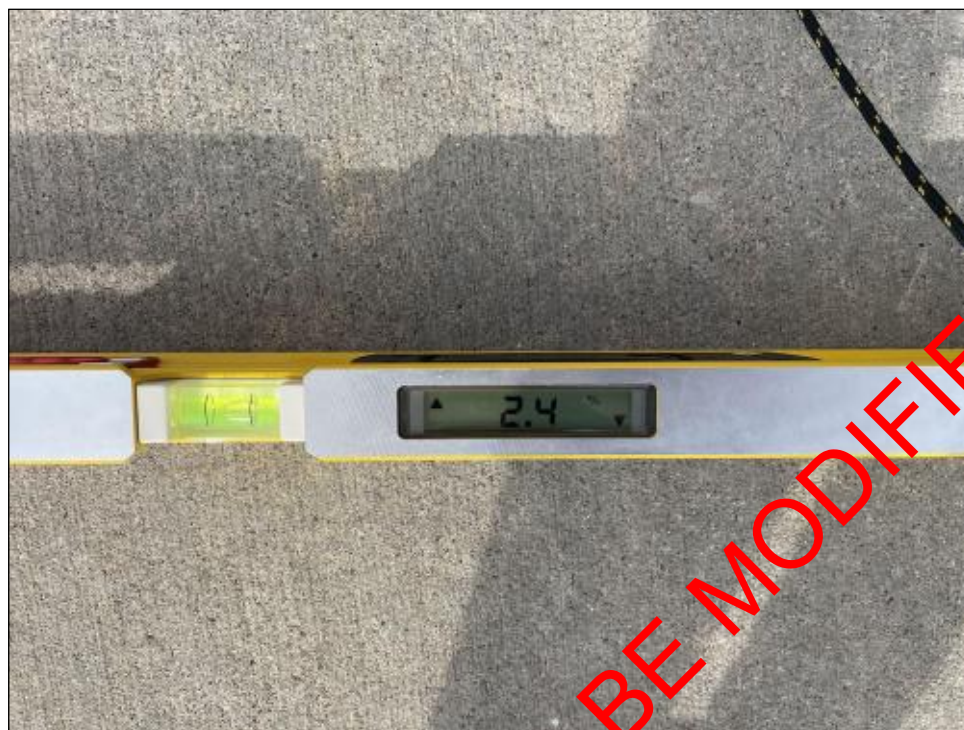
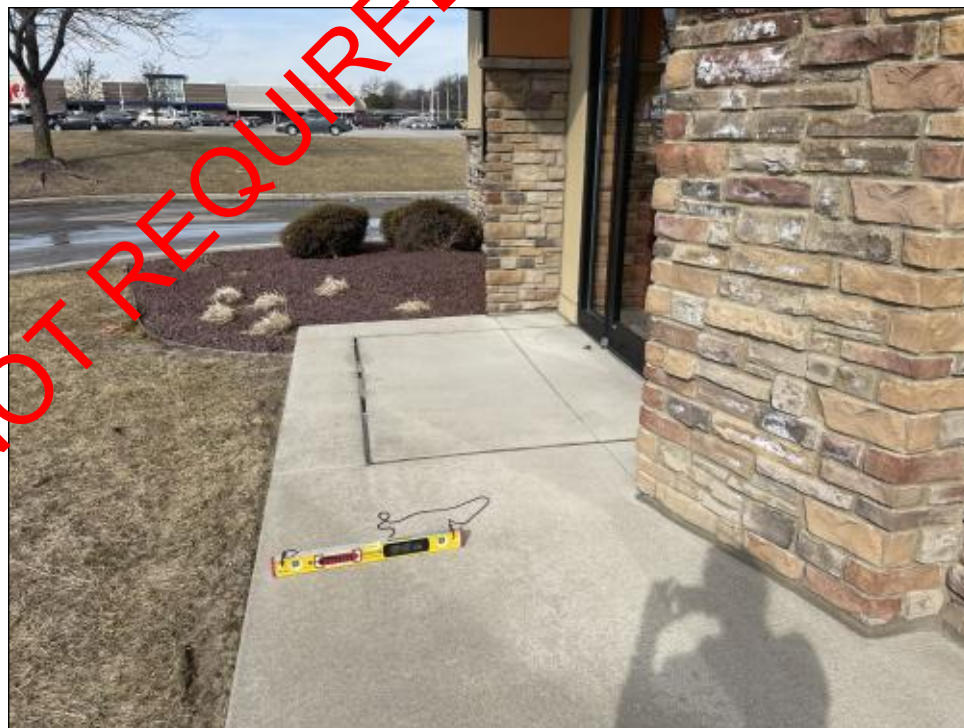
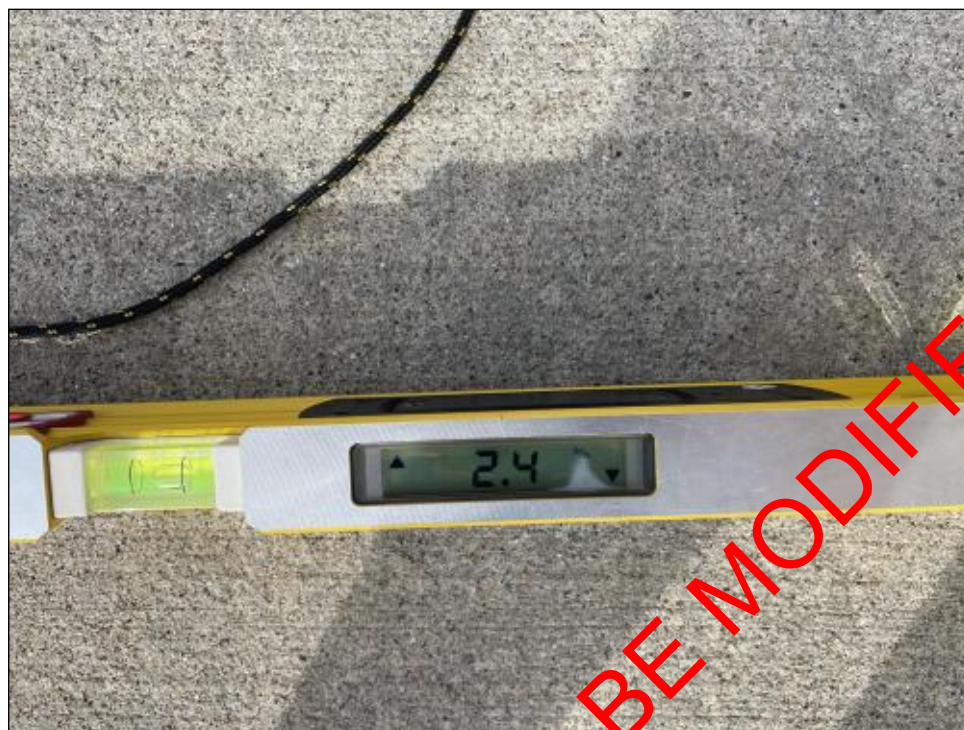
Finding: 10

The accessible path of travel between the building and the public way on the site has cross slopes greater than 2%.

Surface cross slopes shall not exceed one unit vertical in 48 units horizontal (2-percent slope).

(4 panels) 2.4%-3.5%

NOT REQUIRED TO BE MODIFIED

WITHIN REASONABLE CONSTRUCTION TOLERANCE

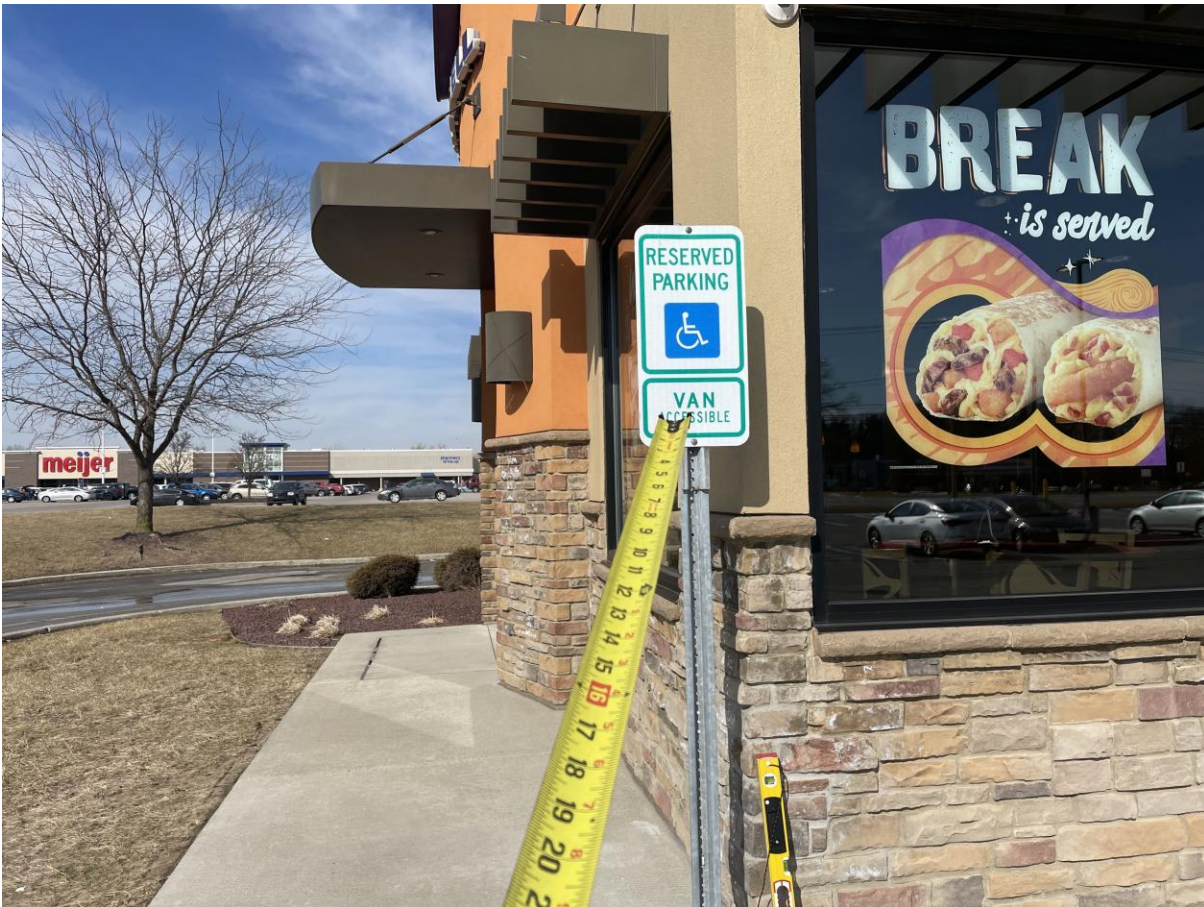
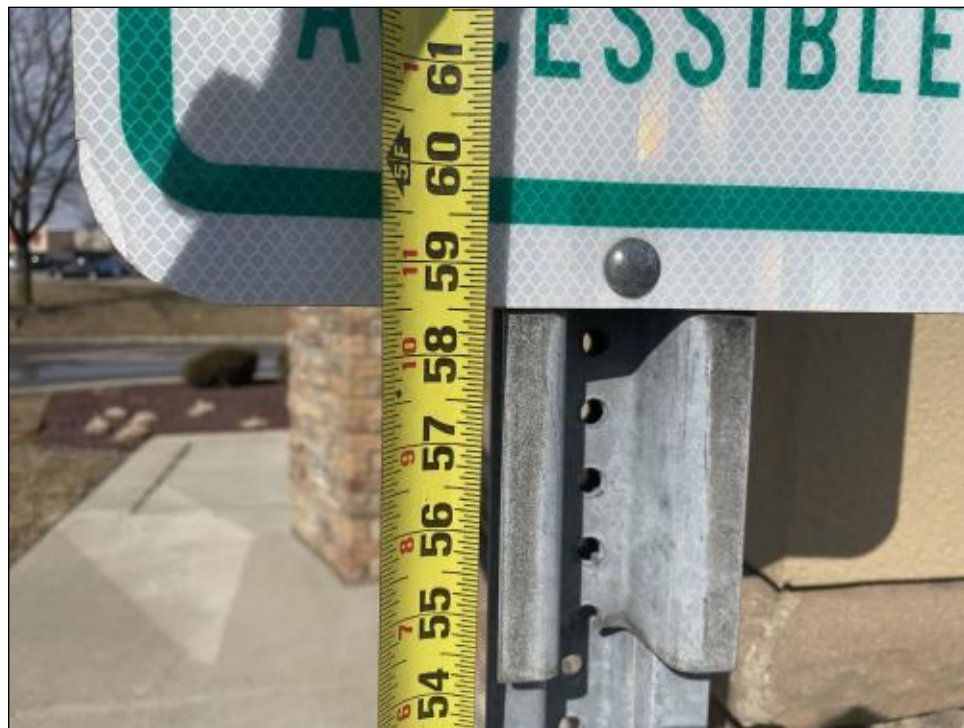
Finding: 11

The parking sign is mounted too low.

Parking space identification signs shall include the International Symbol of Accessibility. Signs identifying van parking spaces shall contain the designation "van accessible." Signs shall be 60 inches minimum above the finish floor or ground surface measured to the bottom of the sign.

58 1/2" (1 sign)

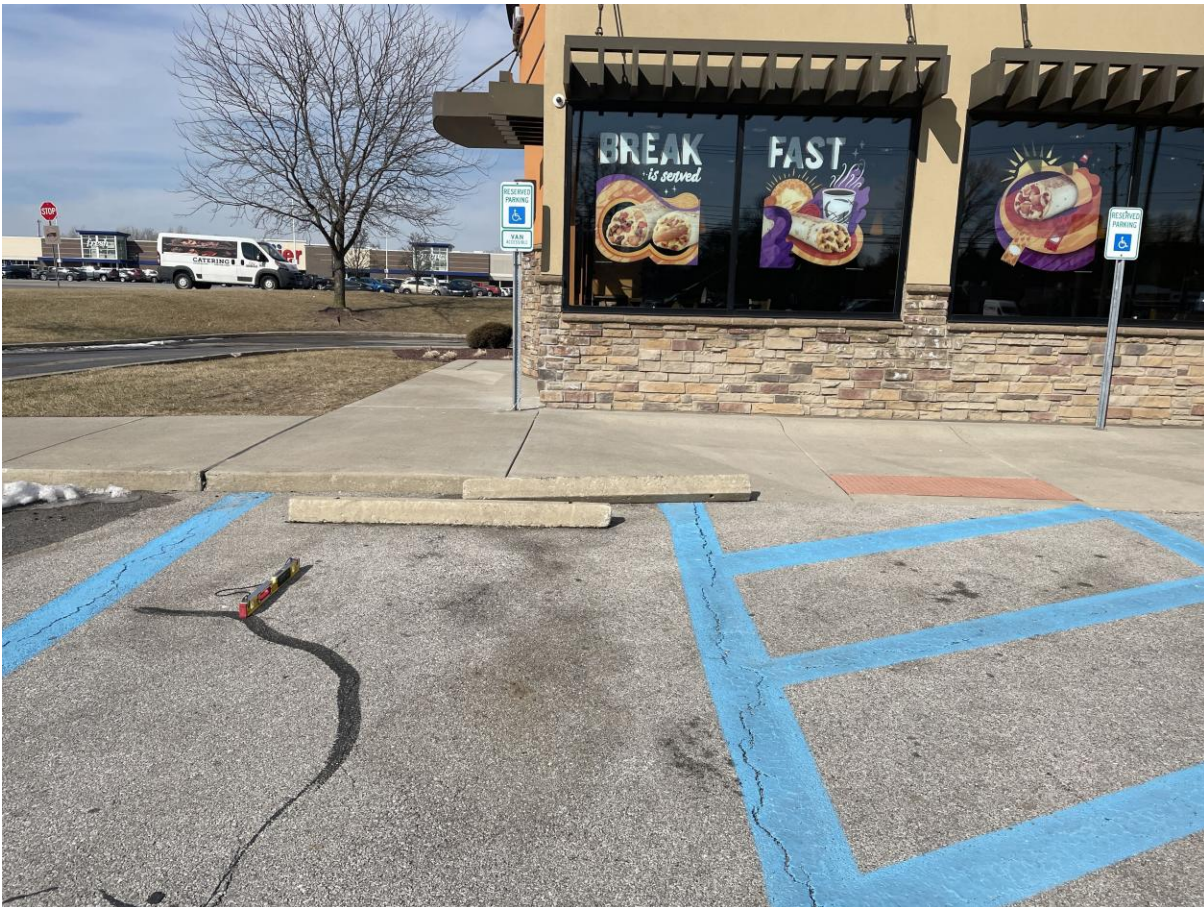
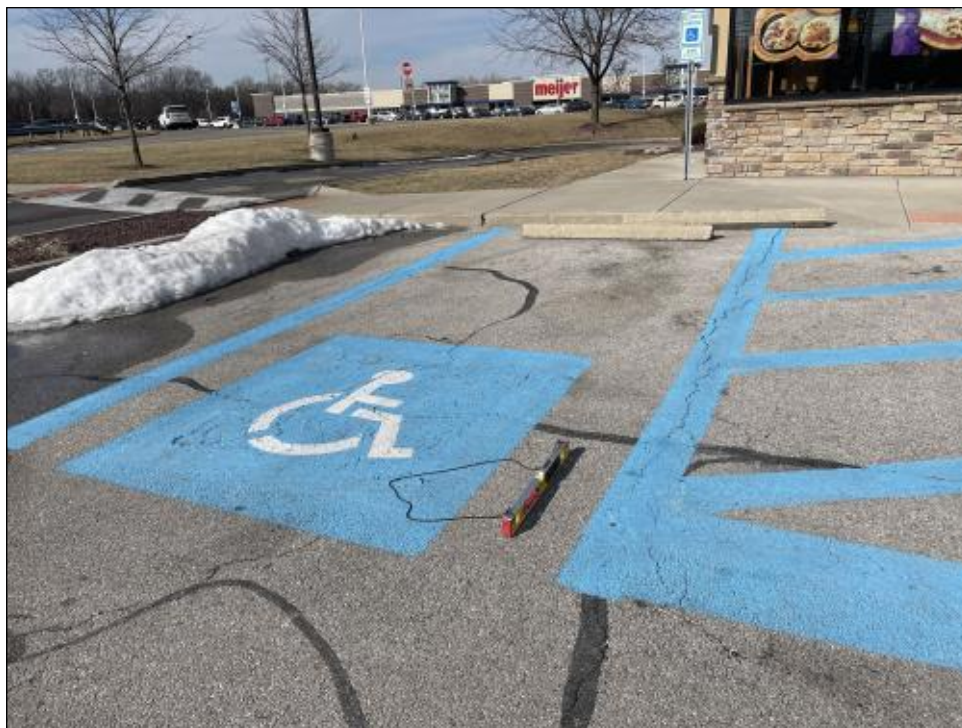
Finding: 12

The running slope (long dimension) of the accessible parking stall exceeds 2%.

The running slope in an accessible parking stall and the access aisle must not exceed 2%.

3.1%-3.9%
