Site Accessibility Evaluation

**Taco Bell Store #024598
(Pre)**

**7246 Central Ave
Toledo, OH 43617**

Pre Inspection

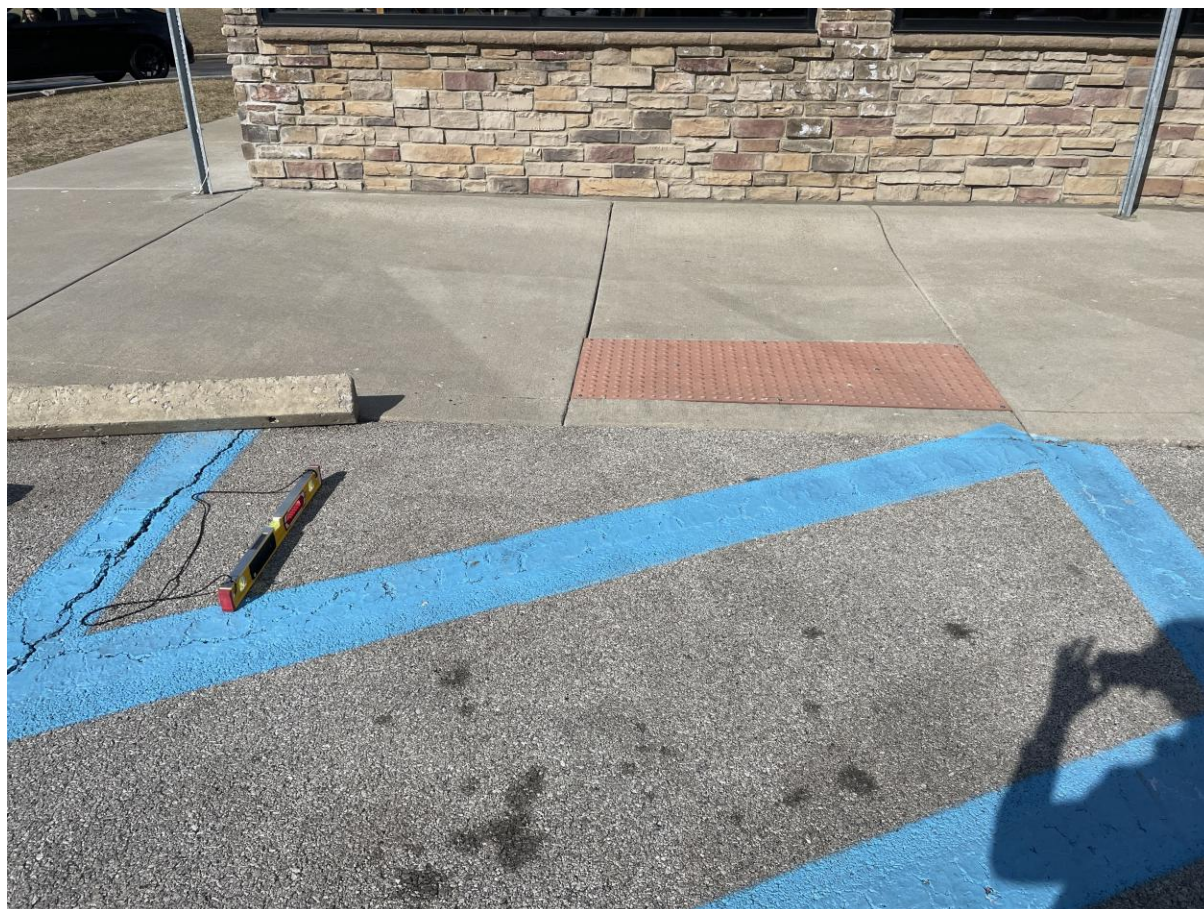
Finding: 13

The running slope of the access aisle (long dimension) exceeds 2%.

The running slope in an accessible parking stall and the access aisle must not exceed 2%.

2.9%-4.3%. (Top half of aisle)

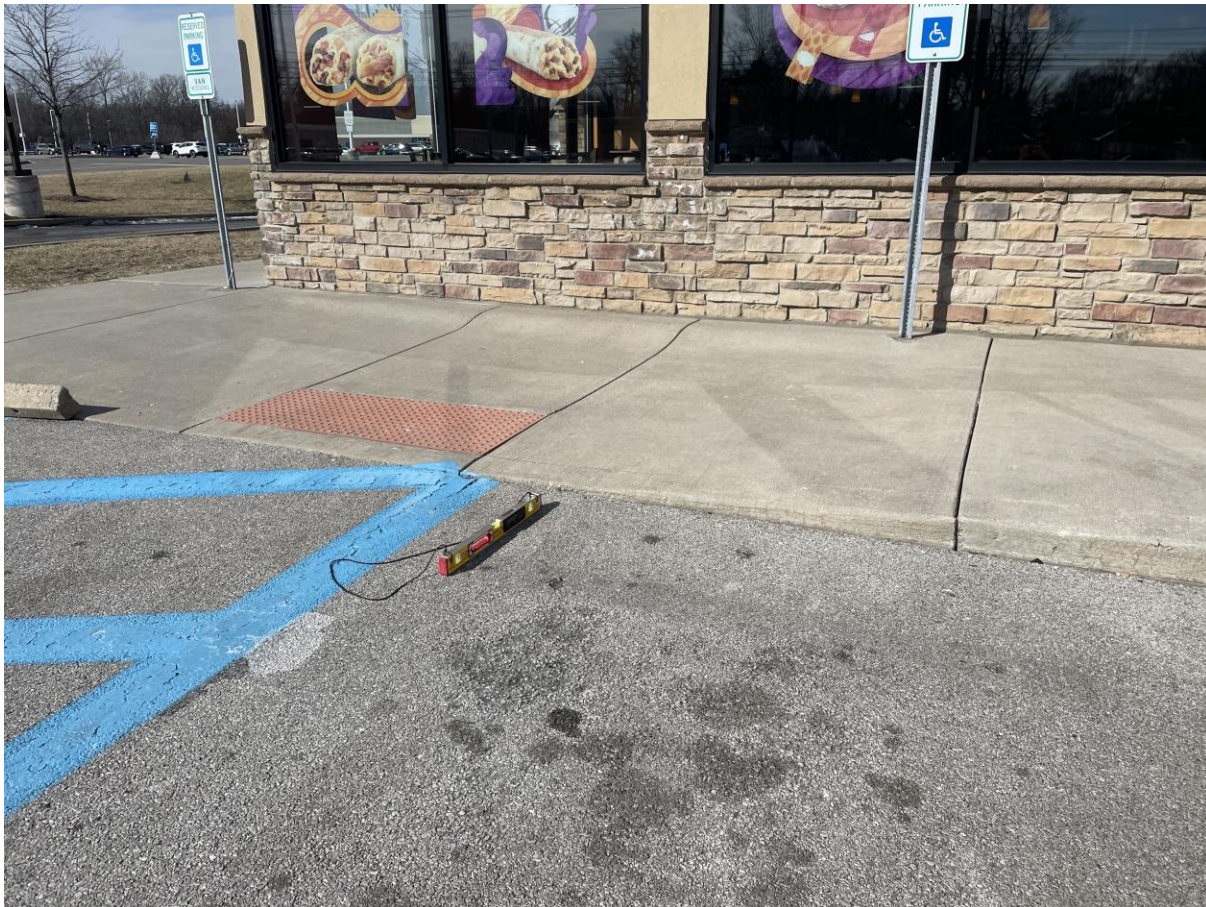
Finding: 14

The running slope (long dimension) of the accessible parking stall exceeds 2%.

The running slope in an accessible parking stall and the access aisle must not exceed 2%.

2.5%-3.9% (entire stall)

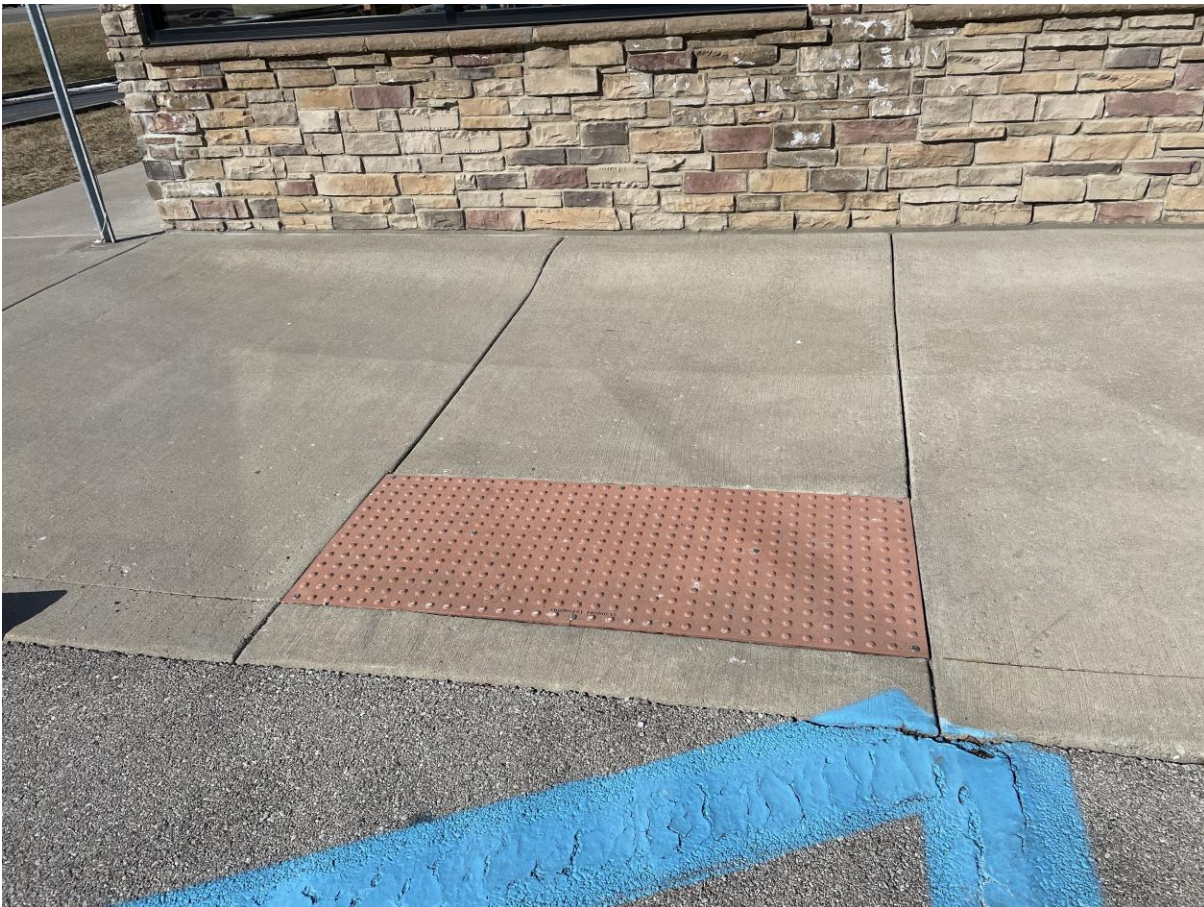
Finding: 15

The accessible route of travel contains detectable warnings (truncated domes) which are not currently required by the 2010 ADAS or ANSI A117.1 for this location.

Due to the ongoing development of guidelines and lack of adopted standards and/or regulations pertaining to the installation of detectable warnings, it is recommended that detectable warnings not be installed until such time that the standards and/or regulations require them. Please confirm with the local AHJ.

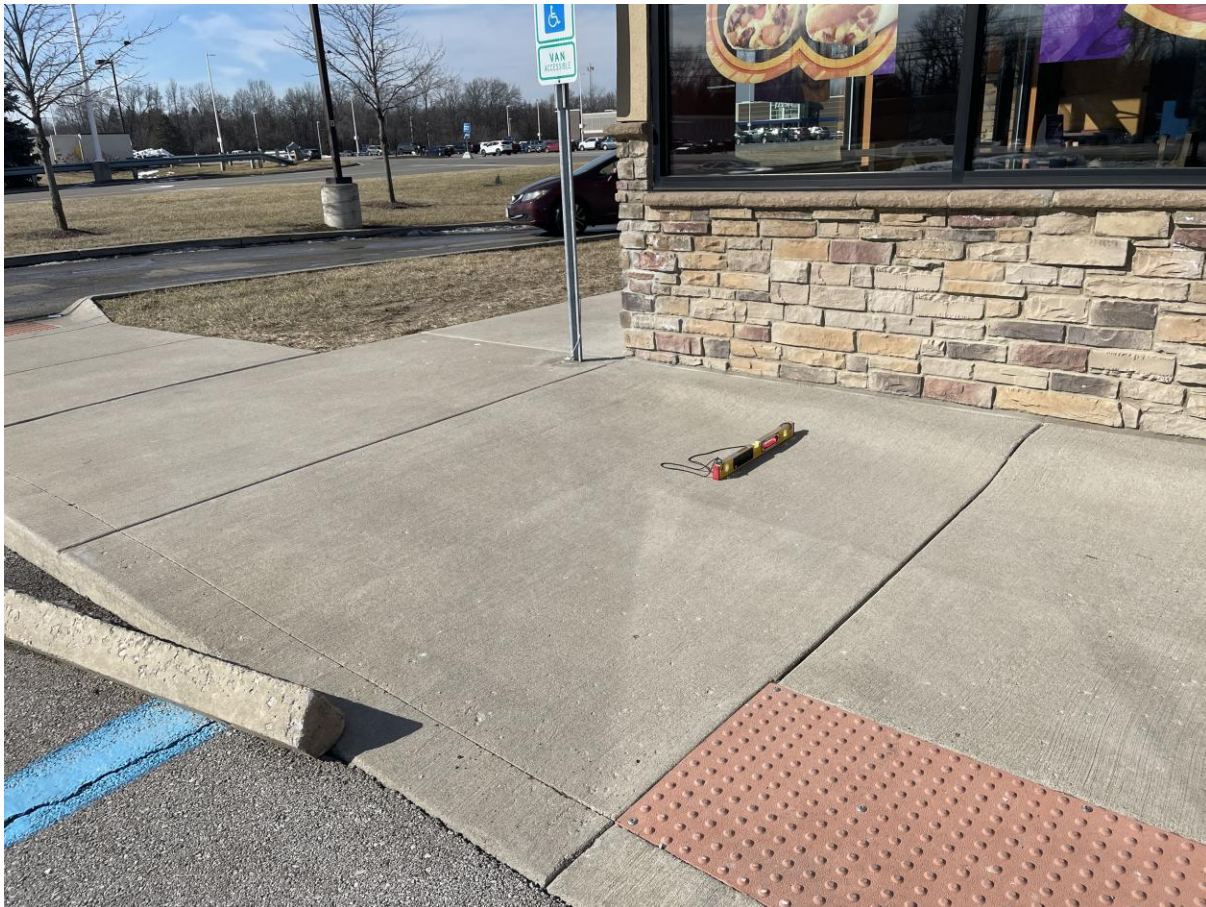
Finding: 16

The curb ramp on the accessible route has cross slopes greater than 2%.

Surface cross slopes shall not exceed one unit vertical in 48 units horizontal (2-percent slope).

2.8%-5.0%

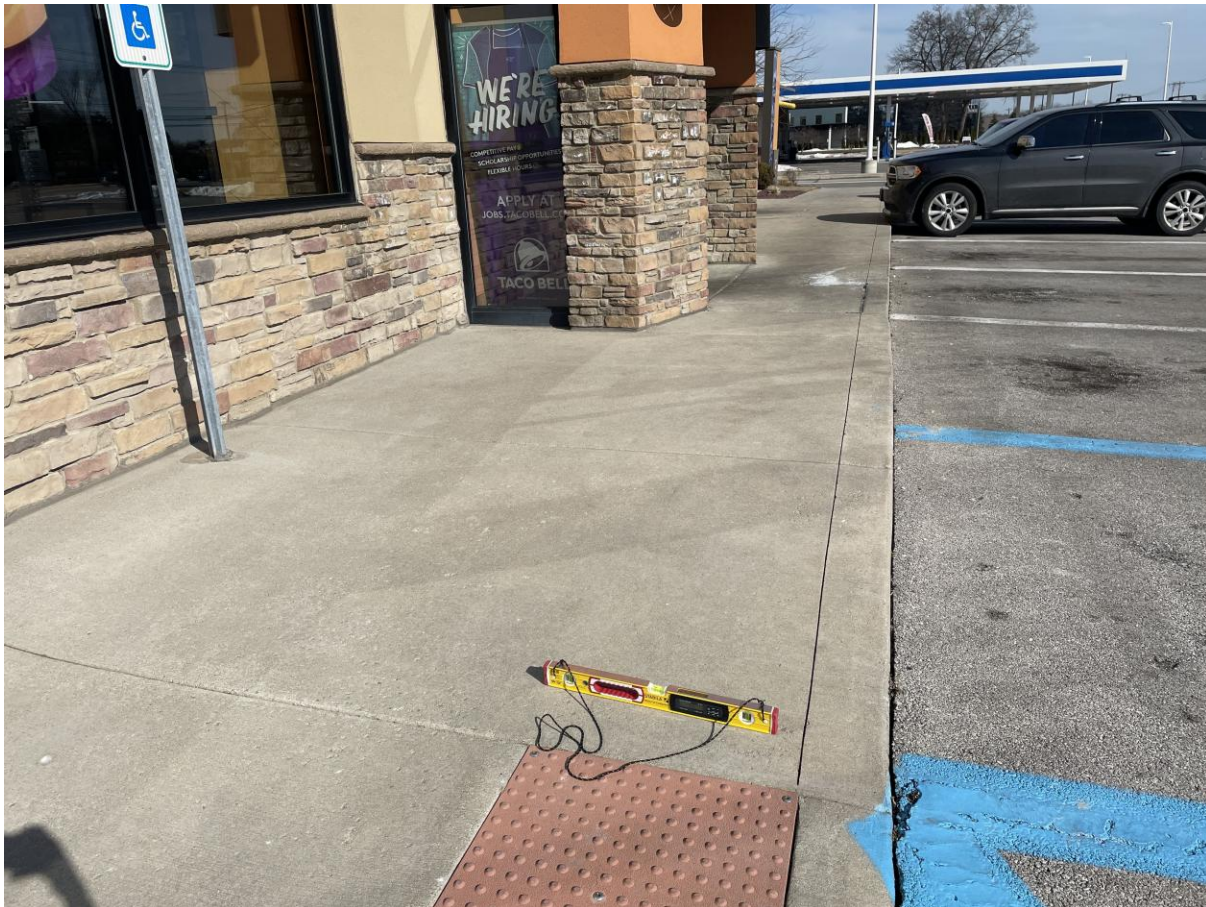
Finding: 17

The curb ramp on the accessible route has cross slopes greater than 2%.

Surface cross slopes shall not exceed one unit vertical in 48 units horizontal (2-percent slope).

3.5%-4.2%

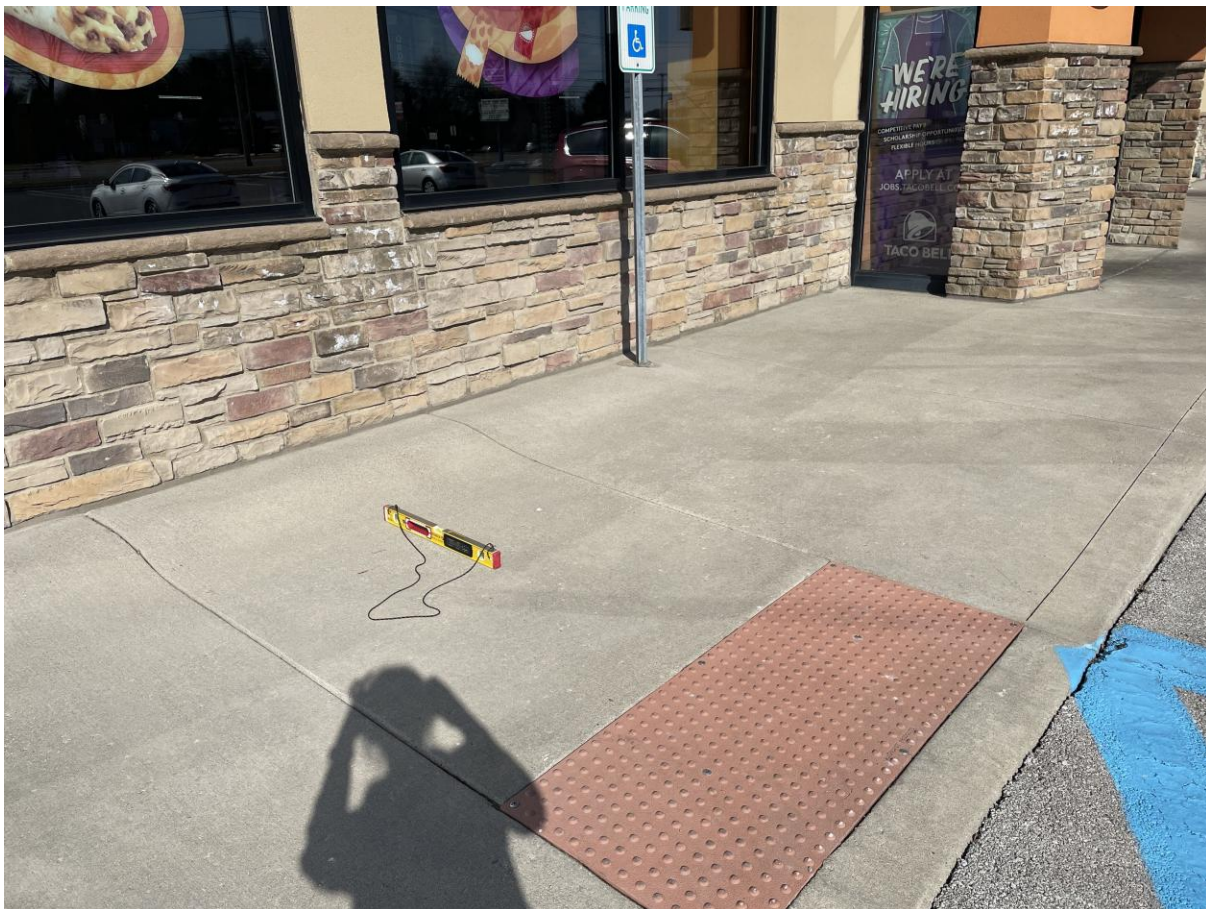
Finding: 18

The landing at the bottom of the ramp has a slope greater than 2%.

Bottom landings shall have a dimension in the direction of ramp run of not less than 60 inches and have a slope of 2% maximum in any direction.

4.1%

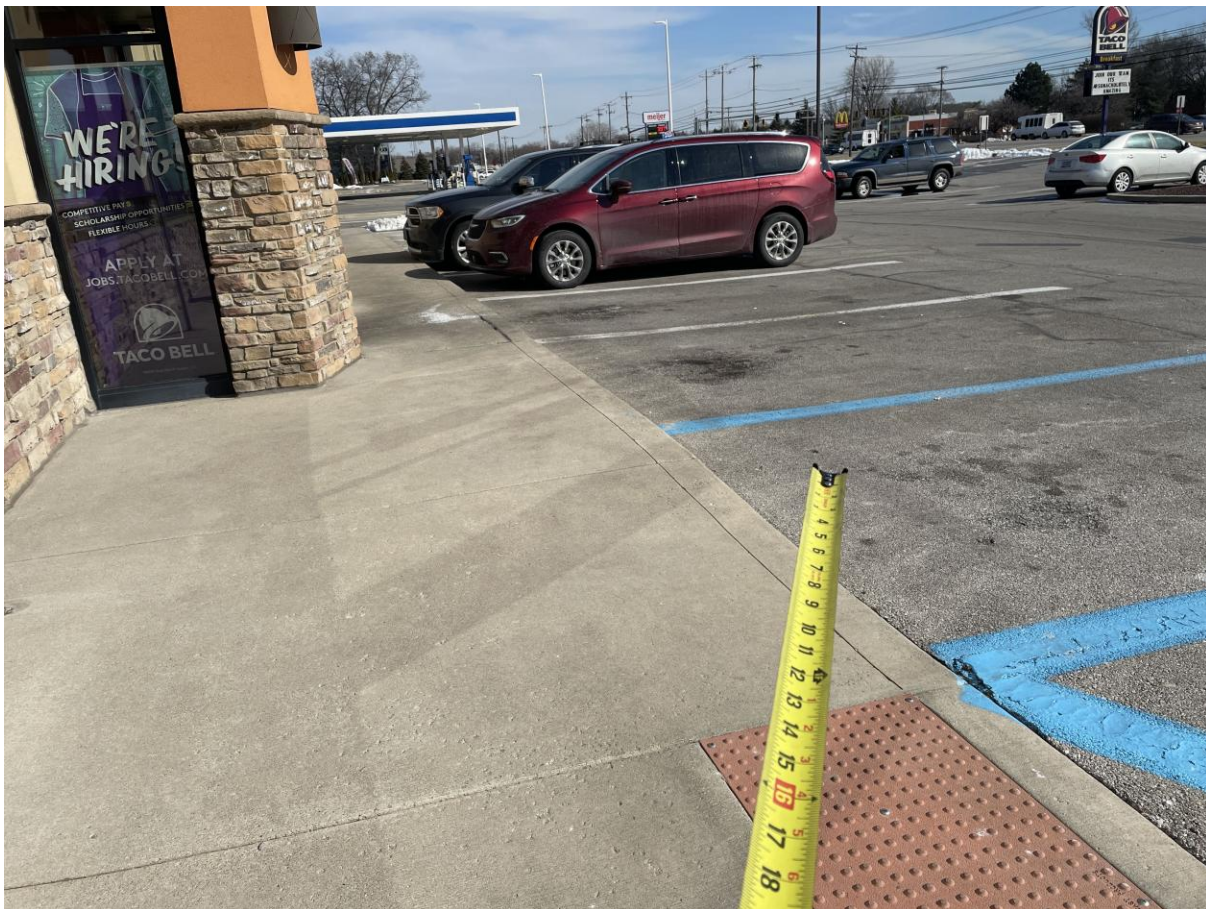
Finding: 19

Parked vehicles reduce the required width of the accessible route.

The accessible route of travel must be maintained at least 36 inches wide. Wheel stops are required when a car parked in any space may reduce the accessible path of travel to less than 36 inches.

Lack of wheel stops < 36"

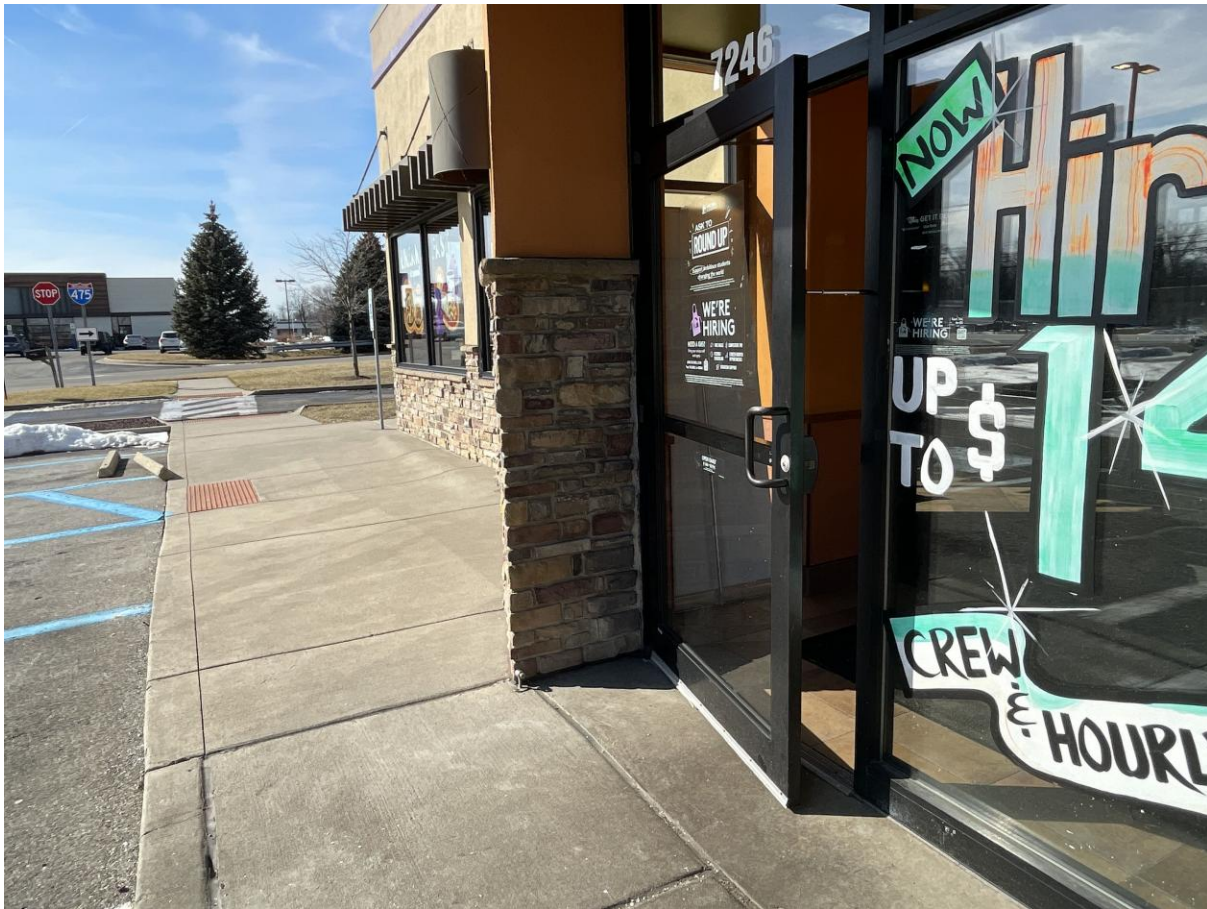
Finding: 20

The door exceeds the maximum pressure to open the door.

Exterior hinged doors shall be designed so that such doors can be pushed or pulled open with a force not exceeding 8.5 pounds.

12 lbs

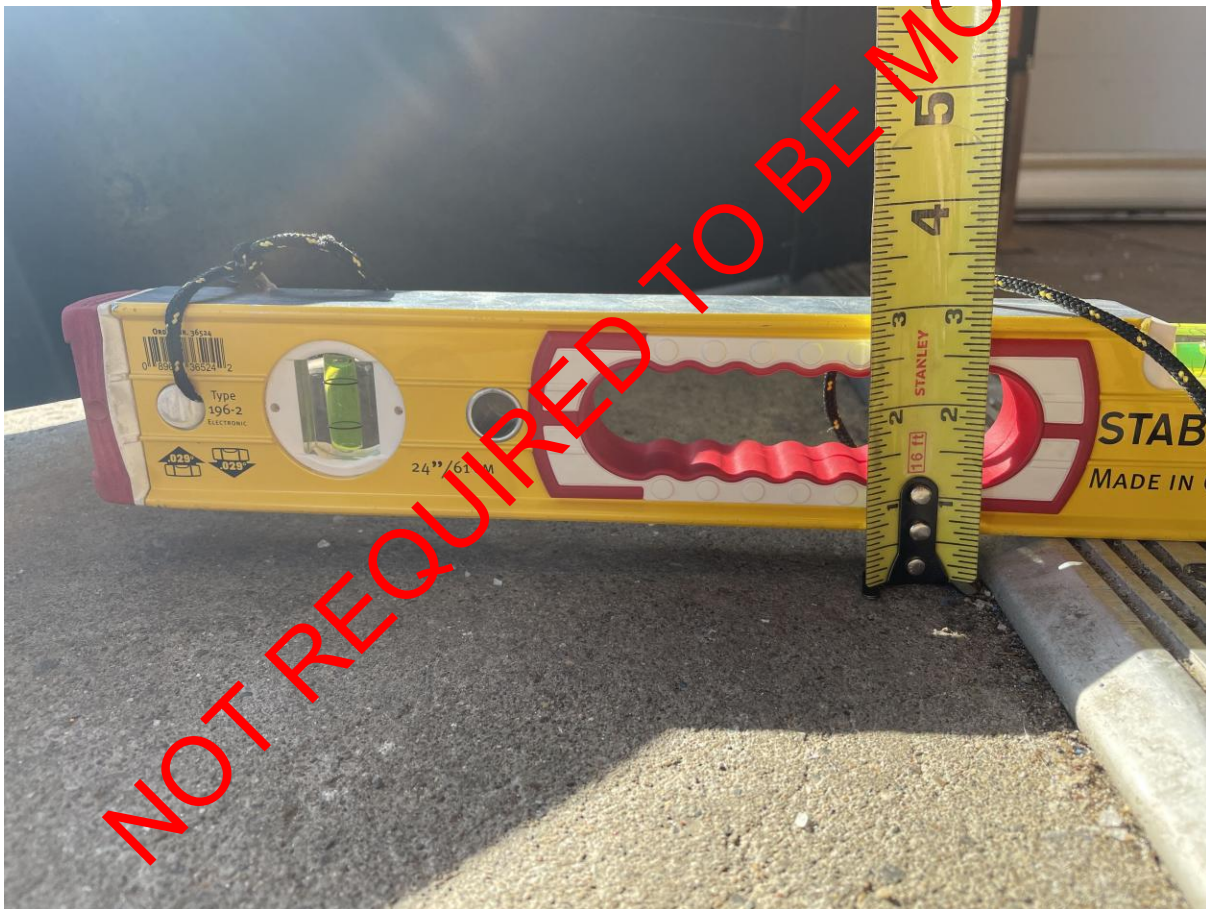
Finding: 21

The threshold is greater than 1/2 inch high.

The threshold at a doorway shall be no higher than 1/2 inch. Changes in level between 1/4 inch and 1/2 inch must be beveled at 1:2 or less. 1/4 inch is the maximum vertical rise.

3/8"

WITHIN REASONABLE CONSTRUCTION TOLERANCE

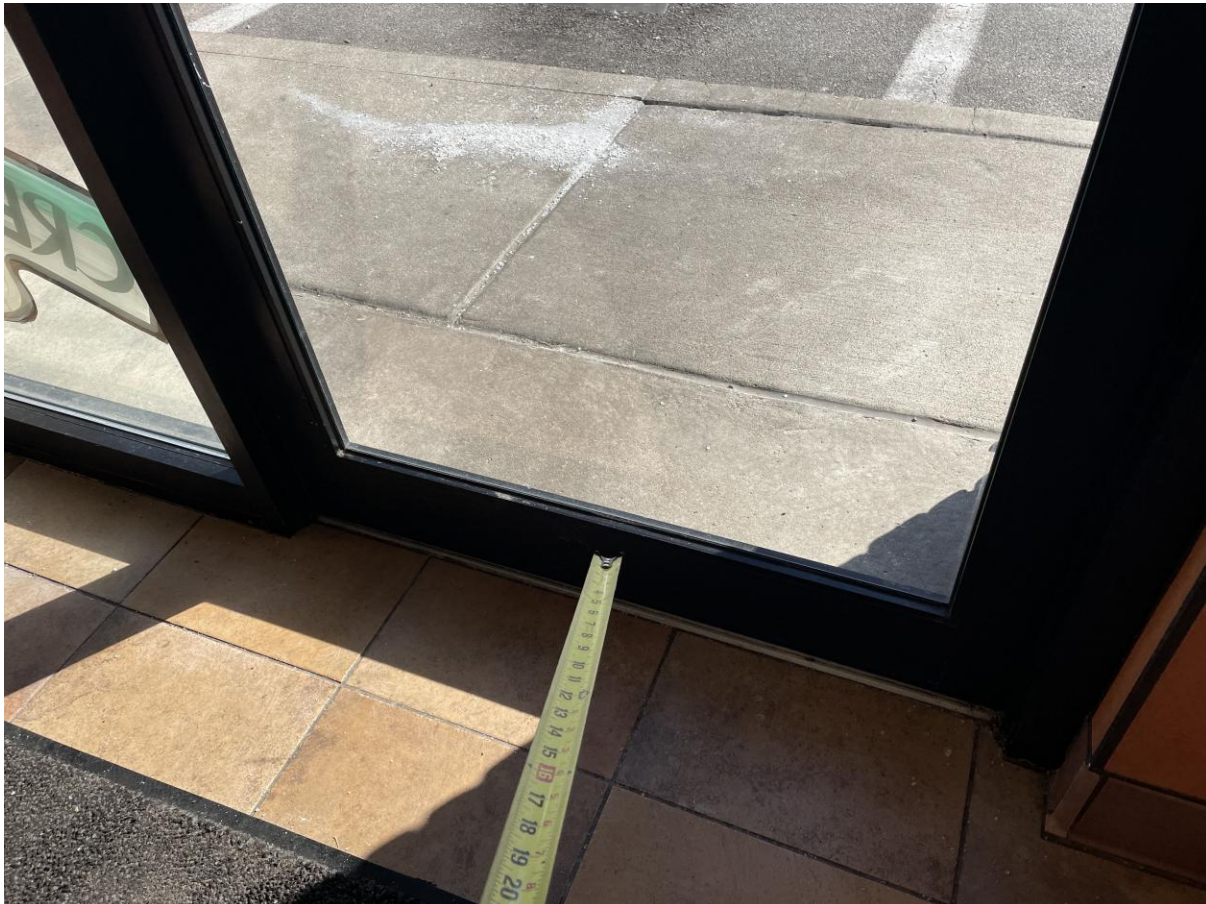
Finding: 22

The door must have a smooth surface within 10 inches of the floor on the push side.

Swinging door surfaces within 10 inches of the finish floor or ground measured vertically must have a smooth surface on the push side extending the full width of the door. Parts creating horizontal or vertical joints in these surfaces shall be within 1/16 inch of the same plane as the other. All gates, including ticket gates, shall meet all applicable specifications for doors.

7 1/4" (not beveled)

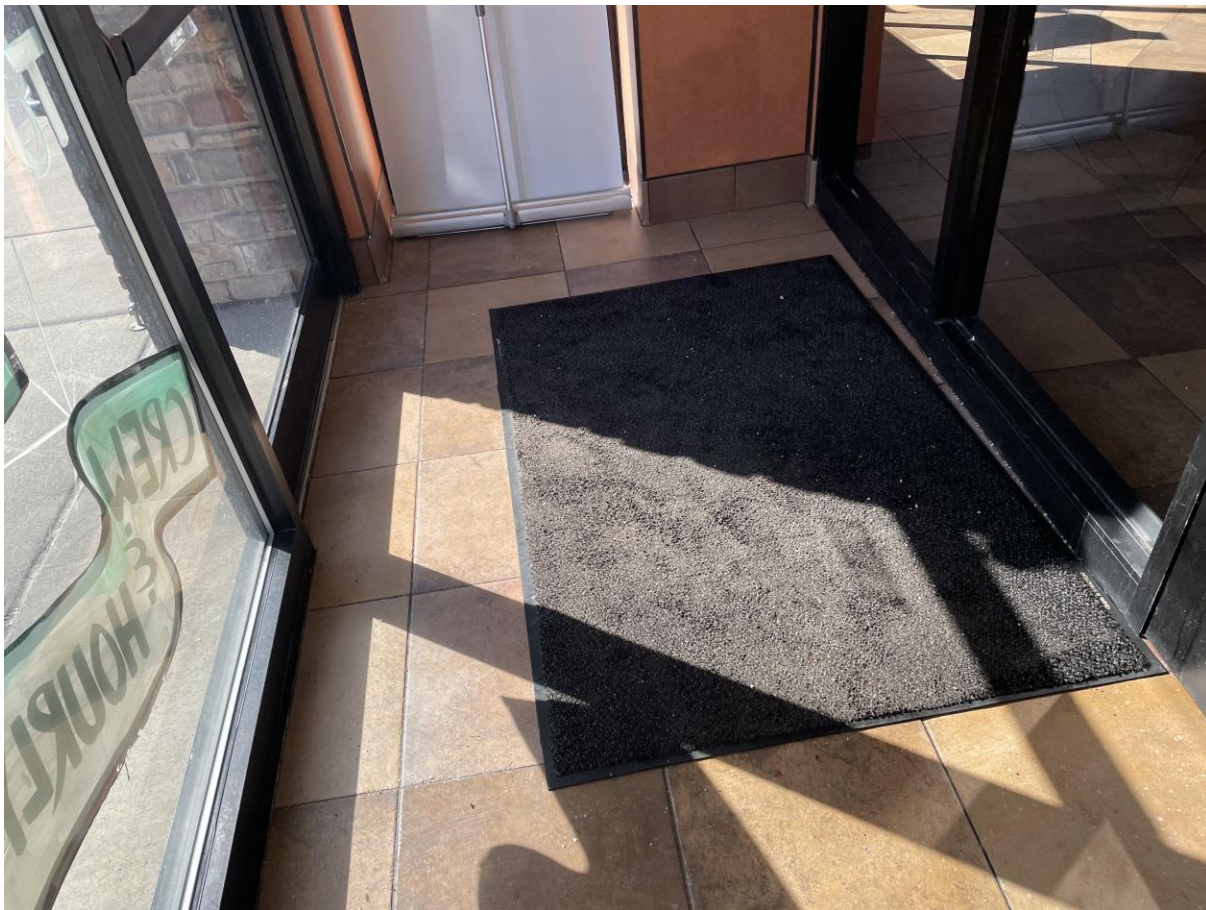
Finding: 23

The floor mat at the door is not secured in place.

If carpet or carpet tile is used on a ground or floor surface, then it shall be securely attached; have a firm cushion, pad or backing or no cushion or pad; and have a level loop, textured loop, level-cut pile or level-cut/uncut pile texture. The maximum pile height shall be 1/2 inch. Exposed edges of carpet shall be fastened to floor surfaces and have trim along the entire length of the exposed edge. Recessed doormats shall be adequately anchored to prevent interference with wheelchair traffic.

Not secured

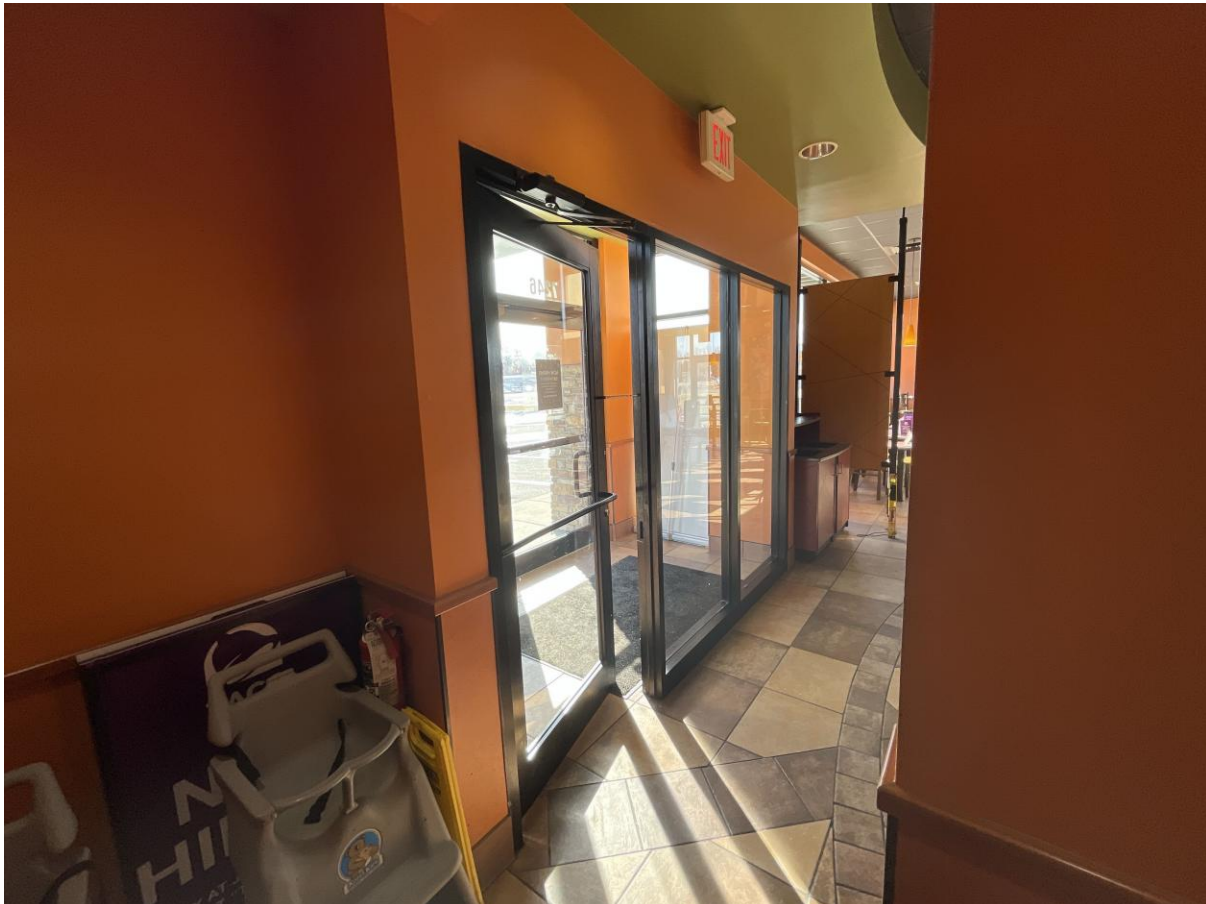
Finding: 24

The door exceeds the maximum allowable opening force.

Interior doors shall have a maximum opening force of 5 pounds.

11 lbs

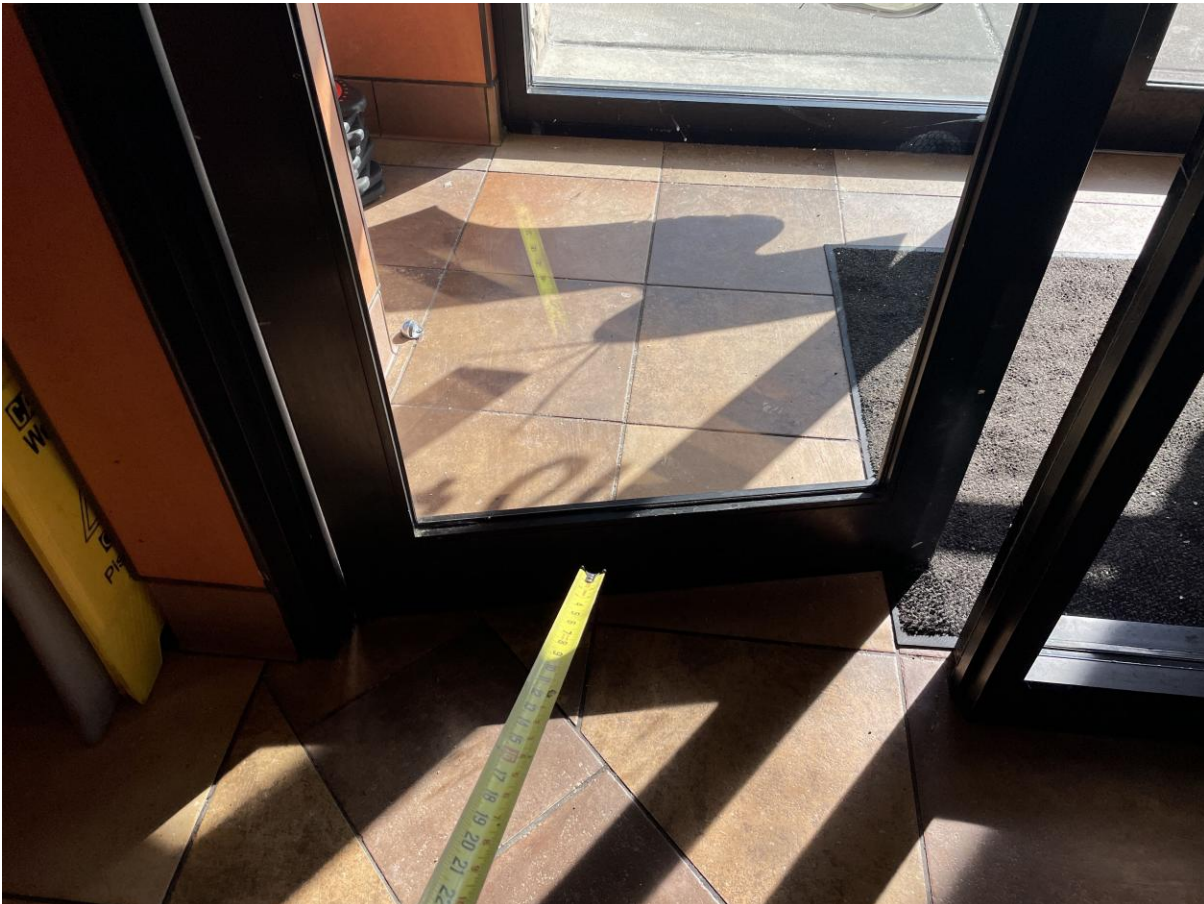
Finding: 25

The door must have a smooth surface within 10 inches of the floor on the push side.

Swinging door surfaces within 10 inches of the finish floor or ground measured vertically must have a smooth surface on the push side extending the full width of the door. Parts creating horizontal or vertical joints in these surfaces shall be within 1/16 inch of the same plane as the other. All gates, including ticket gates, shall meet all applicable specifications for doors.

7 1/2" (not beveled)

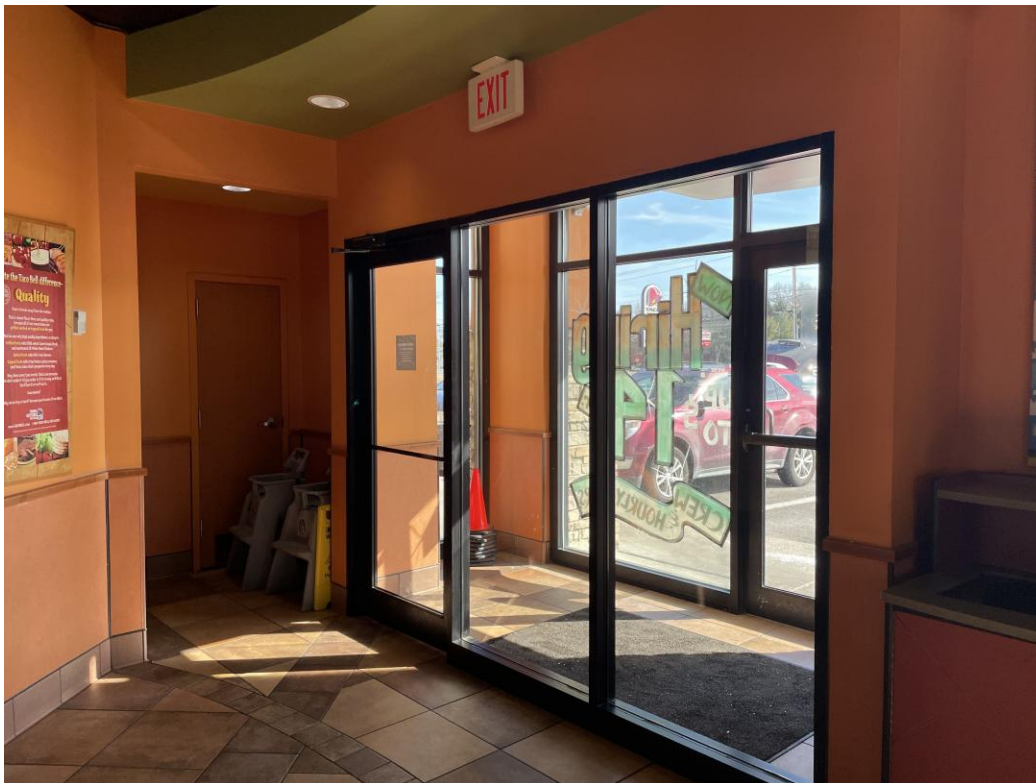
Finding: 26

The tactile EXIT sign is missing at the door.

Wall signs identifying exits shall have characters raised 1/32 inch minimum and shall be uppercase characters a minimum of 5/8 inch and a maximum of 2 inches high. Braille shall be placed directly below the tactile characters; flush left or centered. Signs shall be located a minimum of 48 inches above the floor, measured from the baseline of the lowest tactile characters and 60 inches maximum above the finish floor or ground surface, measured from the baseline of the highest tactile characters.

Missing

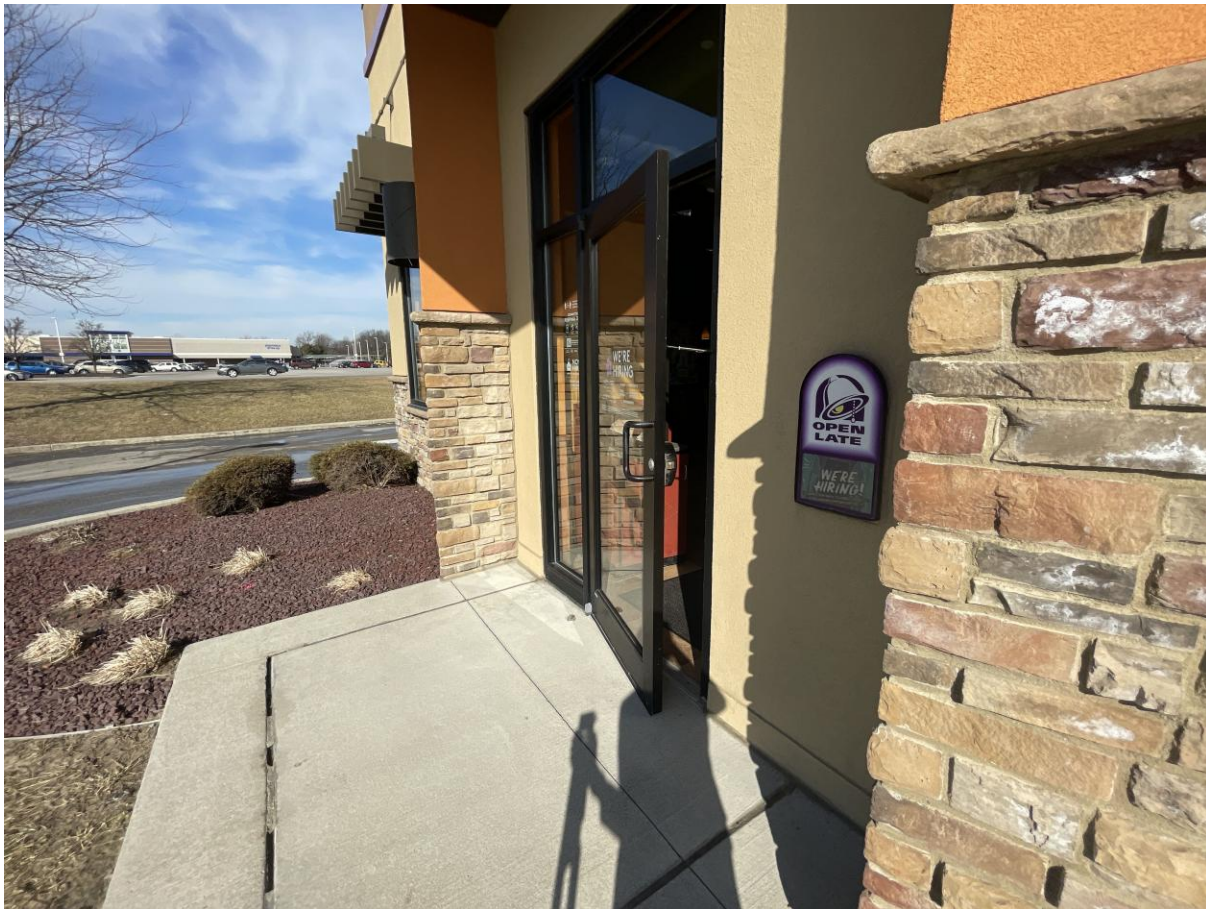
Finding: 27

The door exceeds the maximum pressure to open the door.

Exterior hinged doors shall be designed so that such doors can be pushed or pulled open with a force not exceeding 8.5 pounds.

9 lbs

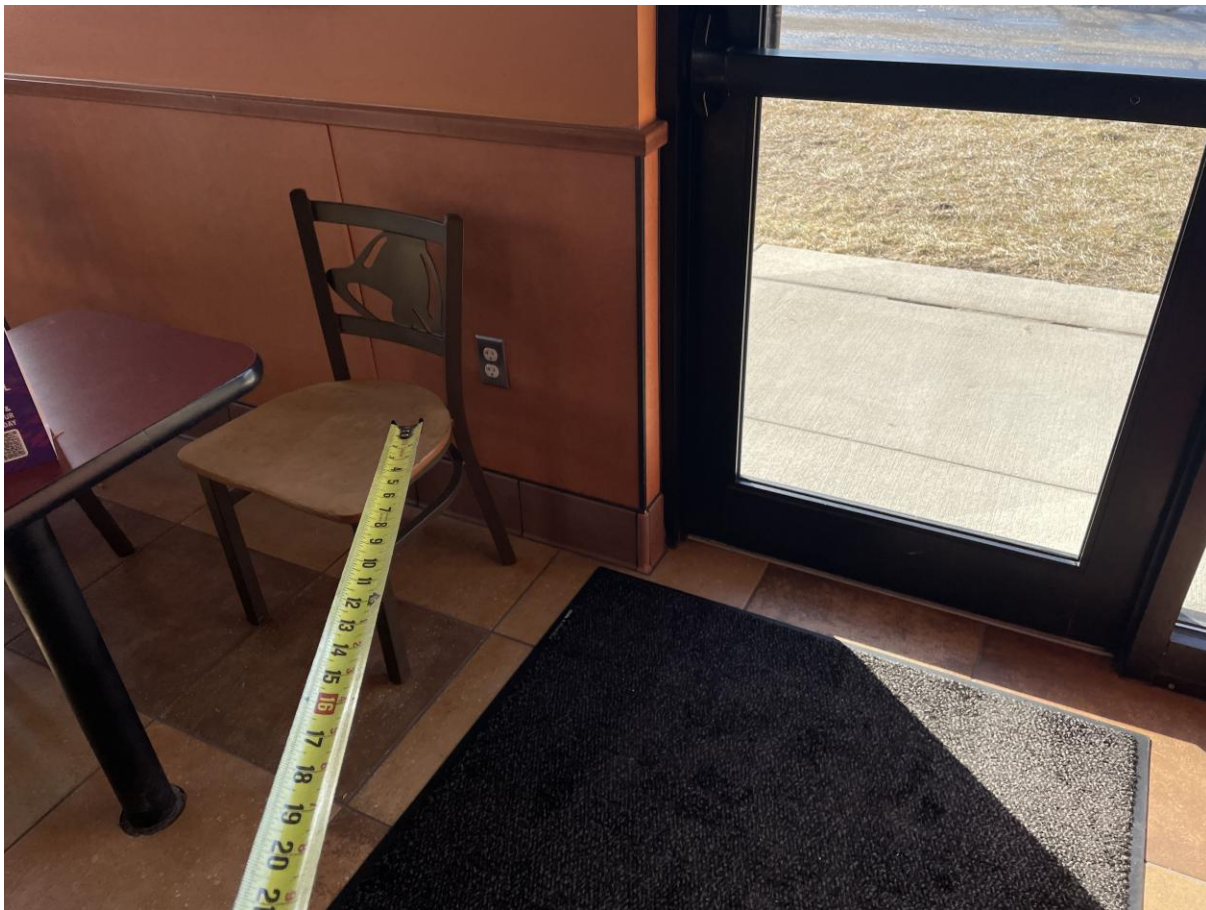
Finding: 28

The door is equipped with both a closer and a latch and there is no latch side clearance.

Maneuvering clearance for doors on the push side equipped with both a closer and latch must be 48 inches minimum in depth. The width of the maneuvering clearance must be as wide as the door plus an additional 12 inches on the latch side. Doors recessed on the latch side greater than 8 inches must provide the additional 12 inches of clearance within the recess. The maneuvering clearance must be flat (2% max. slope in any direction) and clear of obstructions.

Obstructed by chair

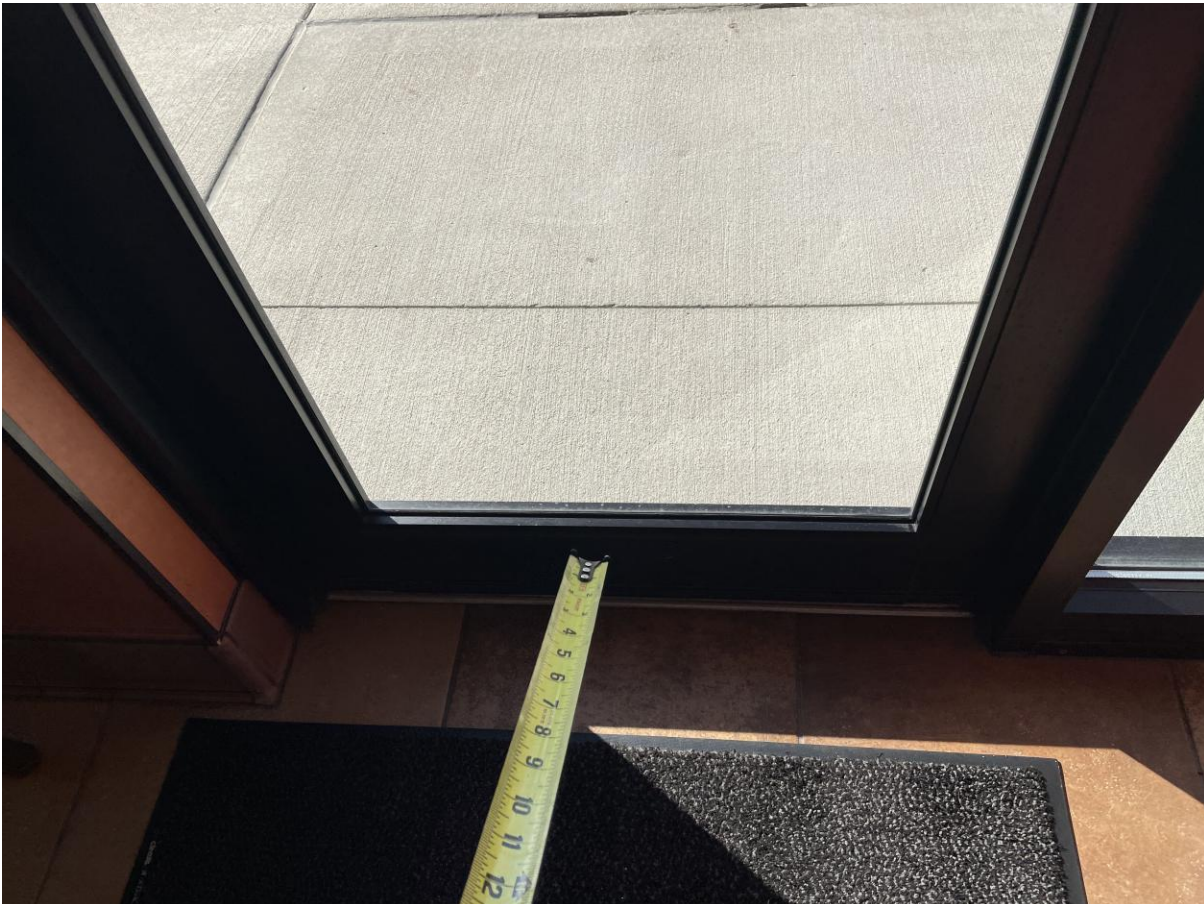
Finding: 29

The door must have a smooth surface within 10 inches of the floor on the push side.

Swinging door surfaces within 10 inches of the finish floor or ground measured vertically must have a smooth surface on the push side extending the full width of the door. Parts creating horizontal or vertical joints in these surfaces shall be within 1/16 inch of the same plane as the other. All gates, including ticket gates, shall meet all applicable specifications for doors.

7 1/2" (not beveled)

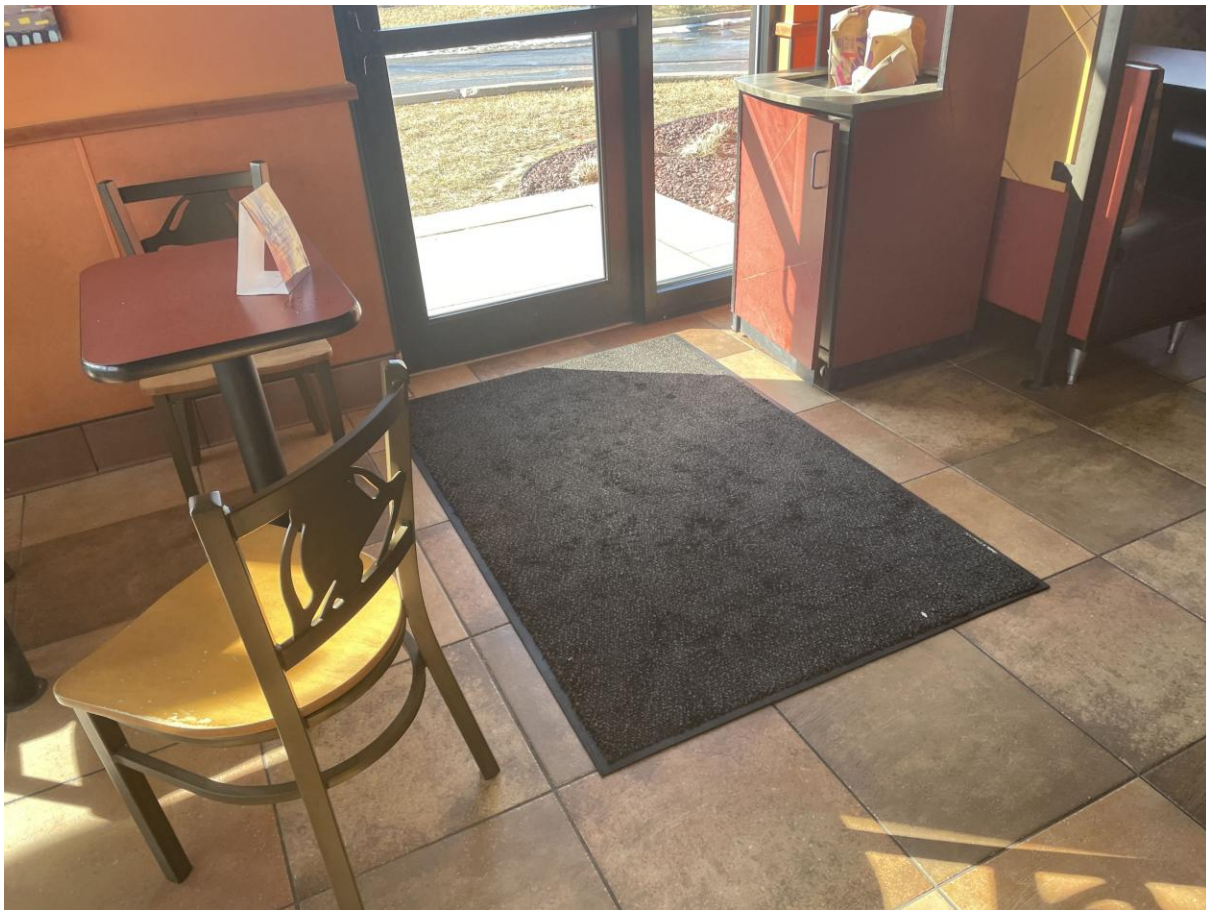
Finding: 30

The floor mat at the door is not secured in place.

If carpet or carpet tile is used on a ground or floor surface, then it shall be securely attached; have a firm cushion, pad or backing or no cushion or pad; and have a level loop, textured loop, level-cut pile or level-cut/uncut pile texture. The maximum pile height shall be 1/2 inch. Exposed edges of carpet shall be fastened to floor surfaces and have trim along the entire length of the exposed edge. Recessed doormats shall be adequately anchored to prevent interference with wheelchair traffic.

not secured

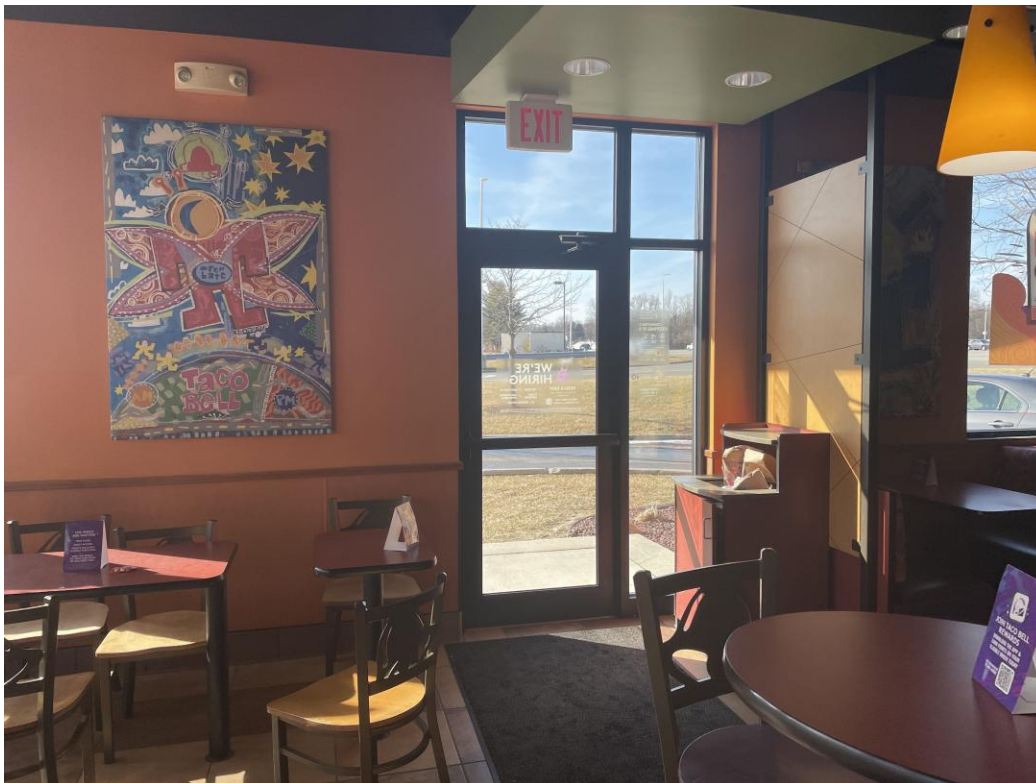
Finding: 31

The tactile EXIT sign is missing at the door.

Wall signs identifying exits shall have characters raised 1/32 inch minimum and shall be uppercase characters a minimum of 5/8 inch and a maximum of 2 inches high. Braille shall be placed directly below the tactile characters; flush left or centered. Signs shall be located a minimum of 48 inches above the floor, measured from the baseline of the lowest tactile characters and 60 inches maximum above the finish floor or ground surface, measured from the baseline of the highest tactile characters.

Missing
