Site Accessibility Evaluation

**Taco Bell Store #024598
(Pre)**

**7246 Central Ave
Toledo, OH 43617**

Pre Inspection

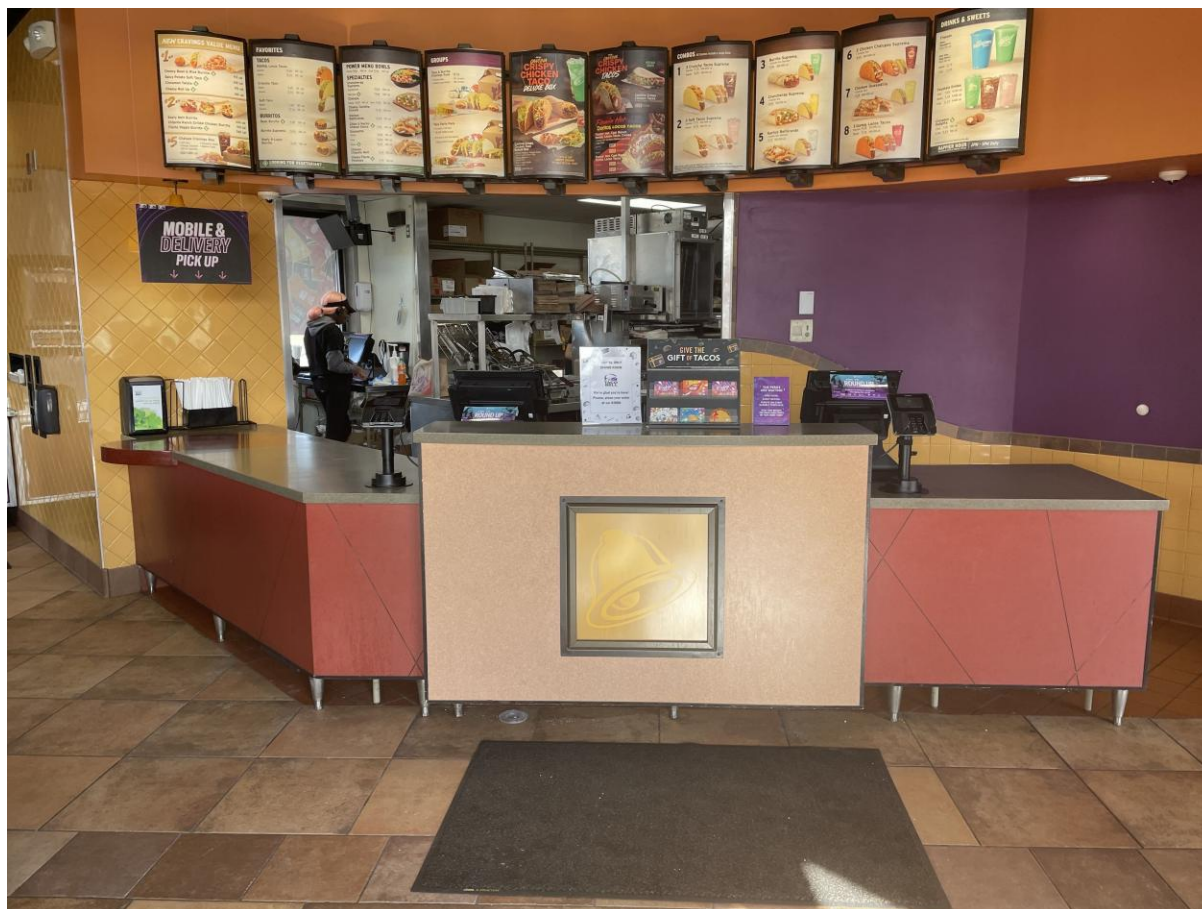
Finding: 32

A front counter sign stating: "Please Ask if You Need Assistance" in a visible location for customers has not been installed.

Missing

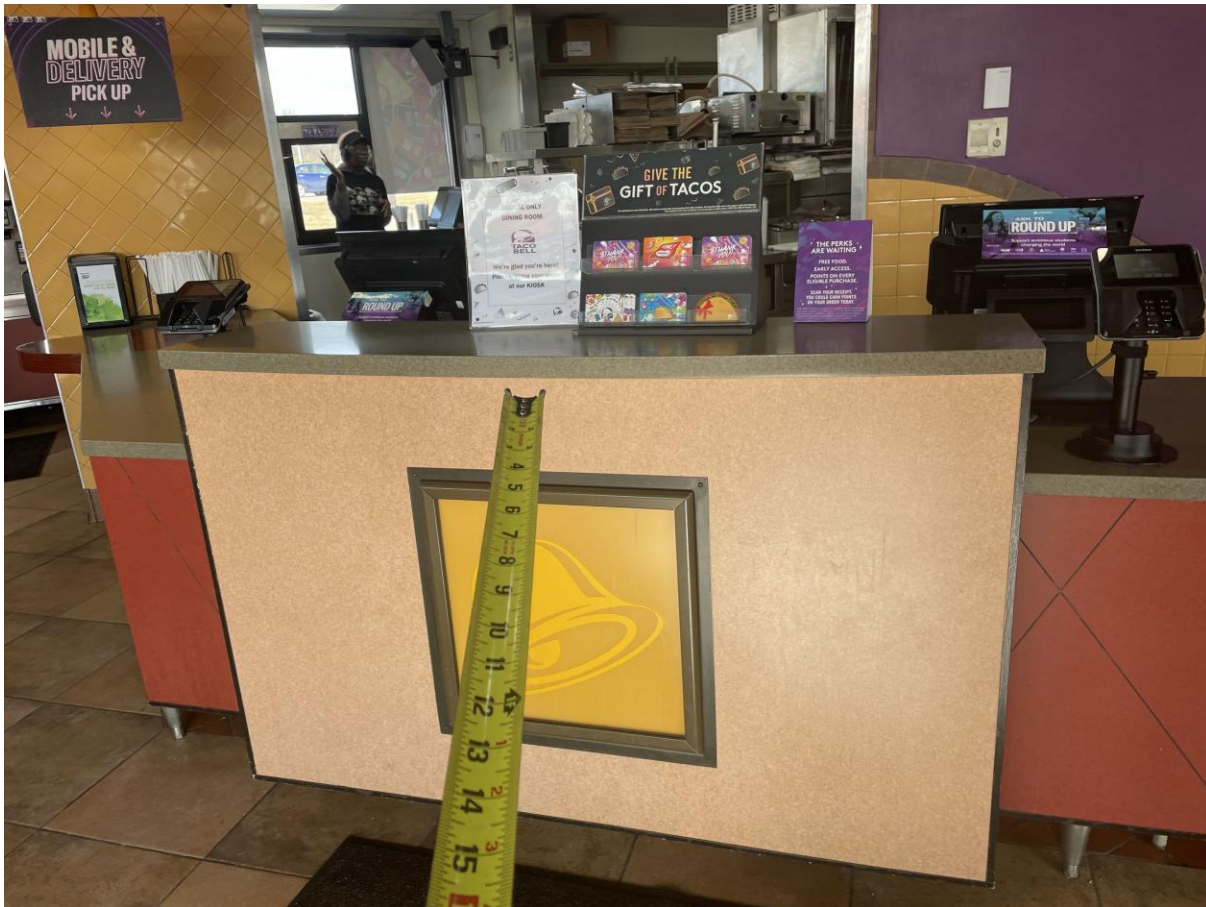
Finding: 33

The counter is too high.

A portion of the counter surface that is 30 inches long minimum and 36 inches high maximum shall be provided. Knee and toe space shall be provided under the counter. A clear floor or ground space shall be positioned for a forward approach to the counter.

43 3/4" (to partition)

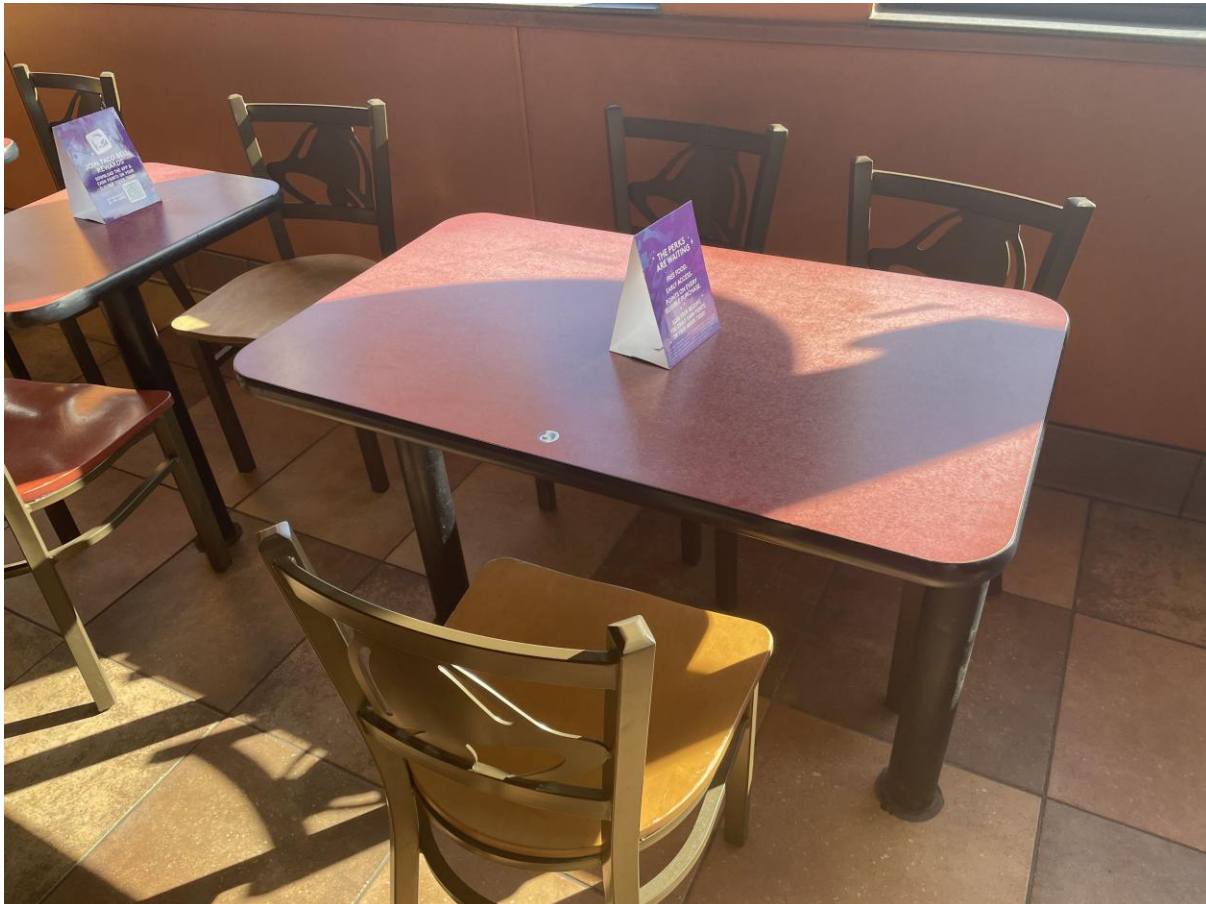
Finding: 34

There is no International Symbol of Accessibility (ISA) symbol designating each accessible seating space within the dining area/s.

3 tables/2 dilapidated
ISA's

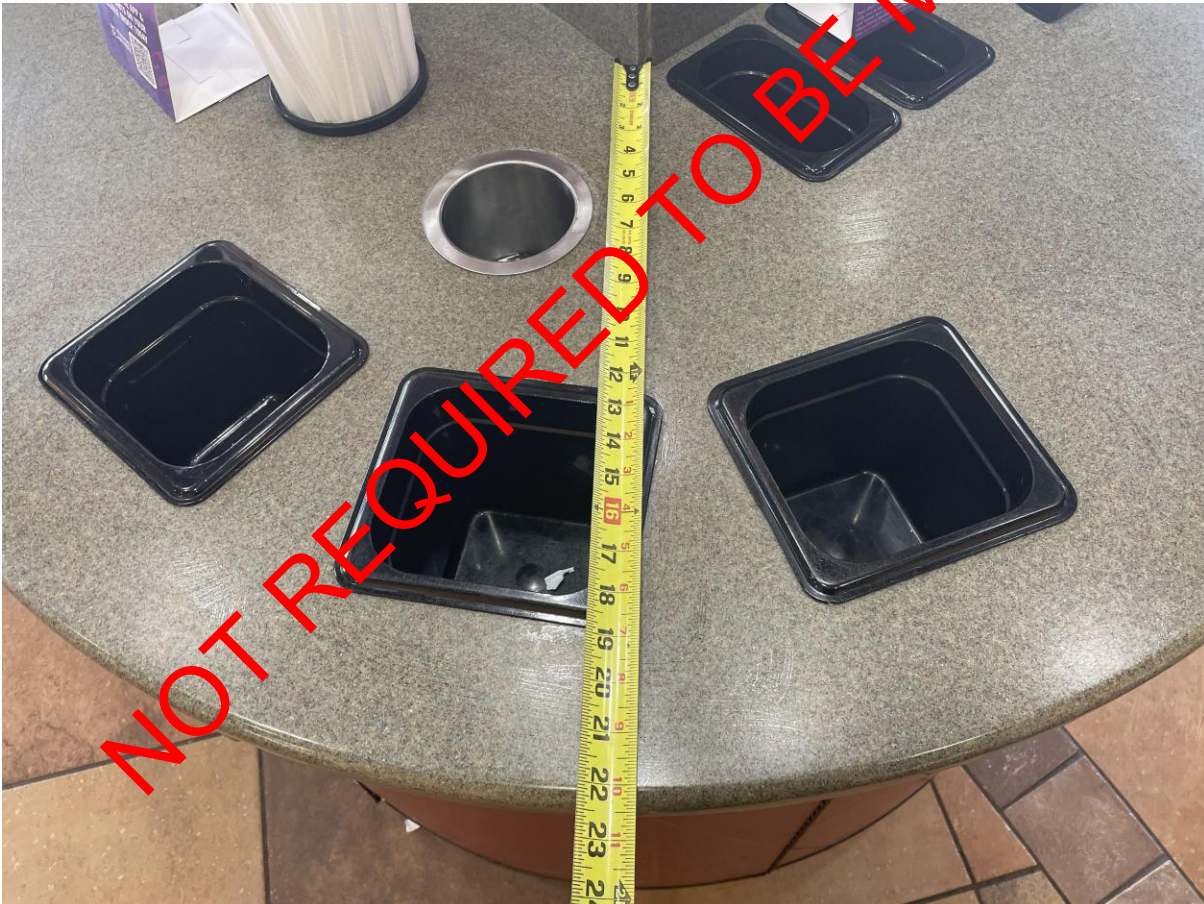
Finding: 35

The condiments are too deep/high and out of the maximum reach range for a side approach.

Where a clear floor or ground space allows a parallel approach to an element and the high side reach is over an obstruction, the height of the obstruction shall be 34 inches maximum and the depth of the obstruction shall be 24 inches maximum. Where the reach depth exceeds 10 inches, the high side reach shall be 46 inches maximum.

>34" (10"> deep)

THIS CAN BE CONSIDERED A "FRONT" APPROACH

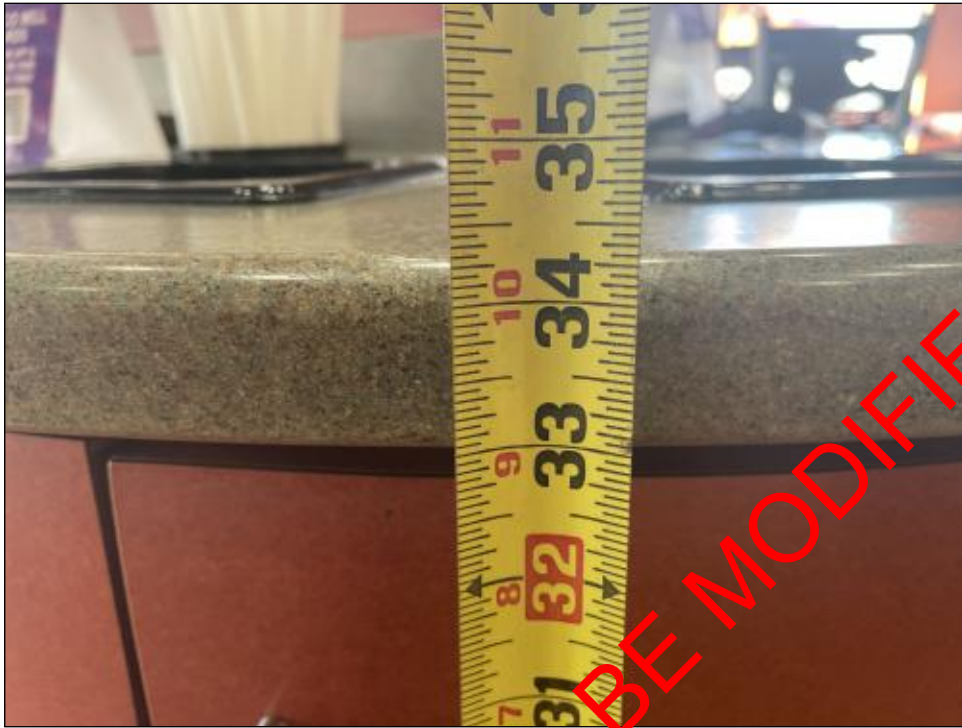
Finding #35 Additional Finding Photos

NOT REQUIRED TO BE MODIFIED

WITHIN REASONABLE CONSTRUCTION TOLERANCE

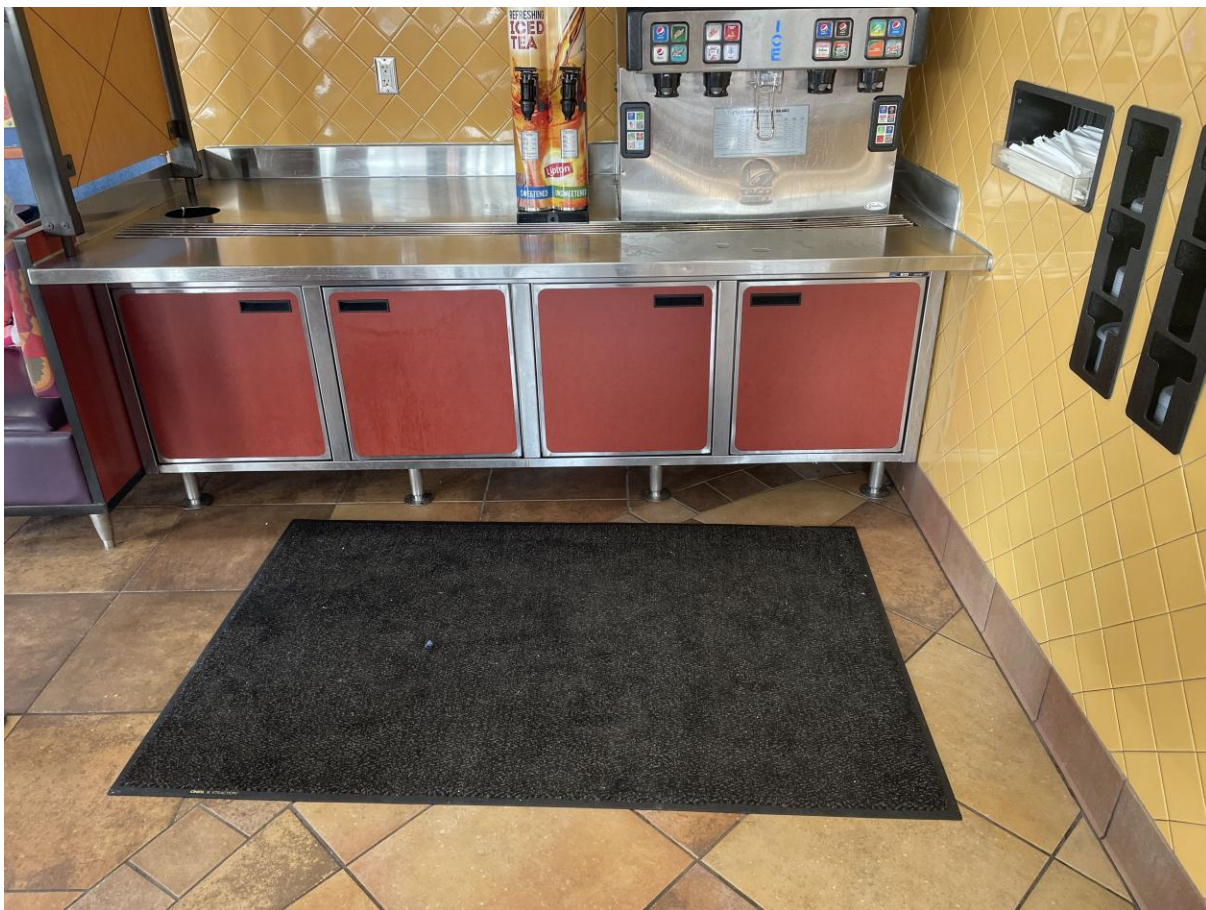
Finding: 36

The floor mat at the drink station is not secured in place.

Not secured

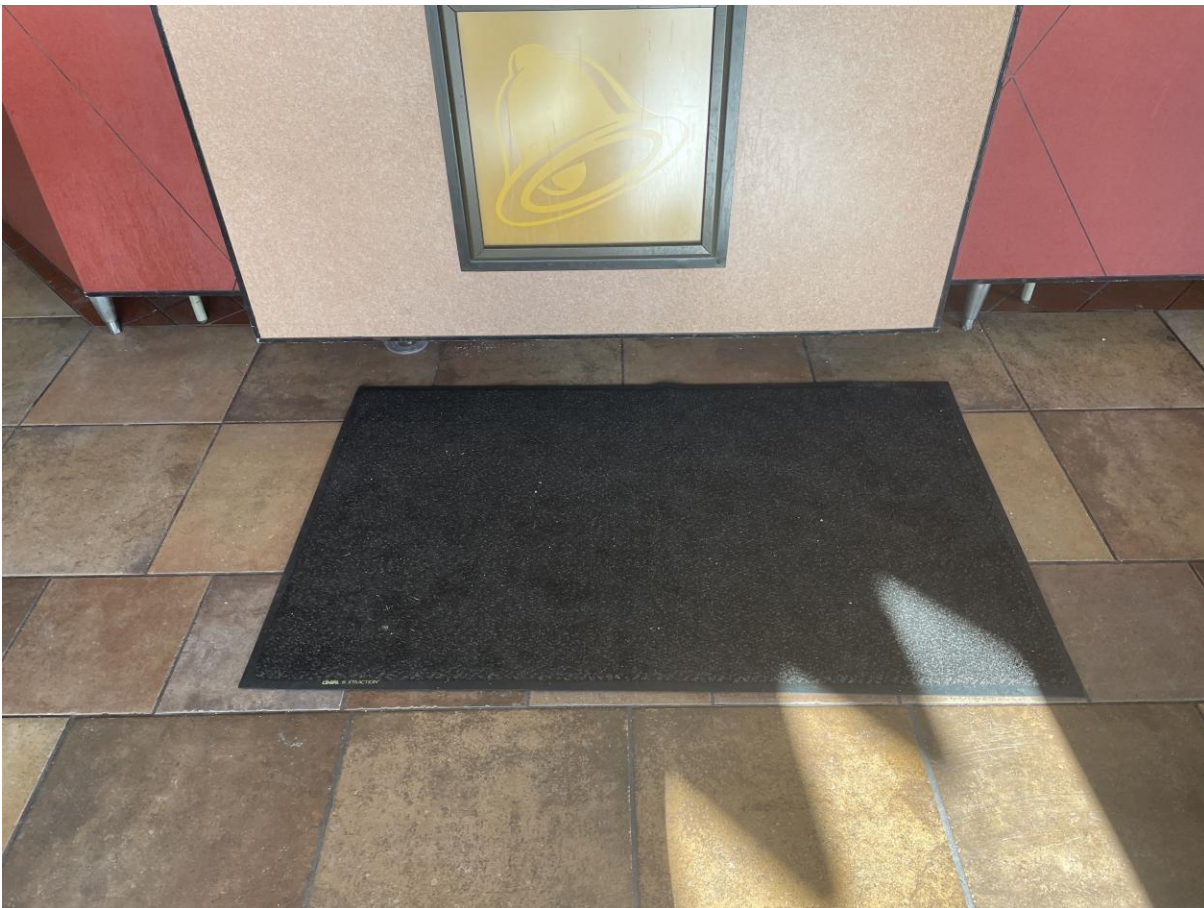
Finding: 37

The floor mat at front counter is not secured in place.

Not secured

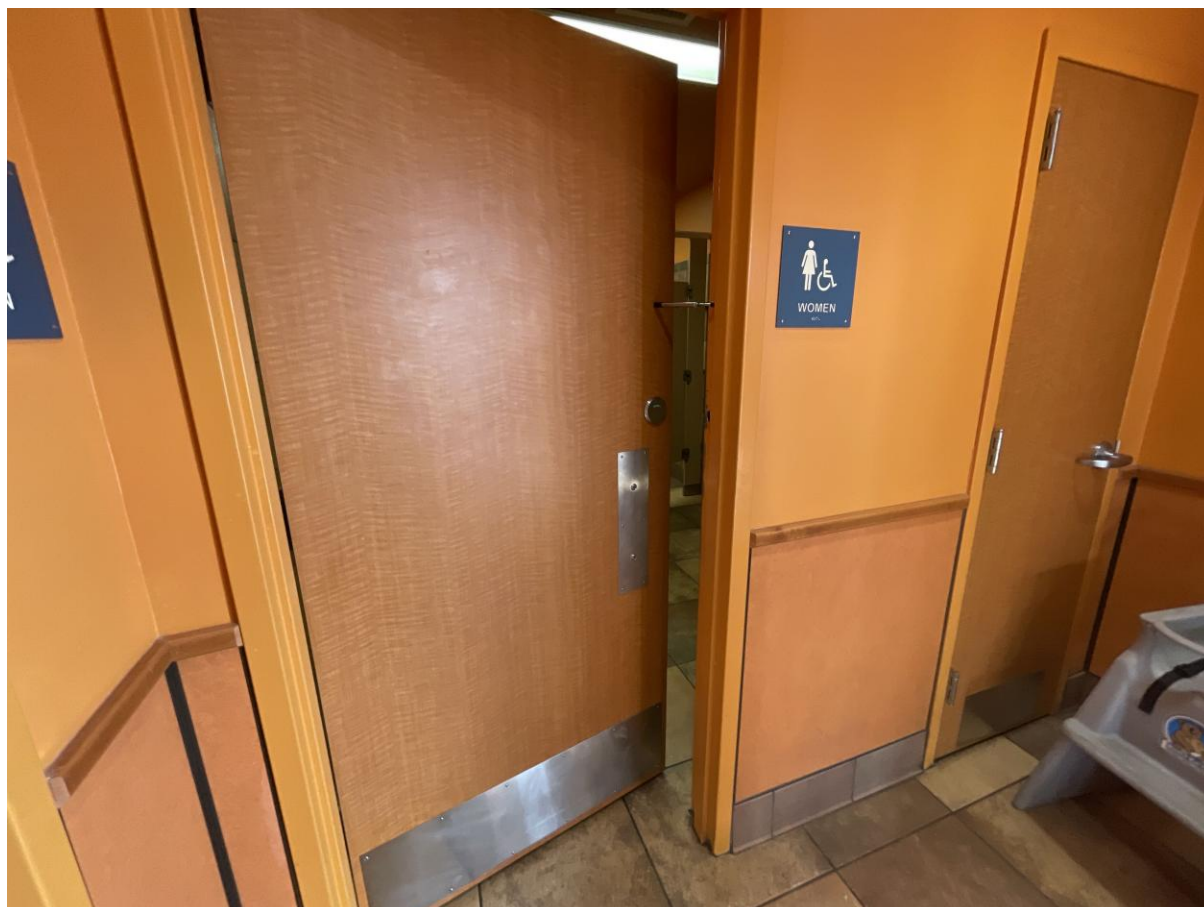
Finding: 38

14 lbs

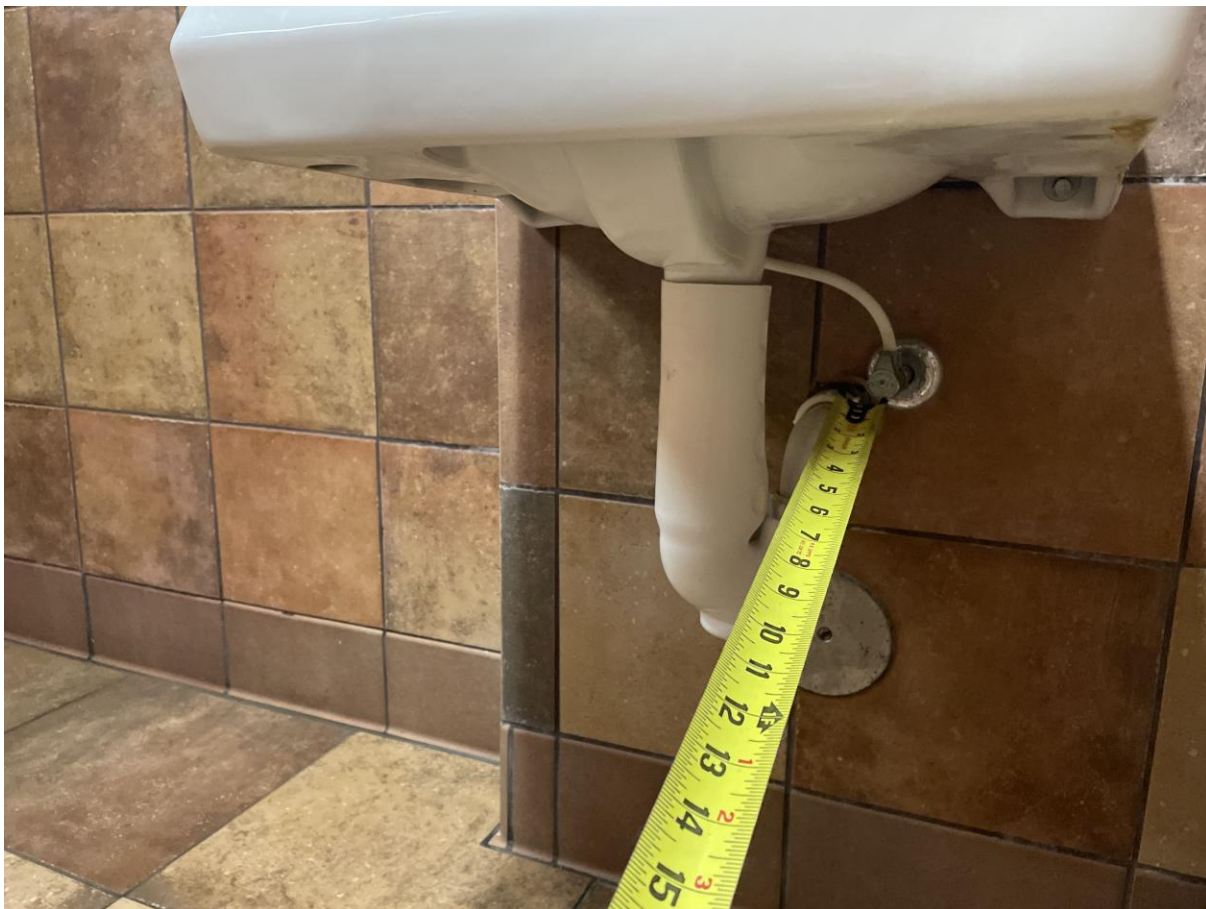
Finding: 39

Partial

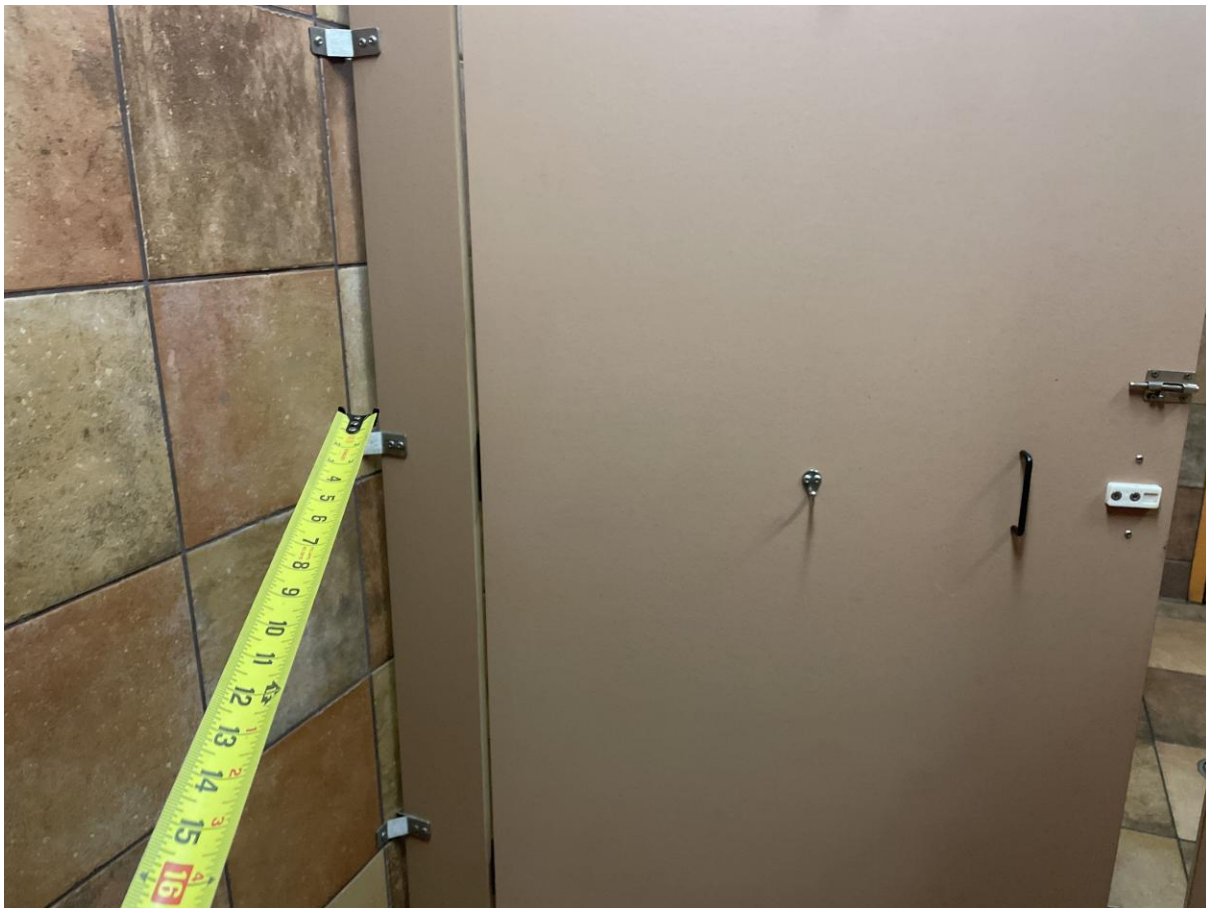
Finding: 40

6 3/8"

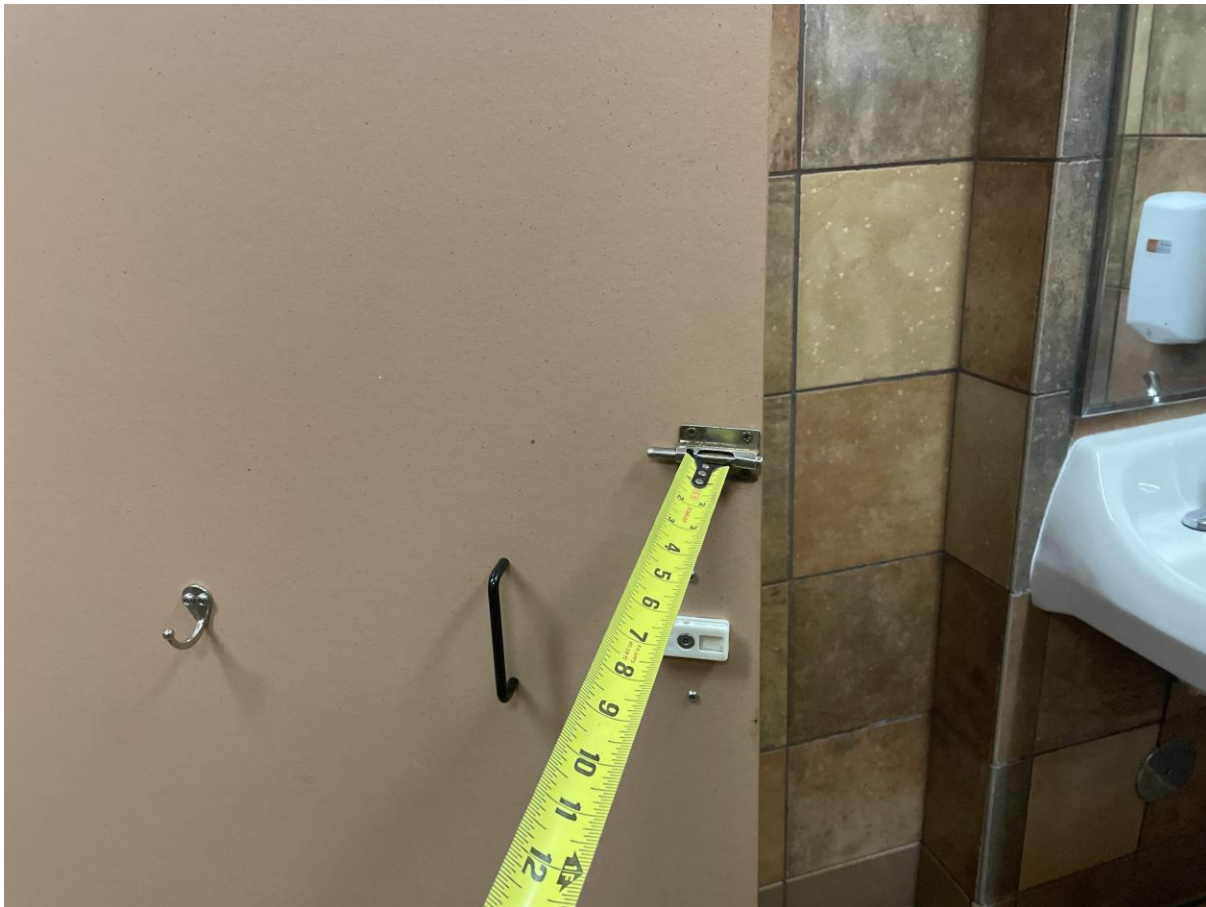
Finding: 41

N/A

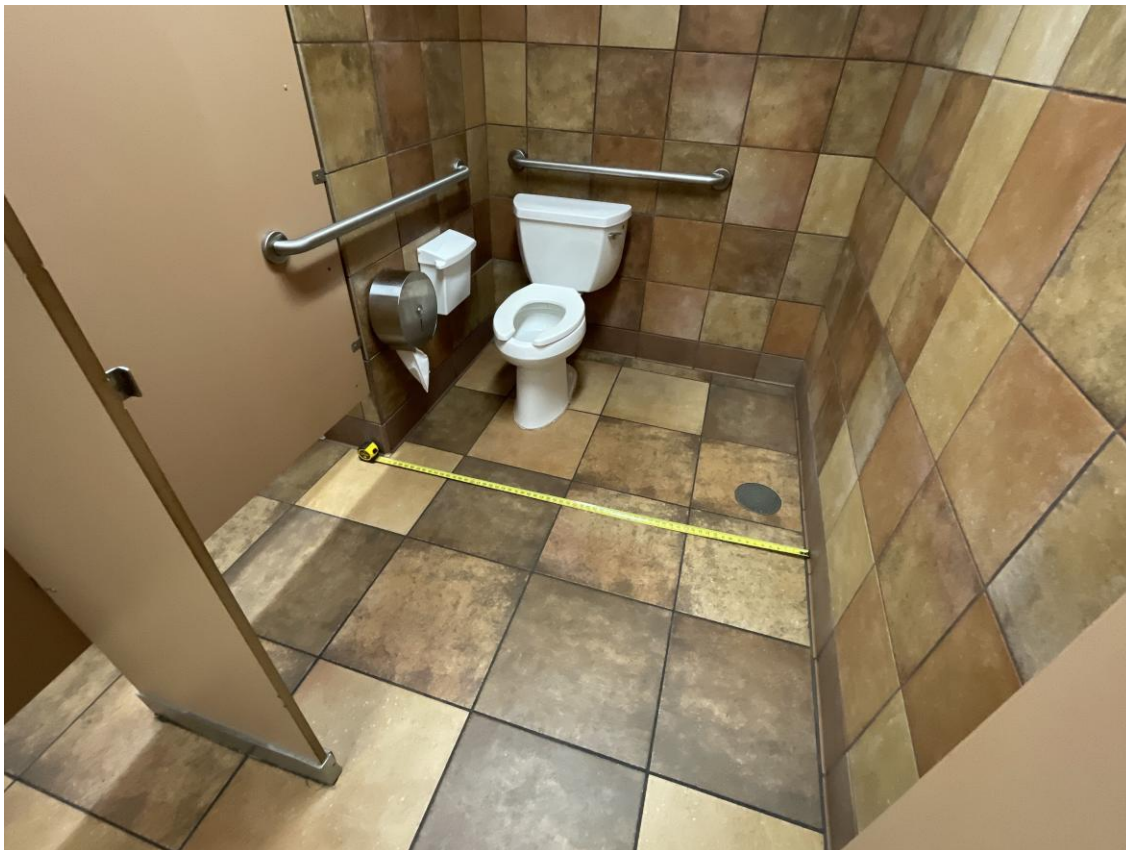
Finding: 42

Partial/ (63" wide stall)

NOTE: IF THIS COMPARTMENT WAS ORIGINALLY CONSTRUCTED PRIOR TO MARCH 2010, THEN IT CAN REMAIN AS-IS. OTHERWISE, IT MUST BE MODIFIED TO CONFORM TO CURRENT ADA STANDARDS.

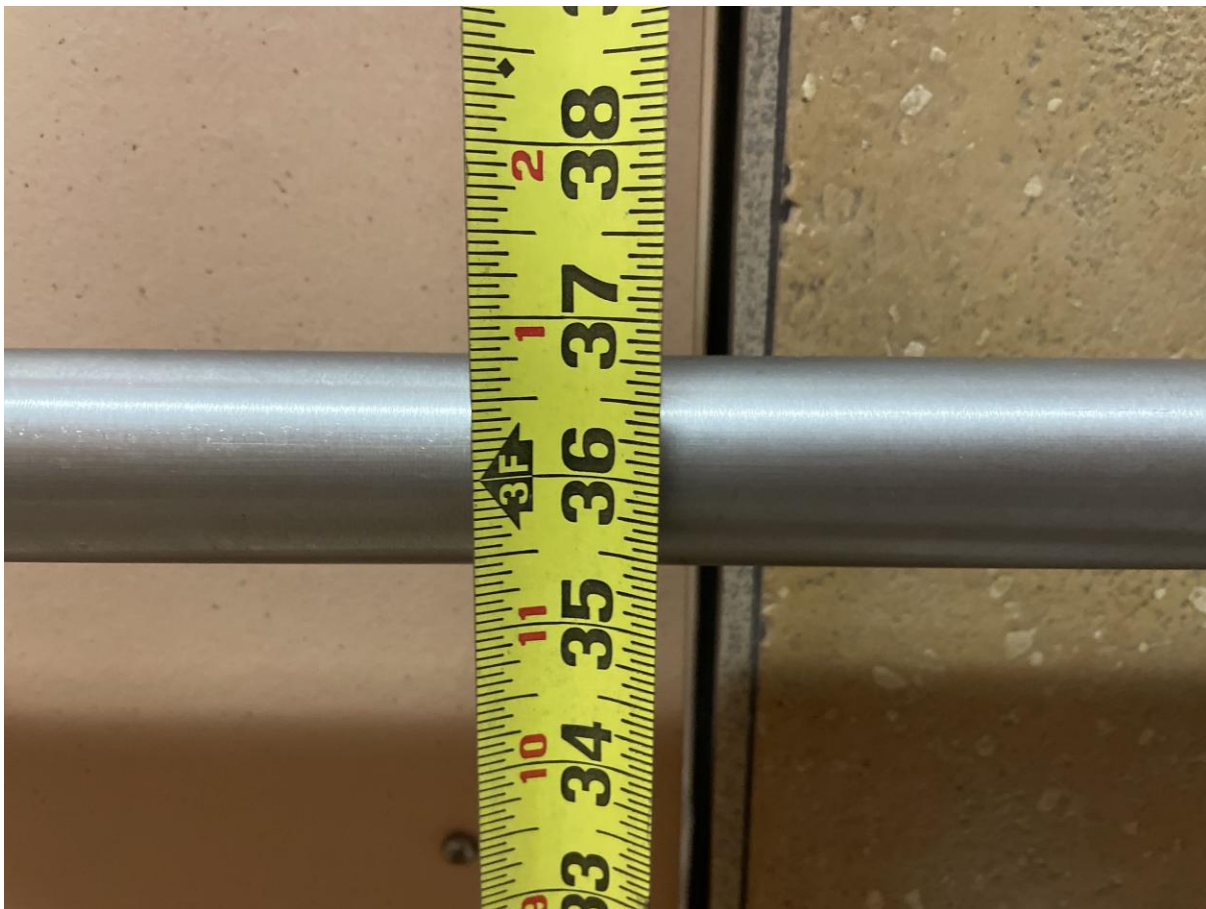
Finding: 43

Restrooms (Women)

The side grab bar is too high.

Grab bars shall be installed in a horizontal position, 33 inches minimum and 36 inches maximum above the finish floor measured to the top of the gripping surface.

2010 ADAS Section: 609.4

2009 ANSI A117.1 Section: 609.4.1

36 3/4"

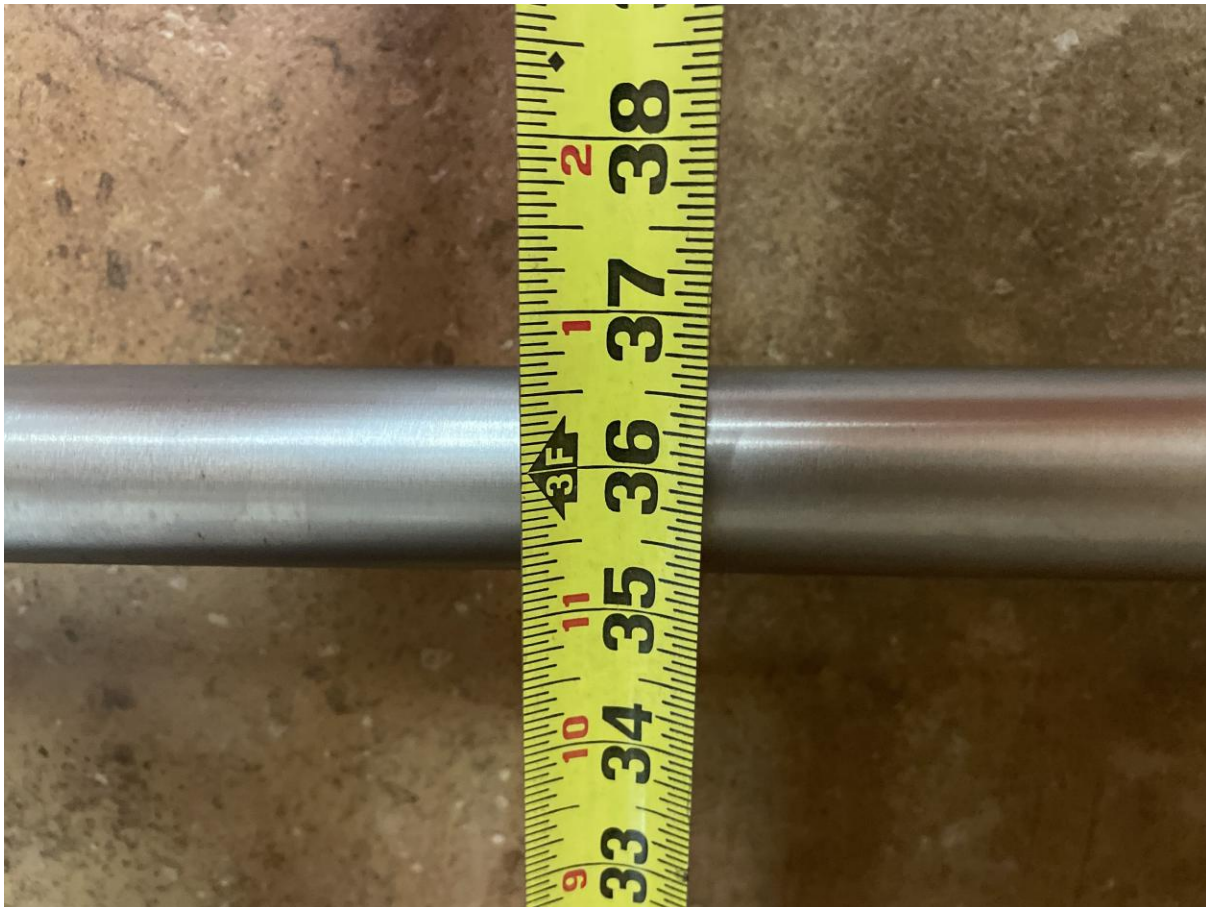
Finding: 44

36 3/4"

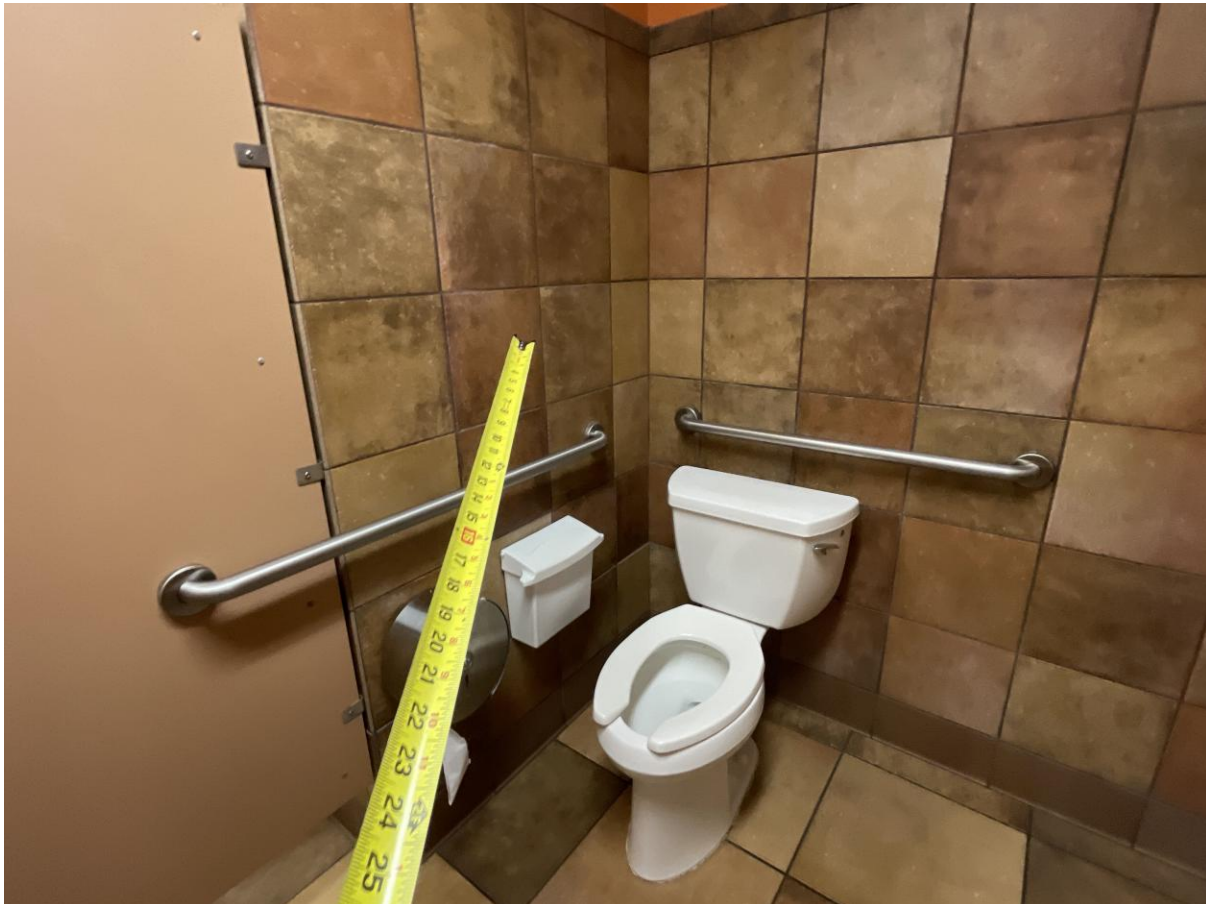
Finding: 45

The vertical grab bar missing.

Missing.

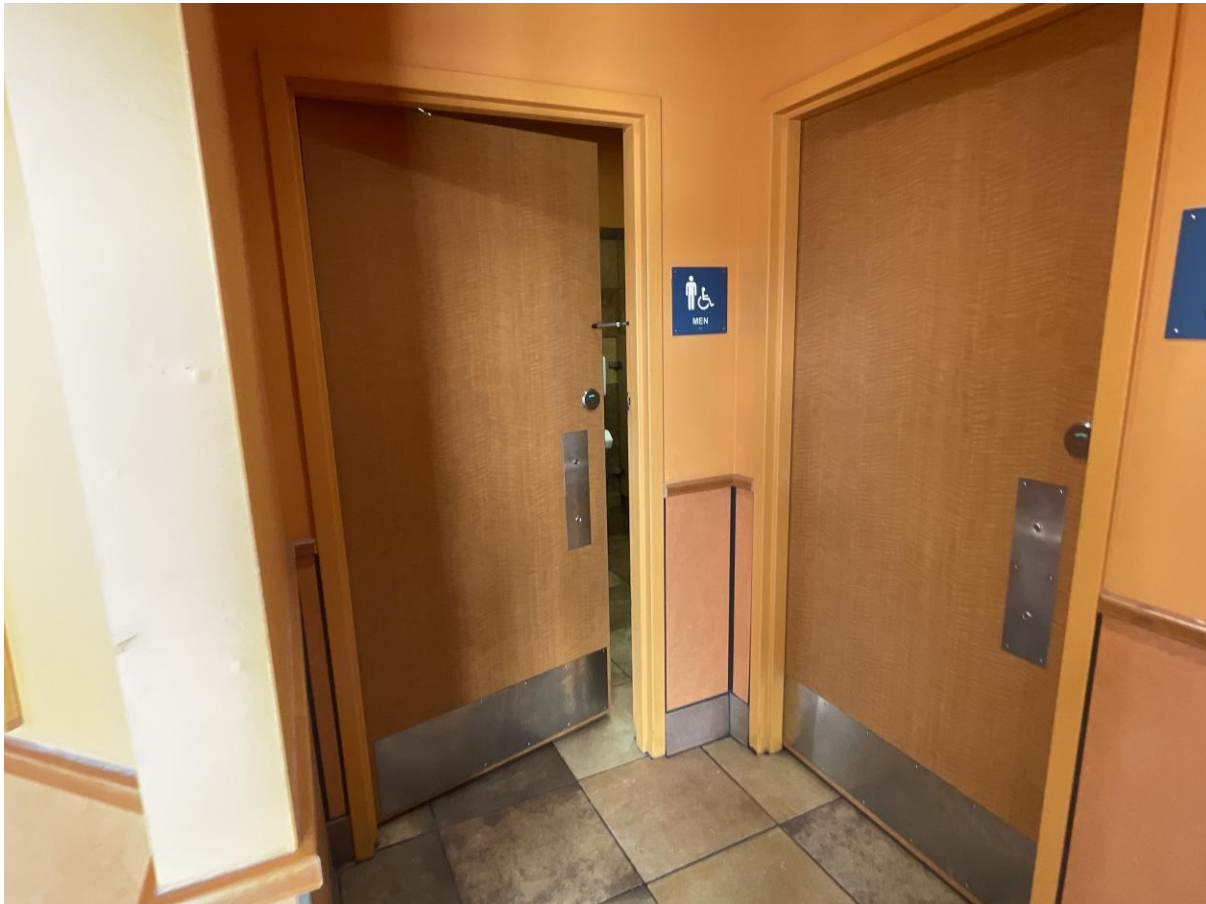
Finding: 46

15 lbs

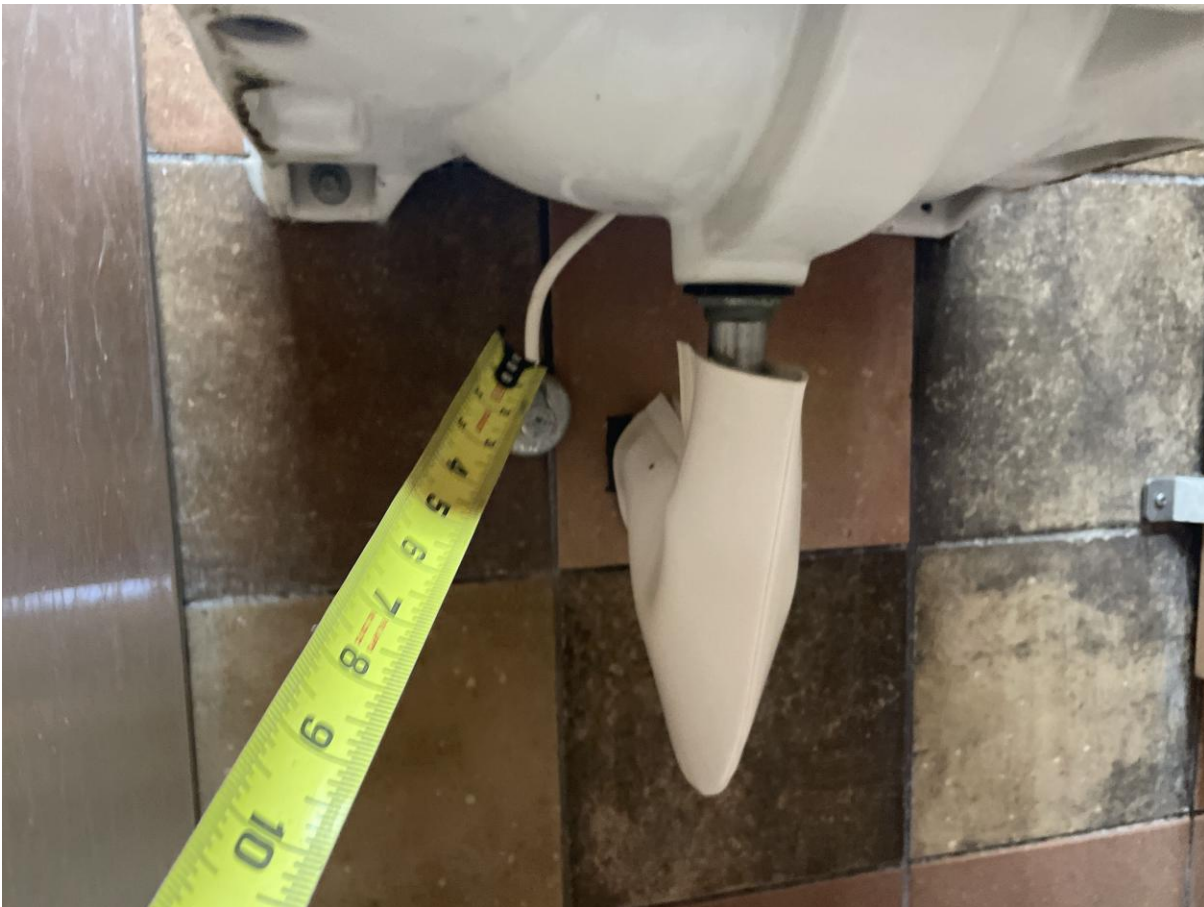
Finding: 47

Partial

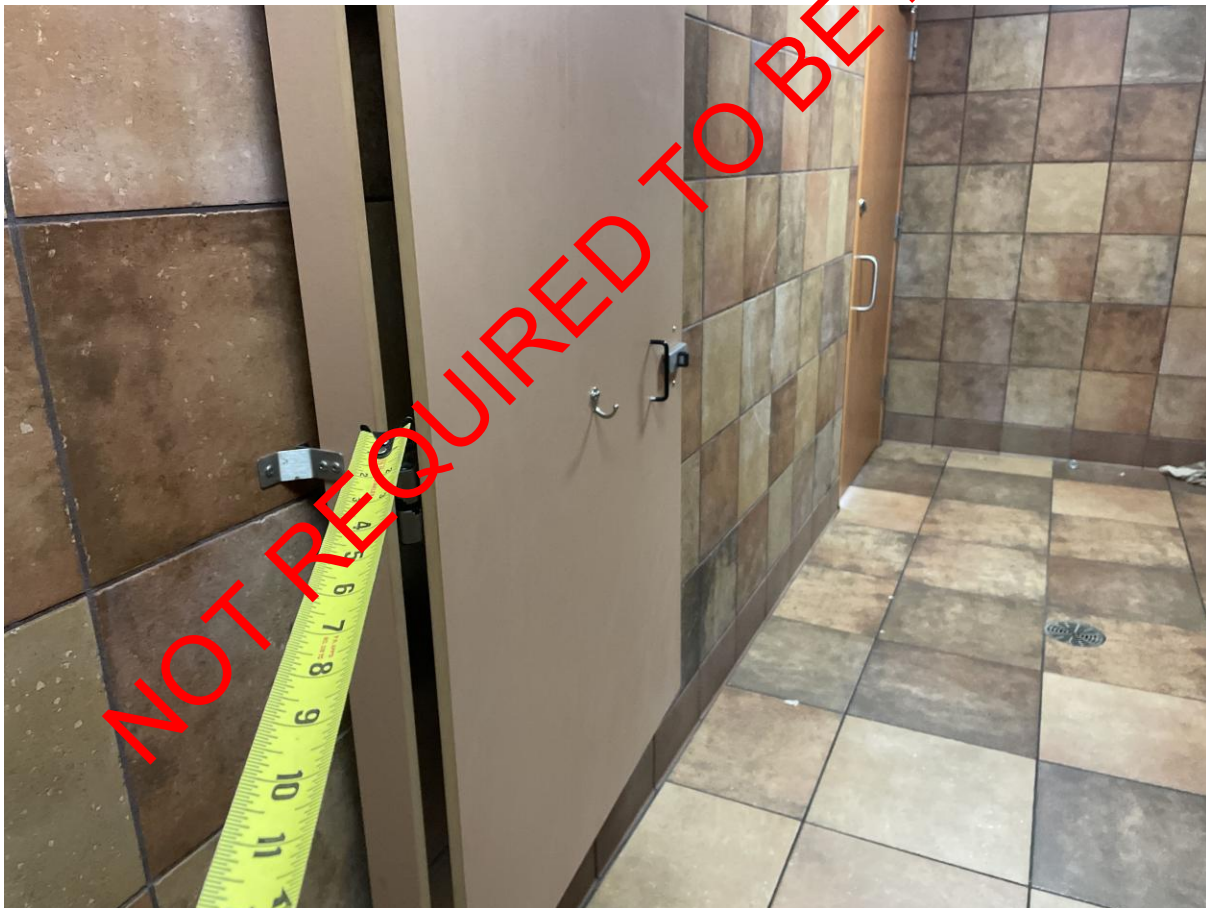
Finding: 48

4 1/2"

WITHIN REASONABLE CONSTRUCTION TOLERANCE

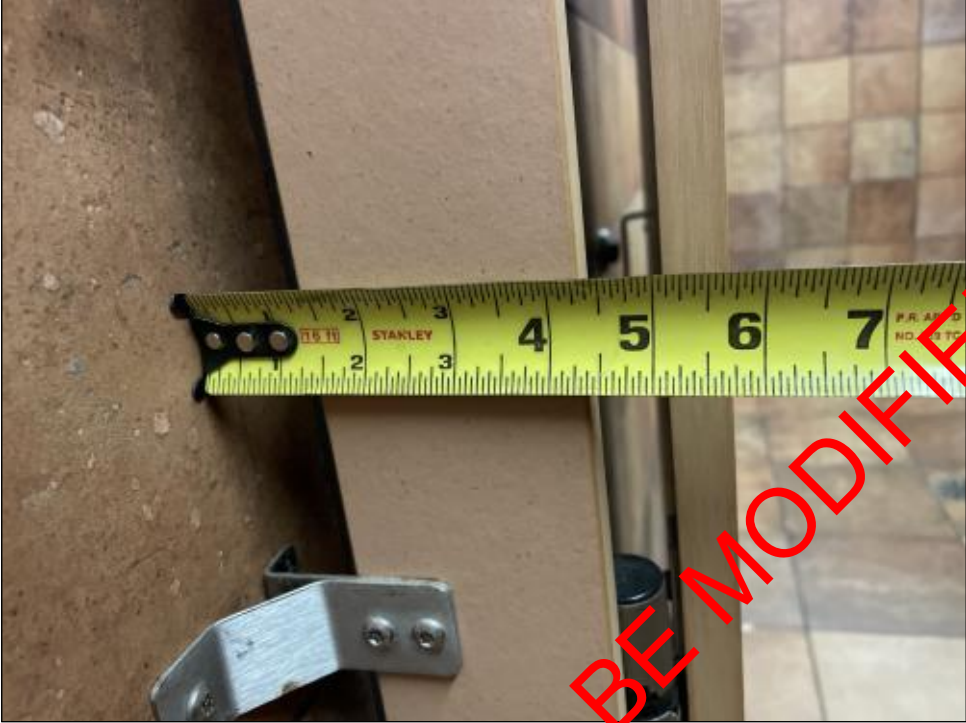
Finding #48 Additional Finding Photos

NOT REQUIRED TO BE MODIFIED

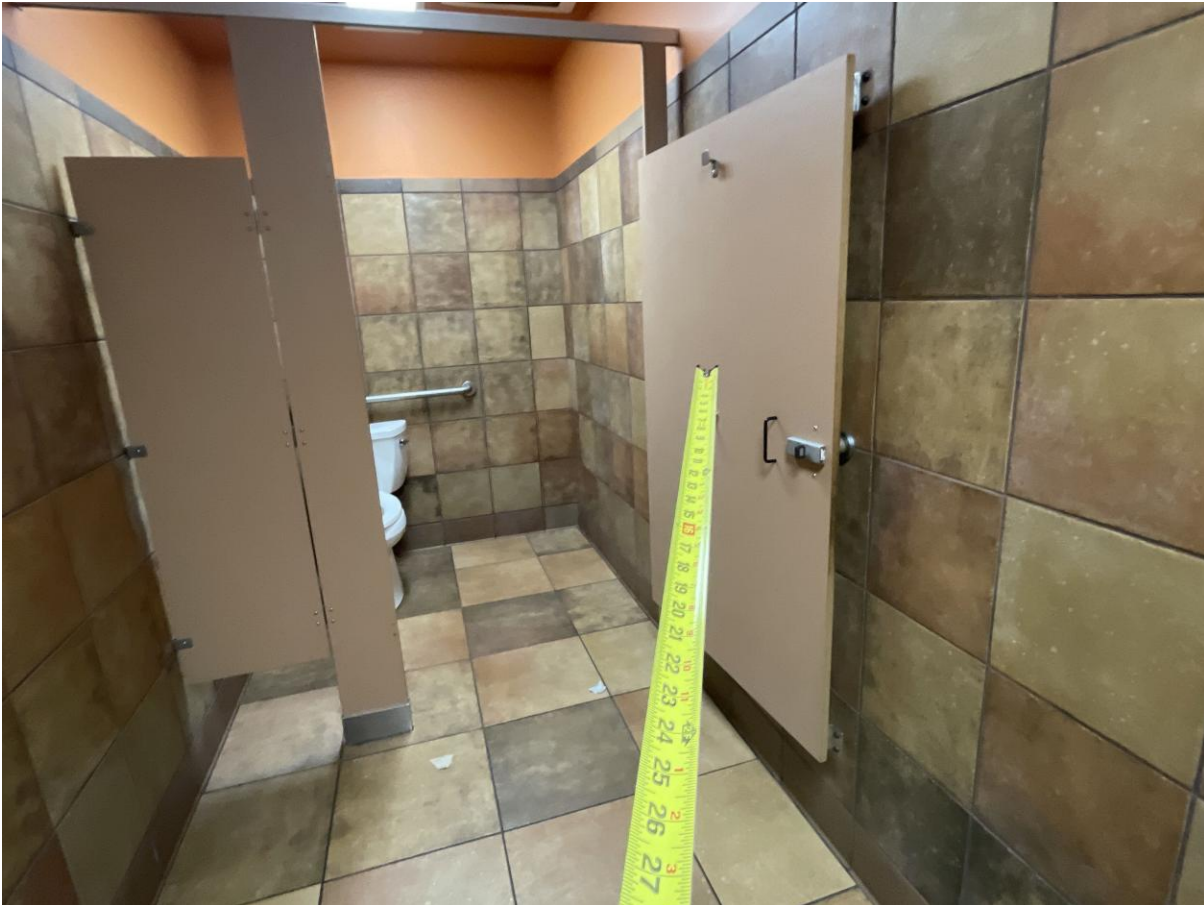
Restrooms (Men)

As Built:

N/A

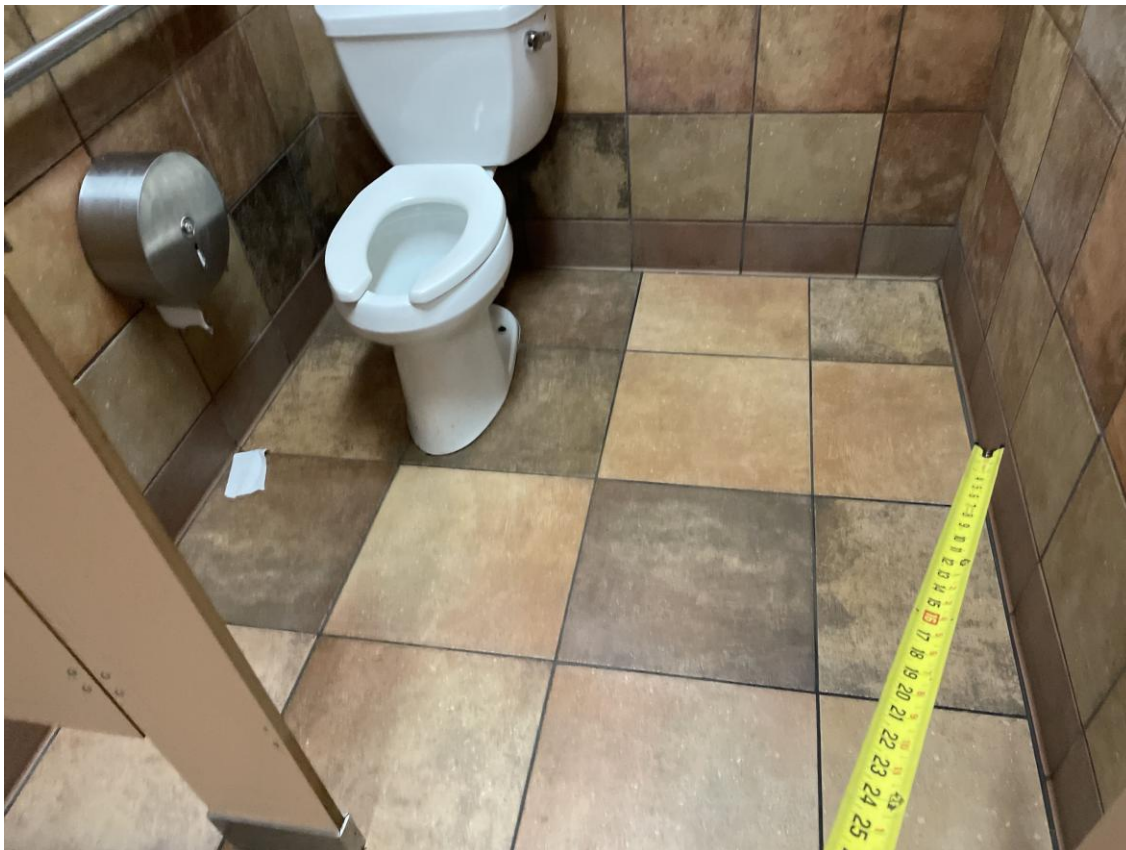
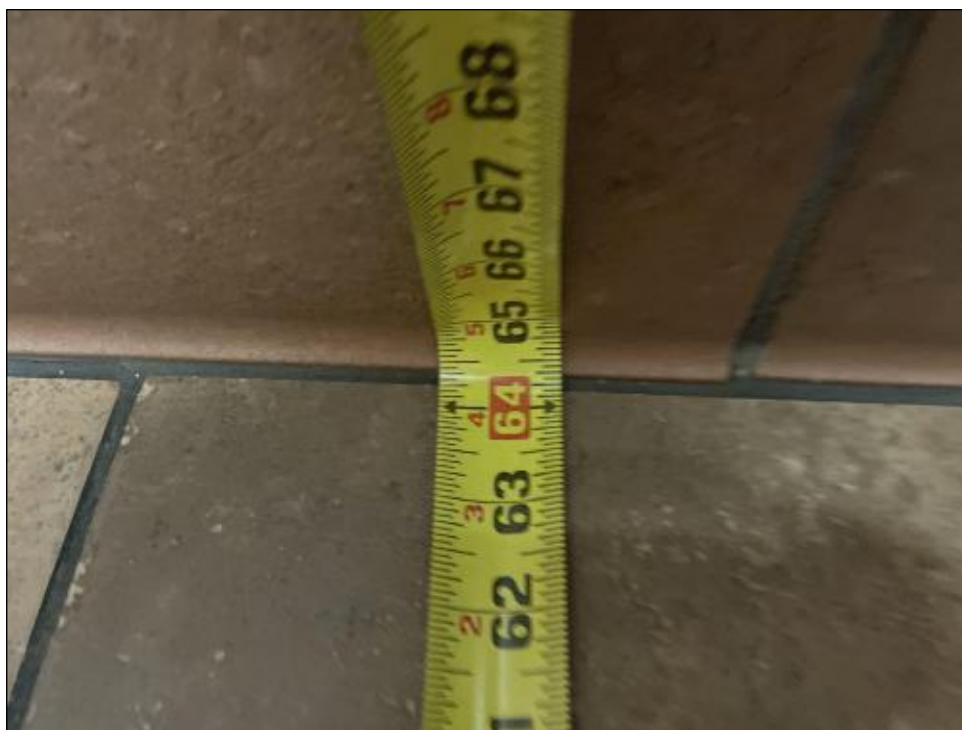
Finding: 50

Missing (64 1/2")

NOTE: IF THIS COMPARTMENT WAS ORIGINALLY CONSTRUCTED PRIOR TO MARCH 2010, THEN IT CAN REMAIN AS-IS. OTHERWISE, IT MUST BE MODIFIED TO CONFORM TO CURRENT ADA STANDARDS.
