Site Accessibility Evaluation

**Taco Bell Store #024598
(Pre)**

**7246 Central Ave
Toledo, OH 43617**

Pre Inspection

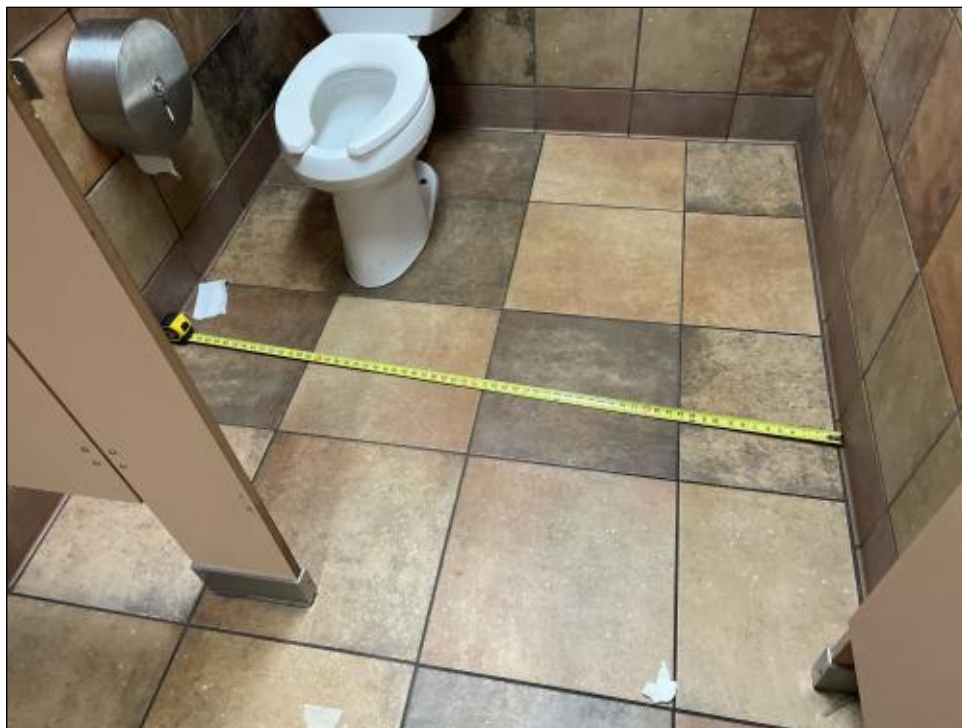
Finding #50 Additional Finding Photos

Missing (64 1/2")

NOTE: IF THIS COMPARTMENT WAS ORIGINALLY CONSTRUCTED PRIOR TO MARCH 2010, THEN IT CAN REMAIN AS-IS. OTHERWISE, IT MUST BE MODIFIED TO CONFORM TO CURRENT ADA STANDARDS.

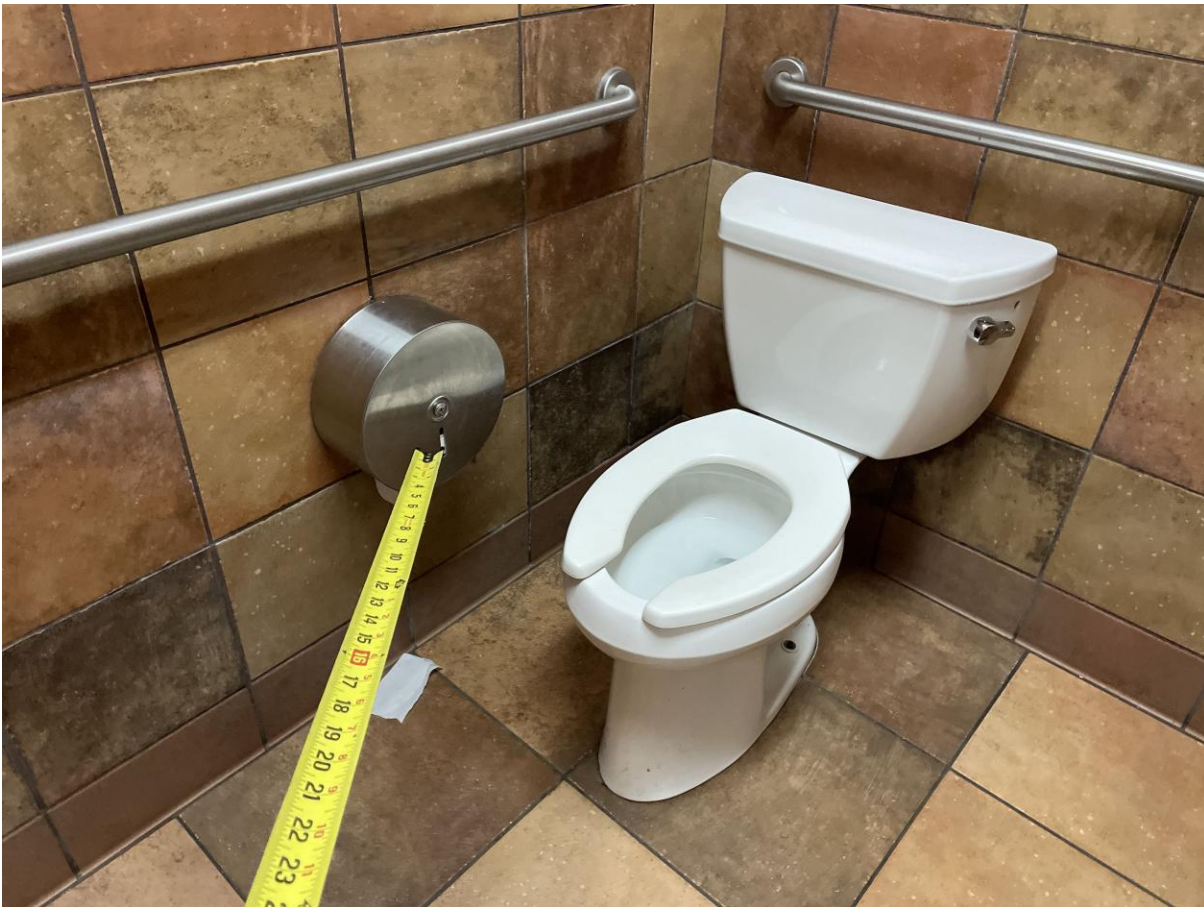
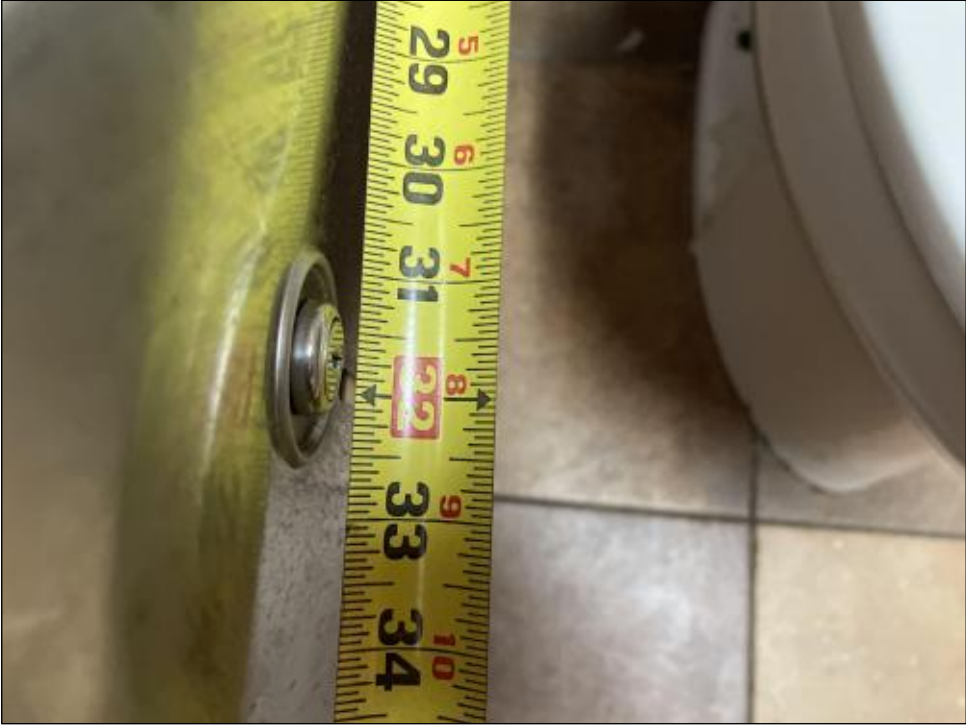
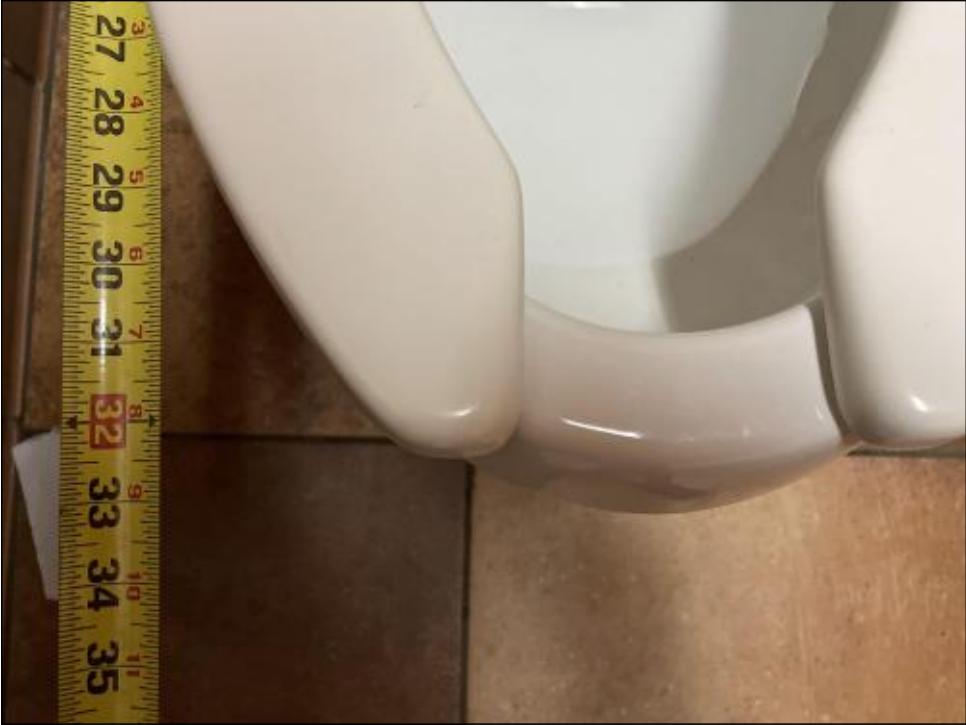
Finding: 51

1"

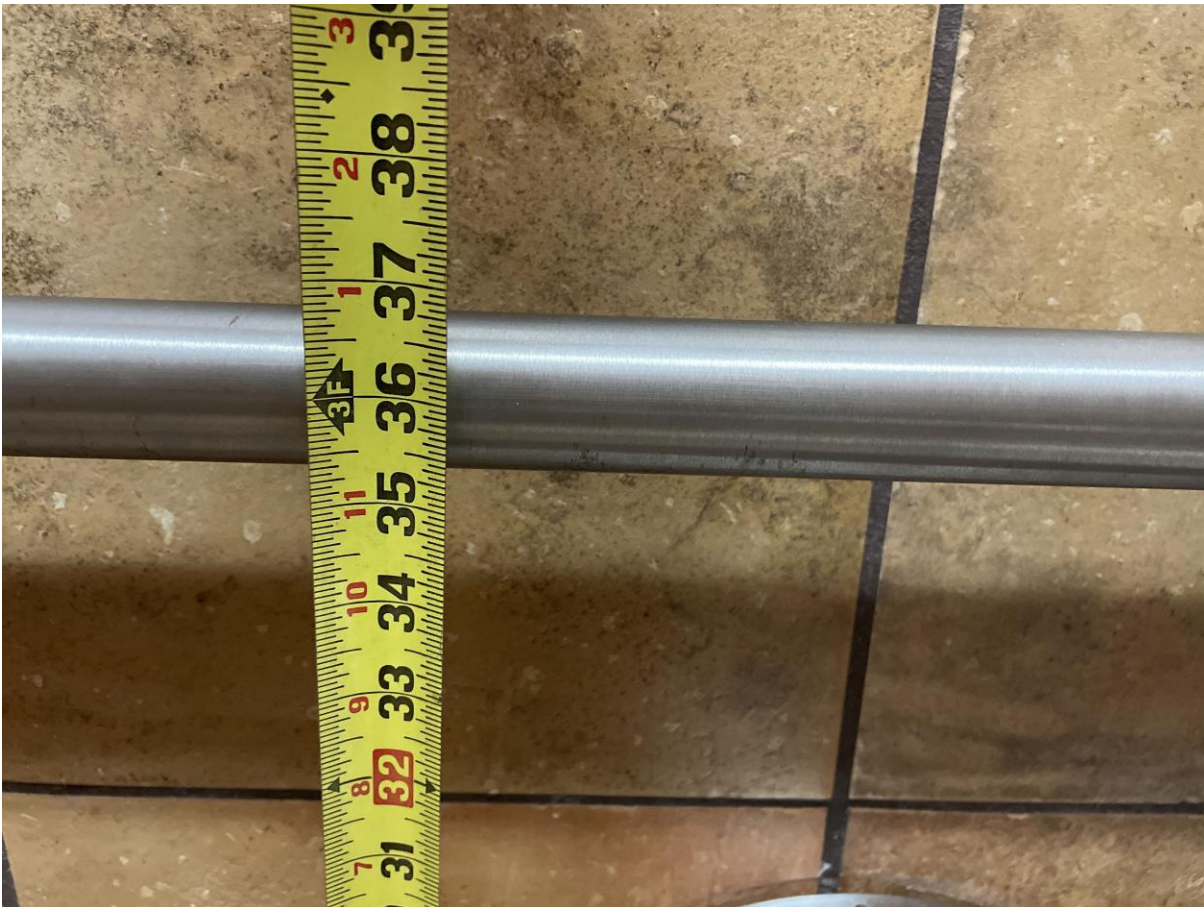
Finding: 52

36 3/4"

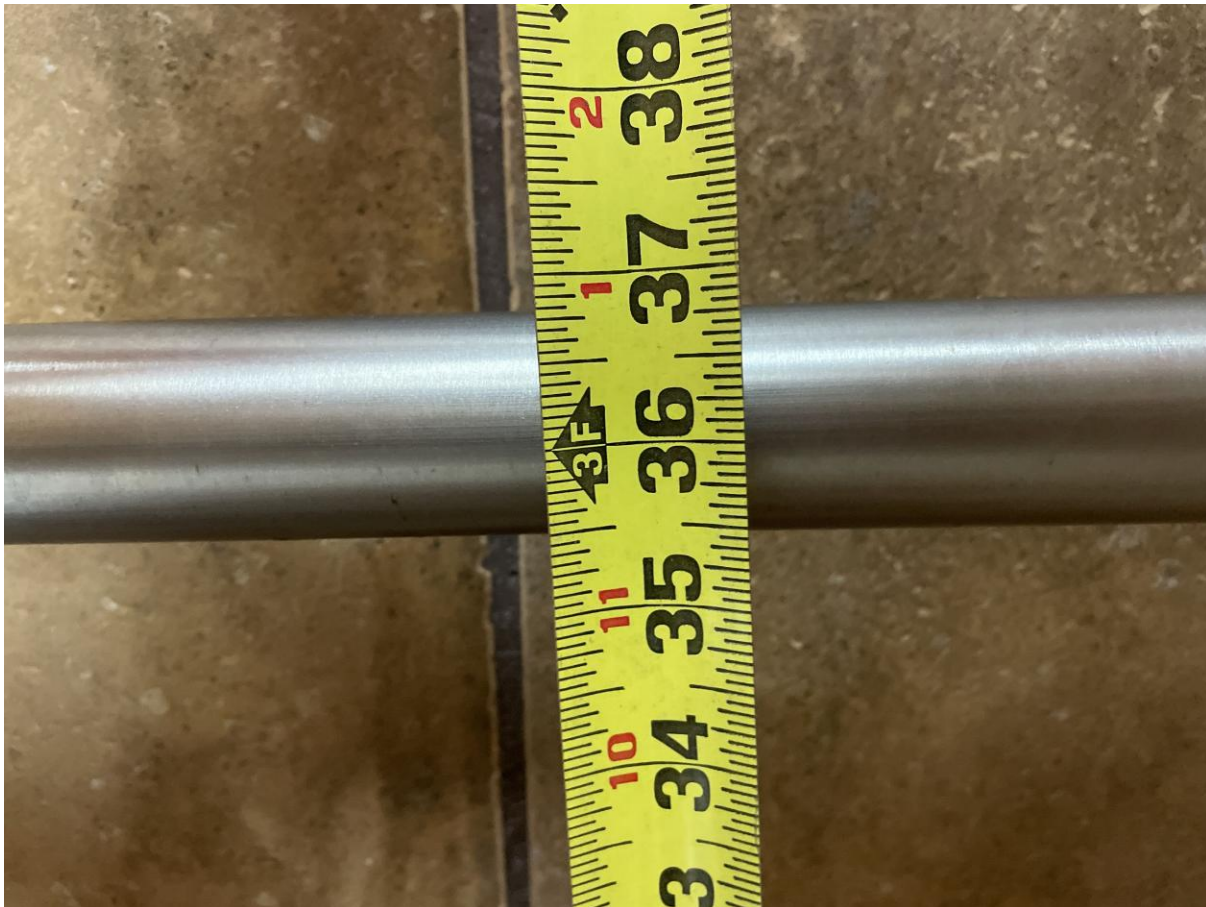
Finding: 53

36 3/4"

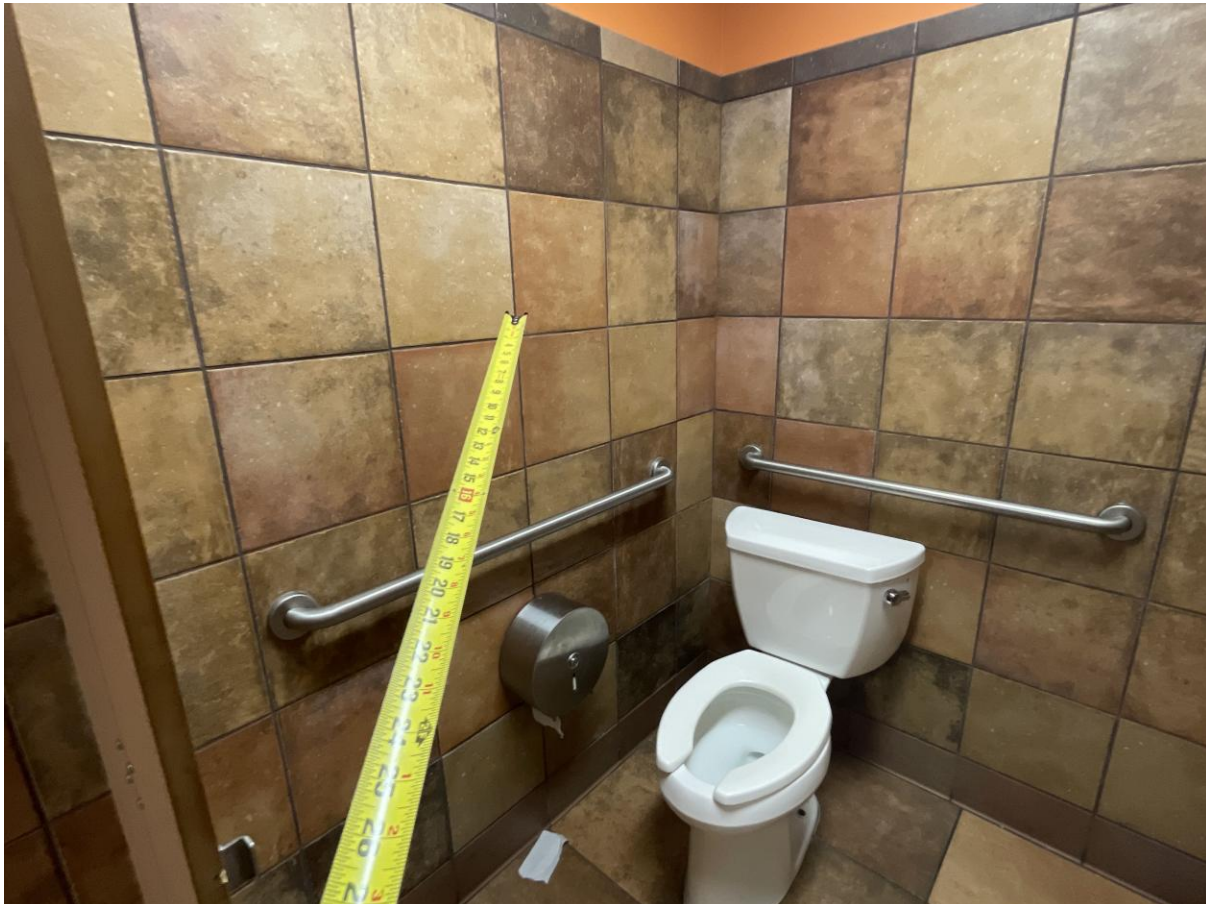
Finding: 54

The vertical grab bar missing.

Missing

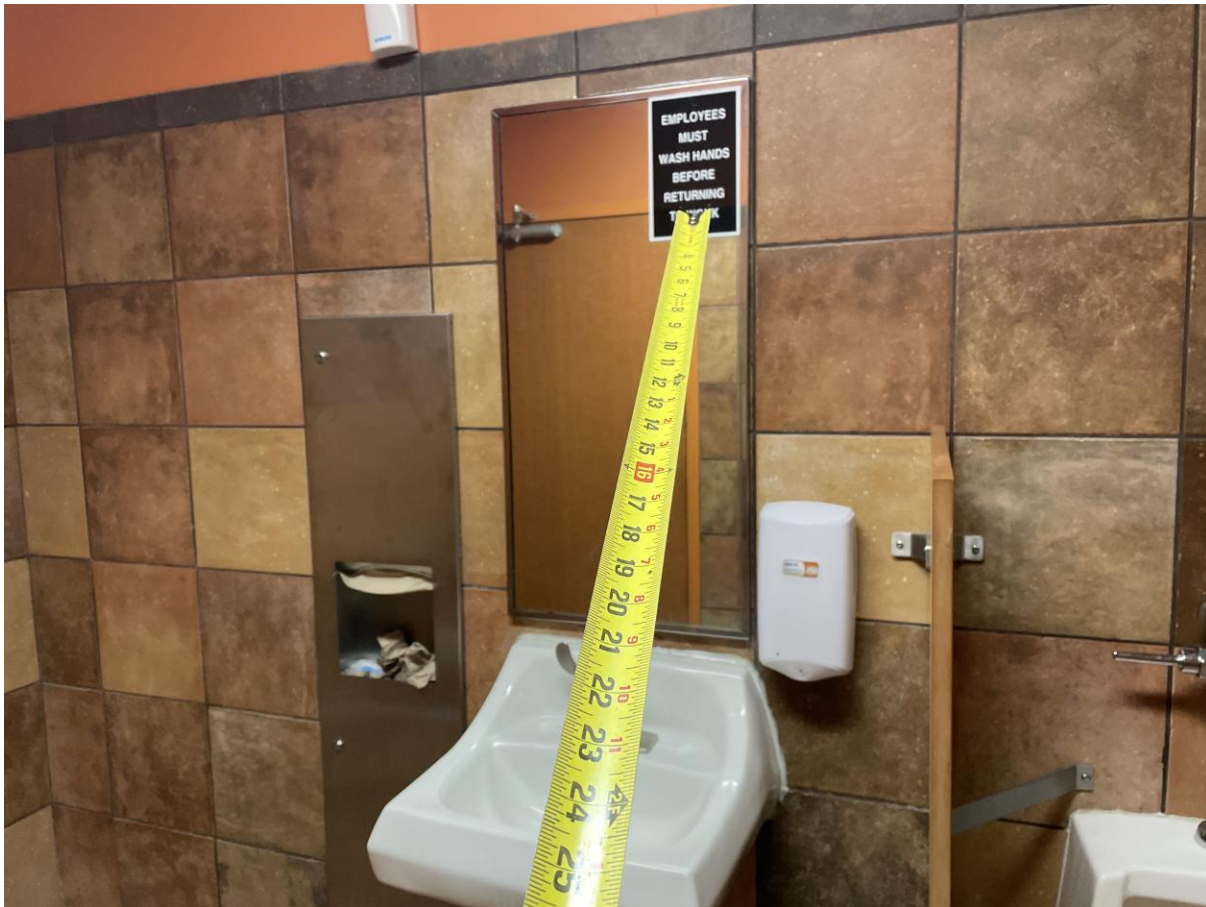
Finding: 55

N/A
