# PROPERTY CONDITION REPORT

## ADA TIER III SURVEY

Project Number: ADA062121SmokeyBonesUticaMI

Inspection Address: 45001 Schoenherr Road, Utica, MI 48315. This is currently an abandoned TGI Friday restaurant facing north.

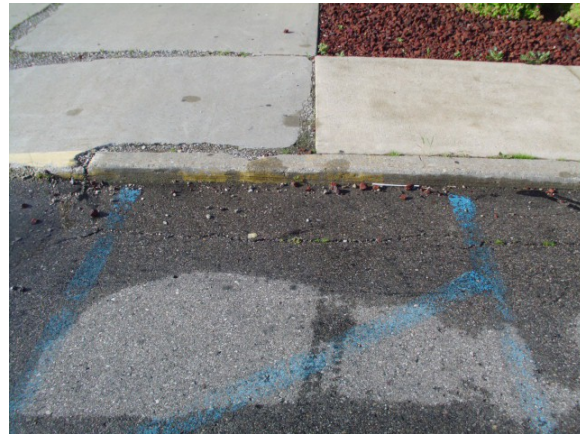
The narrow access aisles do not adjoin an accessible route. The forward end of these access aisles join to the side of a walkway, but there is no curb cut to accommodate the elevation of the walkway. The photo on the right is representative.

**RECOMMENDATION:** Re-design and resurface the existing accessible parking surfaces and access aisles to comply with the Standards. The parking spaces and access aisles should not have any slope exceeding 1:48, or 2.08%, in any direction. Repair the cracks and openings in the surface of the parking lot. Ensure that all access aisles adjoin an accessible route. Install vertical signage for each accessible parking space. Install wheel stops where parking spaces are adjacent to exterior accessible routes.

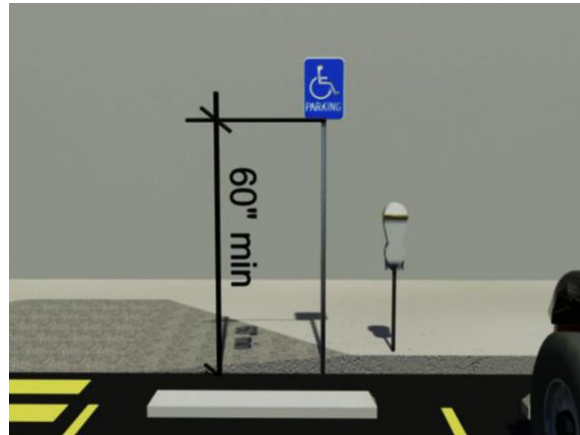
No vertical signage was observed to identify the accessible parking spaces. 2010 ADA Standard 216.5, [Signs] Parking, states, “Parking spaces complying with [Standard] 502 shall be identified by signs complying with [Standard] 502.6.”

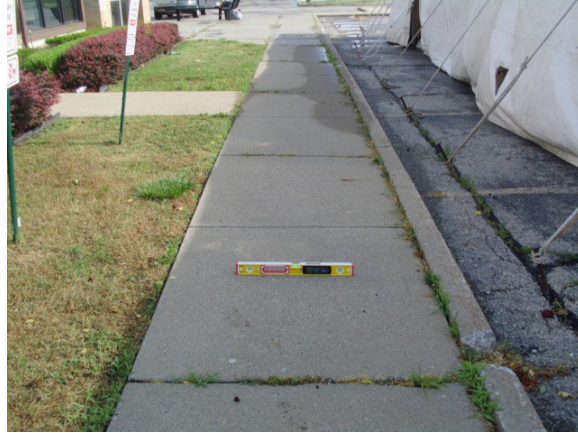
**Item 2. The exterior walking route from the municipal bus stop to the front entry at the facility has excessive cross slope on the east side of the facility and there is a large gap and excessive change of elevation where the walkway approaches the front patio area. See the photo on the right for the excessive cross slope. Along this portion of the route the cross slope is approximately 2.9 – 4.8%.**

RECOMMENDATION: Alter or replace this section of walkway so the cross slope does not exceed 1:48 and the connection to the patio is smooth.

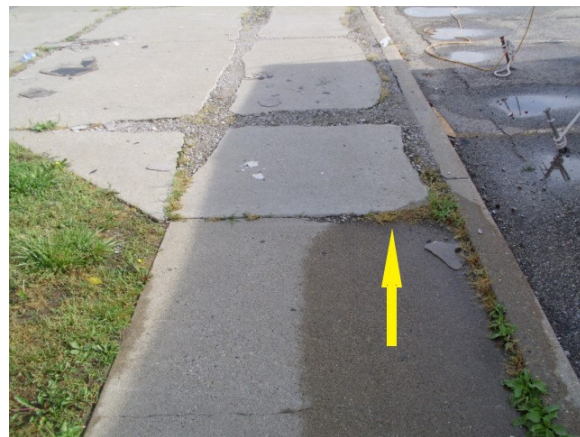
The photo on the right is where the walkway shown above approaches the front patio area at the main entrance. There is a gap between the walkway and patio and an abrupt change in elevation that exceeds ½ inch in some areas.

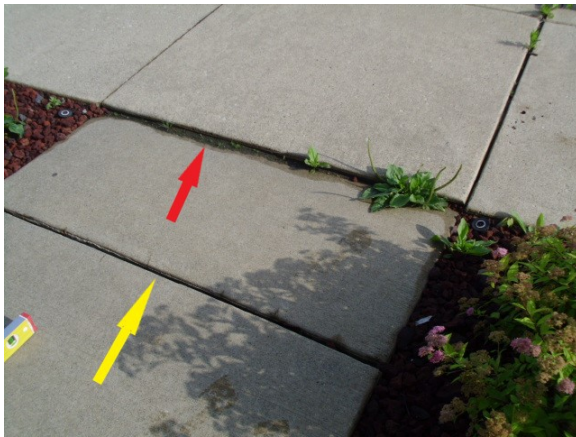
**Item 3. The walkway to the north side auxiliary exterior pedestrian entry/exit door is run sloped excessively, there is a gap where the sections of the sloped walkway meet, and there is an excessive abrupt change of elevation where the short sloped walkway meets the adjacent longer east-west walkway. See the photo on the right.**

The photo on the left shows the gap between the two sections of the walkway (yellow arrow) and the excessive abrupt change of vertical elevation (red arrow). The excessive abrupt change of vertical elevation is a significant tripping hazard.

The gap between the two sections of the walkway can allow a wheelchair caster, crutch tips, cane tip, or shoe heels to enter the opening and cause an individual to fall. 2010 ADA Standard 302.3, [Floor or Ground Surfaces] Openings, states,

**RECOMMENDATION:** Rebuild this sloped walking surface to comply with the 2010 ADA Standards for either a walkway or ramp. Eliminate the gap between the two sections and the abrupt excessive change of vertical elevation at the adjacent east-west walkway. See Exterior Doors below for related comments about the exterior maneuvering space for this door.

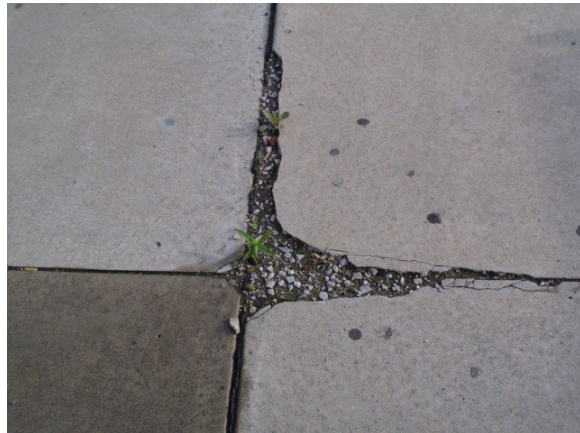
The photo on the right is another example of an opening and tripping hazard.

**RECOMMENDATION:** Consider rebuilding the entire patio surface or repairing the openings to create a patio walking surface that is stable, firm, slip resistant, and level with no excessive abrupt changes of elevation.

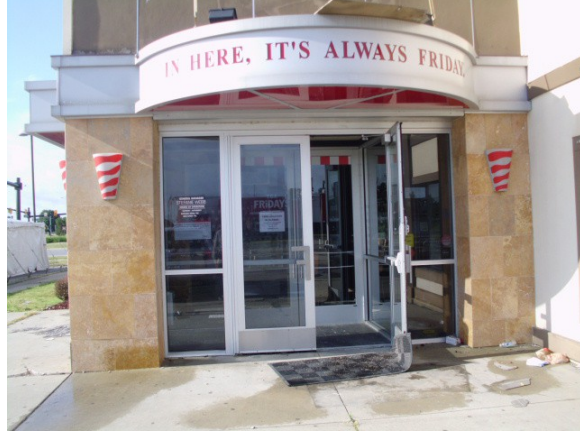
**Item 6. None of the current exterior public entrance doors are labeled correctly for ADA compliance or non-compliance.** The photo on the right is the current primary and accessible pedestrian entry/exit door at the northeast corner of this facility.

**RECOMMENDATION:** Install an exterior ISA sign at the primary accessible entrance at the northeast corner and exterior directional signs at inaccessible entrances on the north and east sides, as applicable.

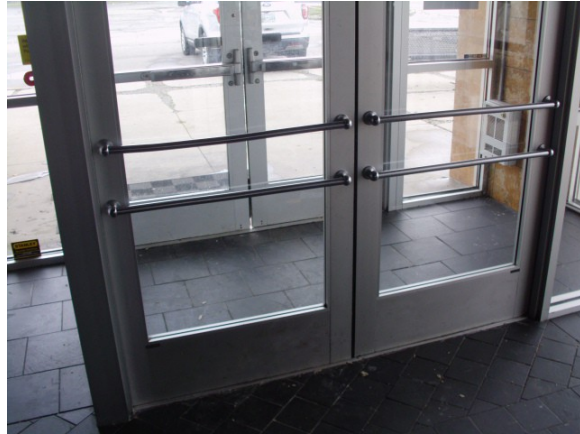
**Item 7. All four doors in the east entry/exit installation close automatically but the left exterior door and both interior doors close too quickly. The single secondary door on the north side also closed too quickly.** These doors closed to a position of 12 degrees from the latch in less than 5 seconds. The photo on the right shows the two interior doors at the primary entrance vestibule.

**RECOMMENDATION:** These door closers should be adjusted, repaired or replaced, as applicable. The east side emergency exit door should be disarmed and tested for compliance with closing rate.

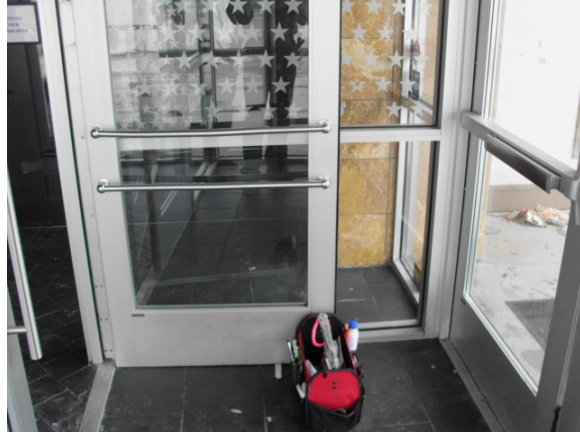
**Item 8. The spacing between the two interior doors and the two exterior doors for the primary entrance vestibule are installed too close together for doors installed in a series. See the photo on the right.**

2010 ADA Standard 404.2.6, [Doors, Doorways, and Gates] Doors in Series and Gates in Series, states, "The distance between two hinged or pivoted doors in series and gates in series shall be 48 inches (1220 mm) minimum plus the width of doors or gates swinging into the space." See the graphic below for a representation of this Standard applied to this installation. In the photo above the distance between the open door and the closed door is approximately 20 inches.

**RECOMMENDATION:** Redesign and re-install the interior doors for this vestibule entrance, or abandon the vestibule installation and remove the interior doors.

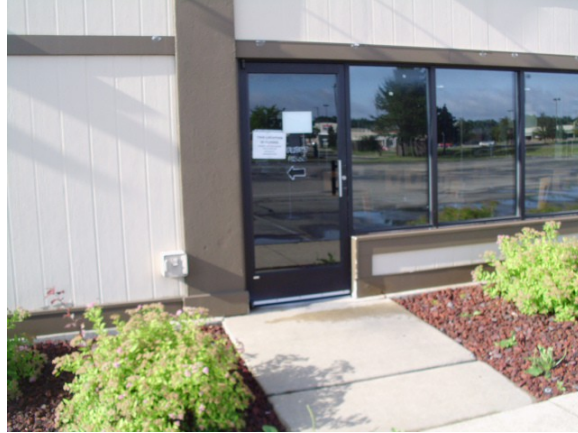
**Item 9. Two of the exterior single door entrances have door handles on the outside and could be used as temporary or alternative entry doors into the facility. If this is the case going forward, the door maneuvering spaces at the exterior of these doors should be accessible, and they are not presently. The north side single door also drags on the threshold and the frame at the latch when operated. The photo on the right shows the north door.**

Doors that are pulled to open should have level door maneuvering spaces on the pull side and adequate accessible door maneuvering space.

**RECOMMENDATION:** Alter the exterior door maneuvering space for these two exterior doors to provide level surfaces and adequate accessible door maneuvering space. Repair the north side single door so it does not drag on the threshold or the frame at the latch when operated.

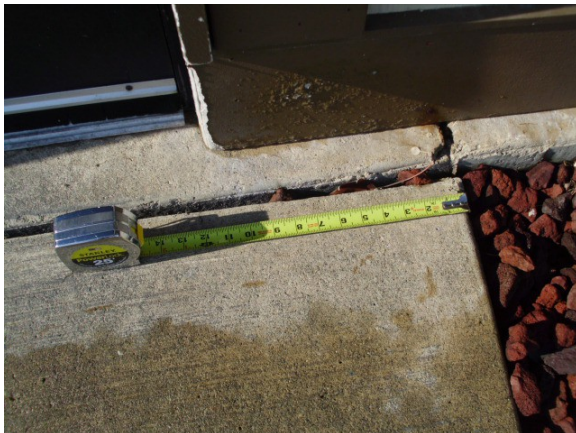
2010 ADA Standard 404.2.4.4, [Doors, Doorways, and Gates] Floor or Ground Surface, states, "Floor or ground surface within required [door] maneuvering clearances shall comply with [Standard] 302. Changes in level are not permitted. EXCEPTION: 1. Slopes not steeper than 1:48 [2.08%] shall be permitted." In other words the door maneuvering space should be mostly level. The run slopes of the maneuvering spaces for these doors are 2.8% for the east side door and approximately 9% for the north side door.

At both door installations the maneuvering space parallel to the door on the latch side is approximately 12 inches, which is not wide enough. The photo on the left is representative.

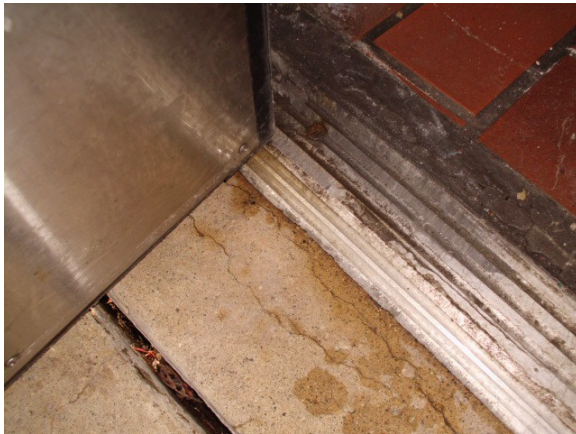
The photo on the left is where the north side door drags on the threshold. This makes the door difficult to open.

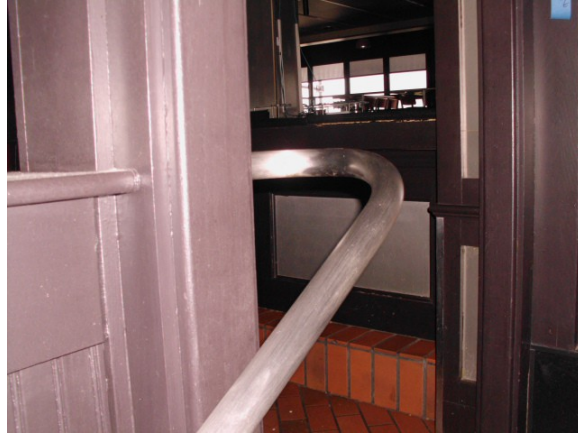
**Item 10. One step handrail is exposed as a protruding object at the top of a step system near the bar. See the photo on the right.**

2010 ADA Standards 307.2, [Protruding Objects] Protrusion Limits, states, "Objects with leading edges more than 27 inches (685 mm) and not more than 80 inches (2030 mm) above the finish floor or ground shall protrude 4 inches (100 mm) maximum horizontally into the circulation path. EXCEPTION: Handrails shall be permitted to protrude 4½ inches (115 mm) maximum."

**RECOMMENDATION:** Replace this handrail installation with a model that does not exceed protrusion limits.

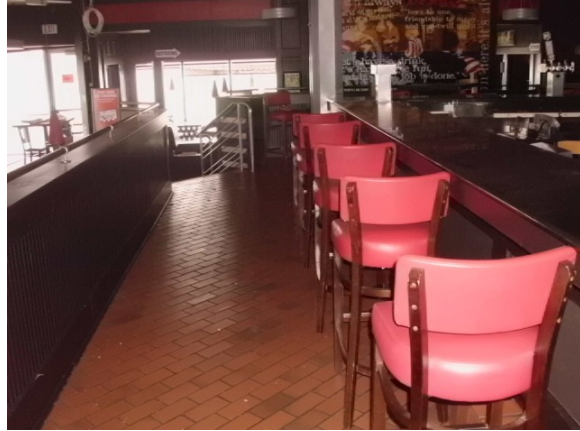
**Item 12. The counter for the bar is consistently 41.5 inches above the finished floor. None of the bar height is accessible for disabled individuals.** See the photo on the right.

The bar counter is a dining surface. 2010 ADA Standard 226.1, [Dining Surfaces and Work Surfaces] General, states, “Where dining surfaces are provided for the consumption of food or drink, at least 5 percent of the seating spaces and standing spaces at the dining surfaces shall comply with [Standard] 902.”

2010 ADA Standard 902.3, [Dining Surfaces and Work Surfaces] Height, states, “The tops of dining surfaces and work surfaces shall be 28 inches (710 mm) minimum and 34 inches (865 mm) maximum above the finish floor or ground.”

**RECOMMENDATION:** Alter the bar counter to provide at least 5 percent of the seating spaces and standing spaces at the bar with an accessible forward approach to an accessible portion of the counter as per Standard 902.

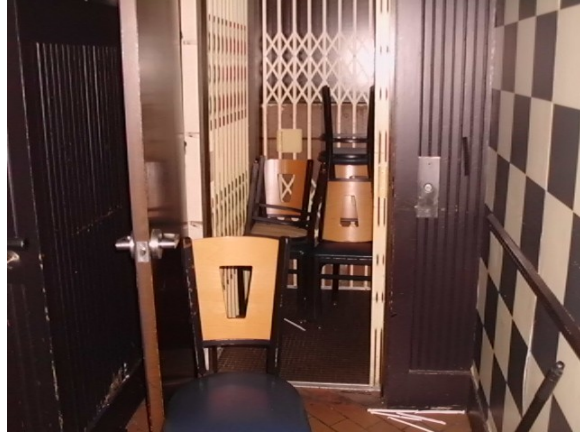
**Item 13. This is a three level facility. There are steps and an elevator that provide access to all three levels. The elevator was not operational at the time of this inspection, probably because the electrical power was disconnected to the facility. See the photo on the right. Note that the elevator was used to store other components.**

2010 ADA Standard 206.1, [Accessible Routes] General, states, “Accessible routes shall be provided in accordance with [Standard] 206 and shall comply with Chapter 4.”

**RECOMMENDATION:** Remove the stored items from the elevator, have power restored to the facility, and have the elevator evaluated for design and operation in accordance with the ADA Standards.

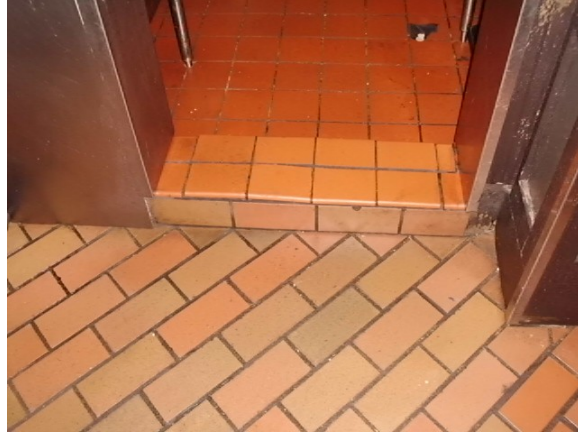
**Item 14. The space inside the bar on the second level of this facility is an employee work area. The access opening/doorway to this employee work area is not accessible for disabled individuals to approach, enter, and exit the employee work area due to the narrow width (30 inches) of the opening/doorway and the raised threshold for the opening/doorway. See the photo on the right.**

2010 ADA Standard 203.9, Employee Work Areas, states, “Spaces and elements within employee work areas shall only be required to comply with [Standard] 206.2.8, 207.1, and 215.3 [Not Applicable] and shall be designed and constructed so that individuals with disabilities can approach, enter, and exit the employee work area.”

2010 ADA Standard 404.2.3, [Doors, Doorways, and Gates] Clear Width, states, “Door openings shall provide a clear width of 32 inches (815 mm) minimum.”

**RECOMMENDATION:** Alter this bar opening/doorway to provide access for disabled employees that is at least 32 inches wide and has no threshold greater than ½ inch in height or step.

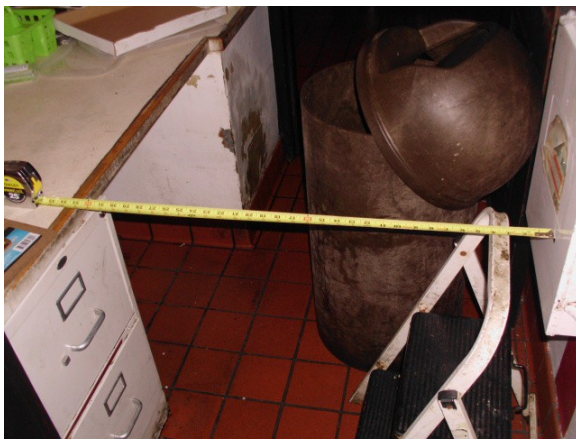
**Item 15. Access to the Manager's office in the kitchen area is limited due to the width of the route inside the office and to protruding objects.** See the photo on the right. See Item 14 above for related comments and Standards.

The photo on the left is where a wall mounted element and a stored ladder limits the width of the route to 32 inches or less to a desk on the opposite side of the route.

**RECOMMENDATION:** Alter the Manager's office to provide 36 inches of route width for most of the space. Door openings should be at least 32 inches wide.

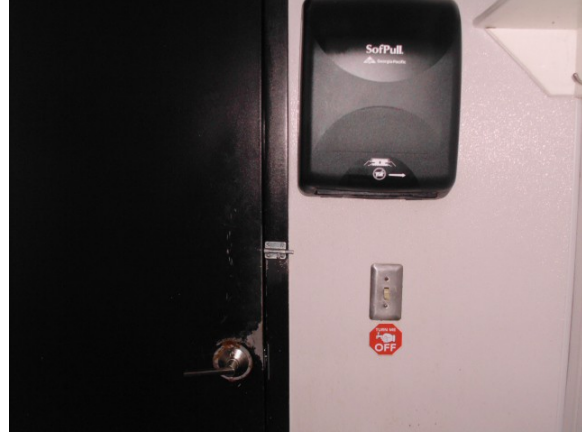
**Item 16. Some wall-mounted elements and controls in the employee work areas are installed too high above the finished floor.** The photo on the right is representative where a paper towel dispenser is mounted 59 inches to the actuator from the floor.

2010 ADA Standard 309.3 [Operable Parts] Height, and Standard 308.2.1, [Forward Reach] Unobstructed, indicate that the maximum recommended height for operable parts is 48 inches above the finished floor.

**RECOMMENDATION:** Consider relocating operable parts in the employee work areas to a maximum height of 48 inches above the finished floor, or lower, as applicable.

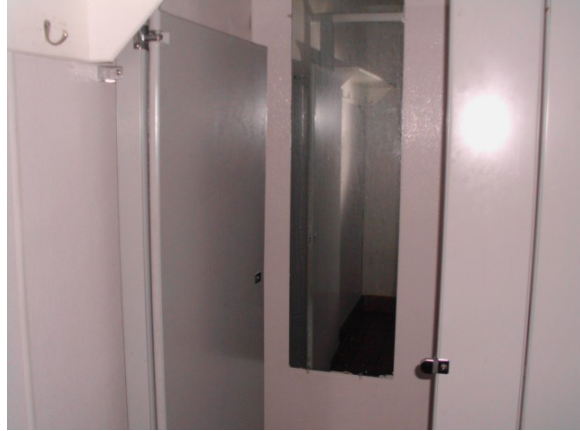
**Item 18. In both employee toilet rooms the stall doors are only approximately 24 inches in width, the doors do not close automatically, door pulls are not located on both sides of the doors, both doors swing into the minimum required compartment area, and the door maneuvering spaces from inside the compartments are too small. The photo on the right is representative.**

2010 ADA Standard 604.8.1.2, [Wheelchair Accessible Toilet Compartments] Doors, states, "Toilet compartment doors, including door hardware, shall comply with [Standard] 404 except that if the approach is to the latch side of the compartment door, clearance between the door side of the compartment and any obstruction shall be 42 inches (1065 mm) minimum. Doors shall be located in the front partition or in the side wall or partition farthest from the water closet. Where located in the front partition, the door opening shall be 4 inches (100 mm) maximum from the side wall or partition farthest from the water closet. Where located in the side wall or partition, the door opening shall be 4 inches (100 mm) maximum from the front partition. The door shall be self-closing. A door pull complying with [Standard] 404.2.7 shall be placed on both sides of the door near the latch. Toilet compartment doors shall not swing into the minimum required compartment area."

**RECOMMENDATION:** These partitions create ADA problems. Consider removing the partitions, or consider ways to increase the toilet compartment space in these toilet rooms, or convert the two toilet rooms to one compliant unisex toilet room. See item 17 above for related comments.

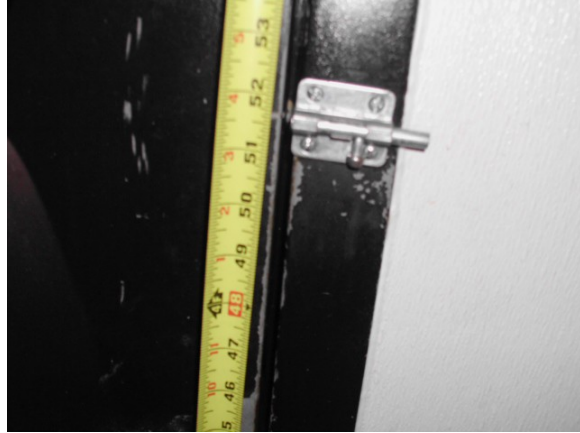
**Item 20. A makeshift door latch/lock was installed for the Men's employee toilet room entry/exit door that is too high above the finished floor. See the photo on the right. This latch/lock is an operable part that requires tight grasping and twisting of the wrist to operate.**

2010 ADA Standard 309.3, [Operable Parts] Height, states, "Operable parts shall be placed within one or more of the reach ranges specified in [Standard] 308."

2010 ADA Standard 309.4, [Operable Parts] Operation, states, "Operable parts shall be operable with one hand and shall not require tight grasping, pinching, or twisting of the wrist."

**RECOMMENDATION:** Replace this latch/lock with a model that is accessible according to the ADA and located within ADA reach ranges.

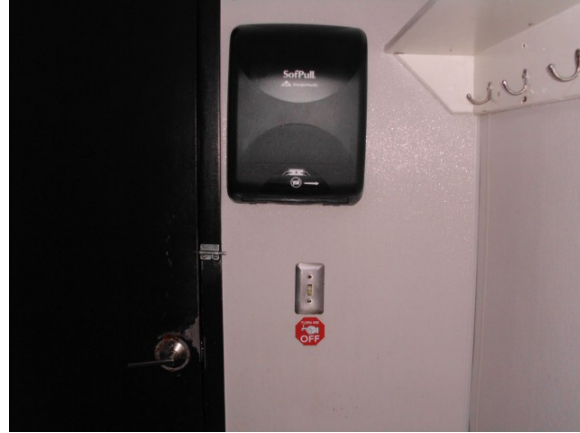
**Item 21. In both employee toilet rooms the paper towel dispensers are installed too high above the finished floor and so as to create a protruding object in the circulation path.** The photo on the right is representative. These dispensers are more than 27 inches above the finished floor and project more than 4 inches into the circulation path.

2010 ADA Standard 309.3, [Operable Parts] Height, states, “Operable parts shall be placed within one or more of the reach ranges specified in [Standard] 308.

2010 ADA Standard 204.1, [Protruding Objects] General, states, “Protruding objects on circulation paths shall comply with [Standard] 307.”

2010 ADA Standard 307.2, [Protruding Objects] Protrusion Limits, states, “Objects with leading edges more than 27 inches (685 mm) and not more than 80 inches (2030 mm) above the finish floor or ground shall protrude 4 inches (100 mm) maximum horizontally into the circulation path.” The graphic on the right is representative of these Standards.

**RECOMMENDATION:** Relocate these dispensers so they are not protruding objects, or replace with a model that does not protrude. Lower these installations to within ADA reach ranges.

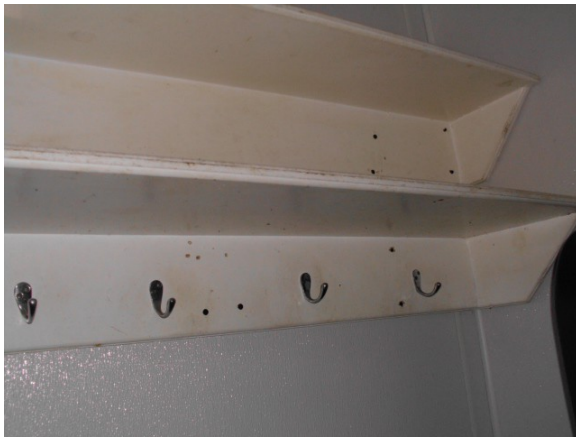
The photo on the left is representative of the community coat hooks and shelves located near the entry/exit doors.

2010 ADA Standard 603.4, Coat Hooks and Shelves, states, “Coat hooks shall be located within one of the reach ranges specified in [Standard] 308. Shelves shall be located 40 inches (1015 mm) minimum and 48 inches (1220 mm) maximum above the finish floor.” In no case should all of the coat hooks and shelving be located more than 48 inches above the finished floor.

**RECOMMENDATION:** The coat hooks on the back of the toilet stall doors should be lowered to 48 inches maximum, or add a second coat hook at 48 inches maximum above the floor. The community coat hooks should have at least one coat hook that is not more than 48 inches above the finished floor. Some shelving should be installed between 40 and 48 inches above the finished floor.

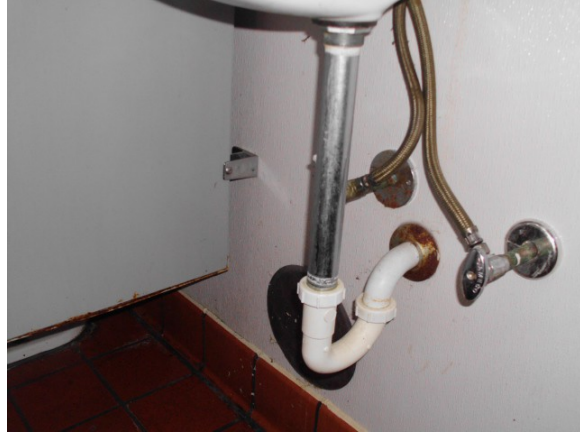
**Item 23. In both employee toilet rooms the water pipes and shutoff valves below the sinks are not fully insulated or otherwise configured to protect against contact and the sinks are installed too high above the floor to the rim of the sink. The photo on the right is representative of the exposed pipes below the sinks.**

2010 ADA Standard 606.5, [Lavatories and Sinks] Exposed Pipes and Surfaces, states, “Water supply and drain pipes under lavatories and sinks shall be insulated or otherwise configured to protect against contact. There shall be no sharp or abrasive surfaces under lavatories and sinks.”

**RECOMMENDATION:** Insulate or otherwise configure the water supply and drain pipes below the sinks to protect against contact. Lower the height of the sinks to less than 34 inches above the finished floor.

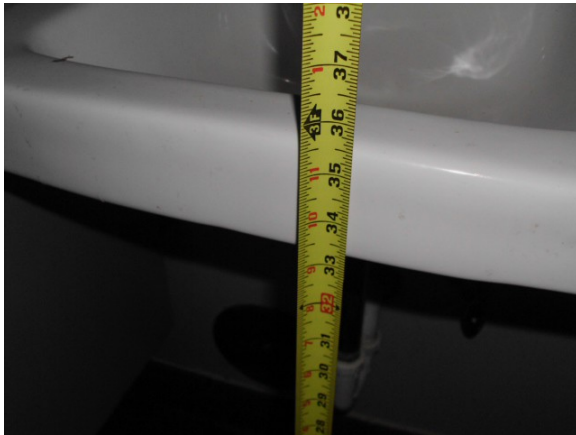
The photo on the left shows the rim of a sink more than 34 inches above the finished floor.

2010 ADA Standard 606.3, [Lavatories and Sinks] Height, states, “Lavatories and sinks shall be installed with the front of the higher of the rim or counter surface 34 inches (865 mm) maximum above the finish floor or ground.”

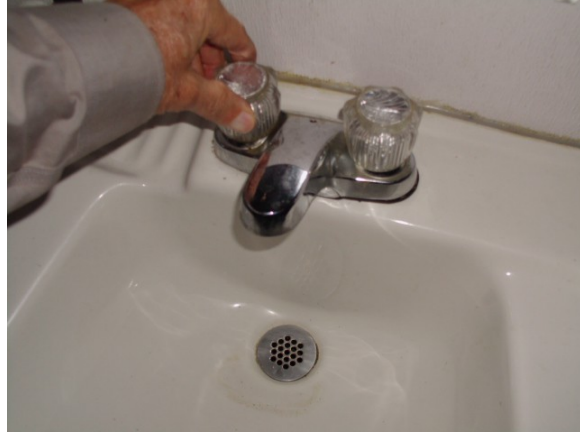
**Item 24. In the Men's employee toilet room the sink faucet handles require tight grasping and twisting to operate. See the photo on the right.**

2010 ADA Standard 606.4, [Lavatories and Sinks] Faucets, states, “Controls for faucets shall comply with [Standard] 309.”

2010 ADA Standard 309.4, [Operable Parts] Operation, states, “Operable parts shall be operable with one hand and shall not require tight grasping, pinching, or twisting of the wrist. The force required to activate operable parts shall be 5 pounds (22.2 N) maximum.”

**RECOMMENDATION:** Replace these faucet handles with models that comply with the ADA Standards.

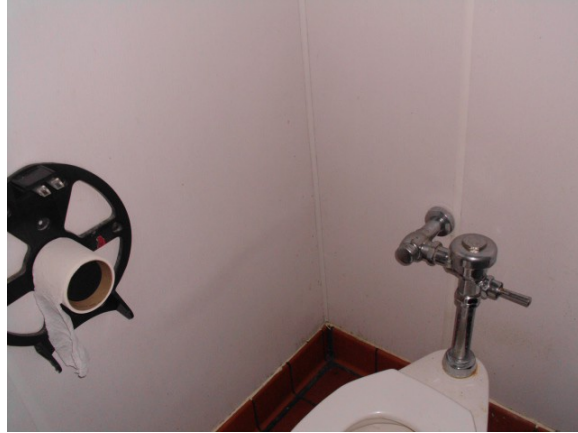
**Item 25. In both employee toilet rooms no grab bars are installed at the toilets.** The photo on the right is representative.

2010 ADA Standard 604.5, [Toilet Rooms and Bathing Rooms] Grab Bars, states, “Grab bars for water closets shall comply with [Standard] 609. Grab bars shall be provided on the side wall closest to the water closet and on the rear wall.”

2010 ADA Standard 604.5.1, [Grab Bar] Side Wall, states, “The side wall grab bar shall be 42 inches (1065 mm) long minimum, located 12 inches (305 mm) maximum from the rear wall and extending 54 inches (1370 mm) minimum from the rear wall. See the graphic on the right for a representation of this standard. A similar installation is required for the rear wall grab bar.

**RECOMMENDATION:** Install the grab bars on the rear and side wall in both employee toilet rooms.

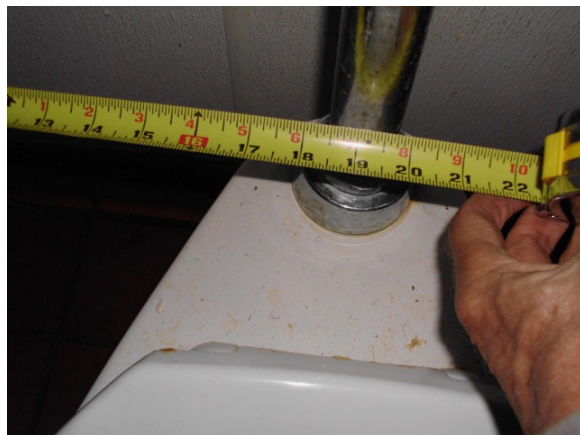
In each toilet room toilet compartment the toilet seats are mounted approximately 19 inches from the side wall. The photo on the right is representative. 2010 ADA Standard 604.2, [Water Closets and Toilet Compartments] Location, states, "The water closet shall be positioned with a wall or partition to the rear and to one side. The centerline of the water closet shall be 16 inches (405 mm) minimum to 18 inches (455 mm) maximum from the side wall or partition, except that the water closet shall be 17 inches (430 mm) minimum and 19 inches (485 mm) maximum from the side wall or partition in the ambulatory accessible toilet compartment specified in [Standard] 604.8.2. Water closets shall be arranged for a left-hand or right-hand approach."

**RECOMMENDATION:** Replace or alter the toilet installations in the both employee toilet rooms to raise the toilet seat height, install the toilets closer to the side wall, relocate the toilet paper dispensers in both toilet rooms and re-install the covers, and alter or replace the toilet in the Women's toilet room to place the flush handle on the open side of the toilet. Repair the Men's toilet seat so it is not loose.

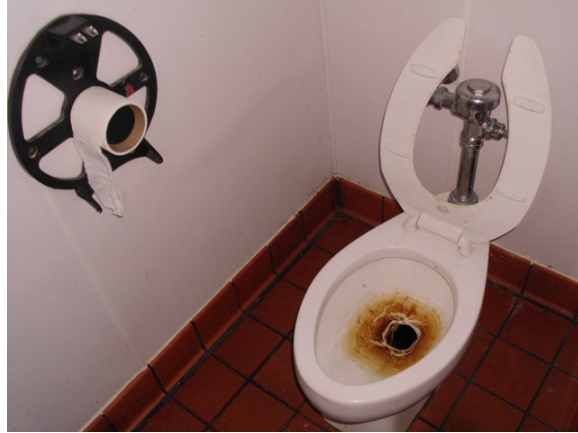
In each employee toilet room the toilet paper dispenser is mounted too close to the toilet and the dispenser covers were removed. The photo on the right is representative. 2010 ADA Standard 604.7, [Water Closets and Toilet Compartments] Dispensers, states, "Toilet paper dispensers shall comply with [Standard] 309.4 and shall be 7 inches (180 mm) minimum and 9 inches (230 mm) maximum in front of the water closet measured to the centerline of the dispenser. The outlet of the dispenser shall be 15 inches (380 mm) minimum and 48 inches (1220 mm) maximum above the finish floor and shall not be located behind grab bars. Dispensers shall not be of a type that controls delivery or that does not allow continuous paper flow." The graphic below is representative of this Standards.

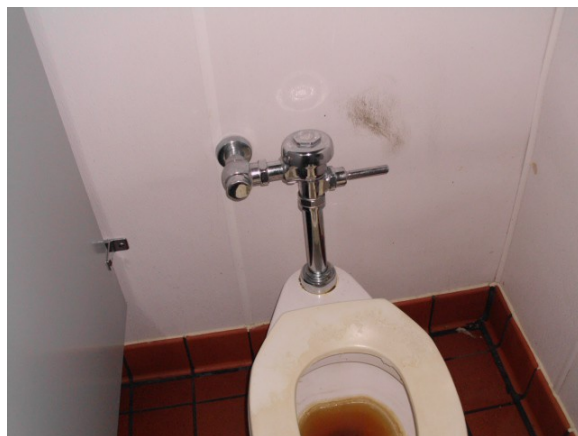
In the Women's toilet room the toilet flush handle is not on the open side of the toilet (assuming the partition is removed and the toilet is more accessible). See the photo on the right. 2010 ADA Standard 604.6, [Water Closets and Toilet Compartments] Flush Controls, states, "Flush controls shall be hand operated or automatic. Hand operated flush controls shall comply with [Standard] 309. Flush controls shall be located on the open side of the water closet except in ambulatory accessible compartments complying with [Standard] 604.8.2." The graphic below is representative of this Standard.

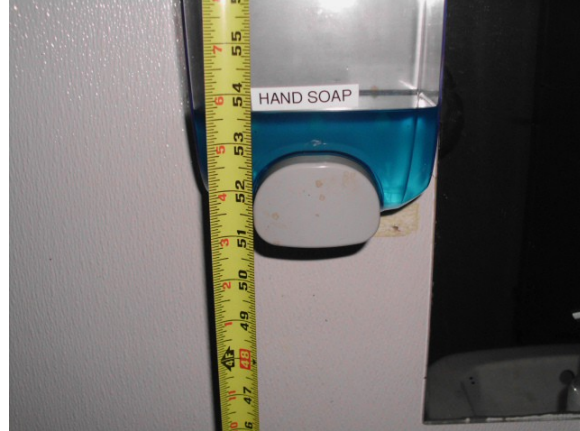
**Item 27. The wall-mounted soap dispenser in the Women's employee toilet room is mounted too high above the floor. See the photo on the right.**

Soap dispensers are operable parts. 2010 ADA Standard 309.3, [Operable Parts] Height, states, "Operable parts shall be placed within one or more of the reach ranges specified in [Standard] 308.

2010 ADA Standard 308.2.2, [Forward Reach] Obstructed High Reach, states, "Where a high forward reach is over an obstruction, the clear floor space shall extend beneath the element for a distance not less than the required reach depth over the obstruction. The high forward reach shall be 48 inches (1220 mm) maximum where the reach depth is 20 inches (510 mm) maximum. Where the reach depth exceeds 20 inches (510 mm), the high forward reach shall be 44 inches (1120 mm) maximum and the reach depth shall be 25 inches (635 mm) maximum." The graphic below is representative of this Standard.

**RECOMMENDATION:** Relocate the wall mounted soap dispenser in the Women's employee toilet room to within ADA requirements for reach range.

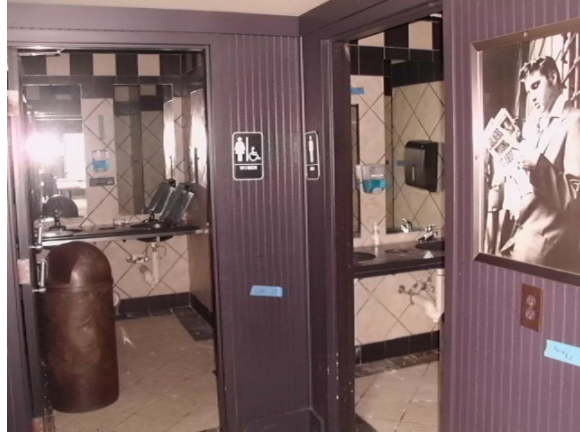
**Item 28. In both public toilet rooms the pedestrian entry/exit doors require excessive force to open and the automatic door closers allow the doors to close too quickly. See the photo on the right.**

Both entry doors required approximately 8 pounds of force to open. Standard 404.2.9, Door and Gate Opening Force, states, "The force for pushing or pulling open a door or gate other than fire doors shall be as follows: 1. Interior hinged doors and gates: 5 pounds maximum."

Standard 404.2.8.1, Door Closers and Gate Closers, states, "Door closers and gate closers shall be adjusted so that from an open position of 90 degrees, the time required to move the door to a position of 12 degrees from the latch is 5 seconds minimum." See the graphic on the left for a representation of this Standard. Both doors closed to the 12 degree position is less than 5 seconds.

**RECOMMENDATION:** These door closers should be adjusted, repaired or replaced.

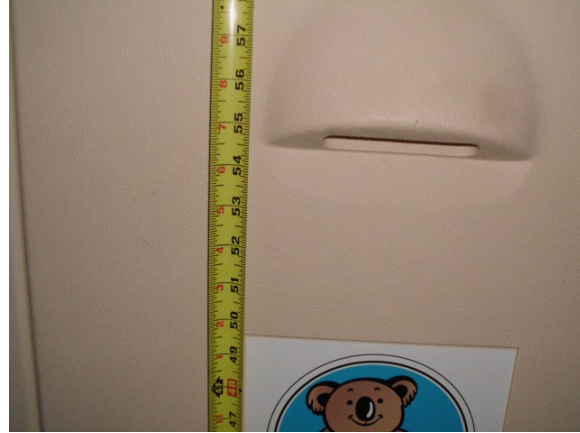
**Item 29. In the Men's public toilet room the baby changing table handle is mounted too high above the finished floor. See the photo on the right.**

The baby changing table is an operable part that must comply with 2010 ADA Standard 309.

2010 ADA Standard 309.3, [Operable Parts] Height, states, "Operable parts shall be placed within one or more of the reach ranges specified in [Standard] 308.

2010 ADA Standard 308.2.1, [Forward Reach] Unobstructed, states. "Where a forward reach is unobstructed, the high forward reach shall be 48 inches (1220 mm) maximum and the low forward reach shall be 15 inches (380 mm) minimum above the finish floor or ground." The graphic on the left is representative of this Standard.

**RECOMMENDATION:** Relocate or replace the baby changing table in the Men's public toilet room to comply with the ADA Standards for reach.

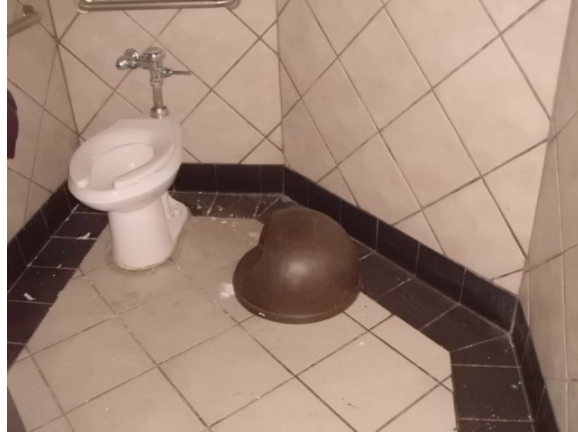
**Item 30. In the Men's public toilet room the rear wall behind the toilet is angled in such a way as to compromise the space required for an accessible toilet compartment (stall) and the space required for wheelchair transfer. See the photo on the right.**

2010 ADA Standard 604.8.1.1, [Toilet Compartments, Wheelchair Accessible Compartments] Size, states, "Wheelchair accessible compartments shall be 60 inches (1525 mm) wide minimum measured perpendicular to the side wall, and 56 inches (1420 mm) deep minimum for wall hung water closets and 59 inches (1500 mm) deep minimum for floor mounted water closets measured perpendicular to the rear wall." The graphic below is representative of this Standard.

2010 ADA Standard 604.3.1, [Water Closets and Toilet Compartments] Size, states, “Clearance around a water closet [toilet] shall be 60 inches (1525 mm) minimum measured perpendicular from the side wall and 56 inches (1420 mm) minimum measured perpendicular from the rear wall.” The graphic on the left is representative of this Standard. This space allows for transfer from/to the toilet and a wheelchair.

**RECOMMENDATION:** Alter the rear wall in the Men's public toilet room to provide the space required for an accessible toilet compartment (stall) and the space required for wheelchair transfer.

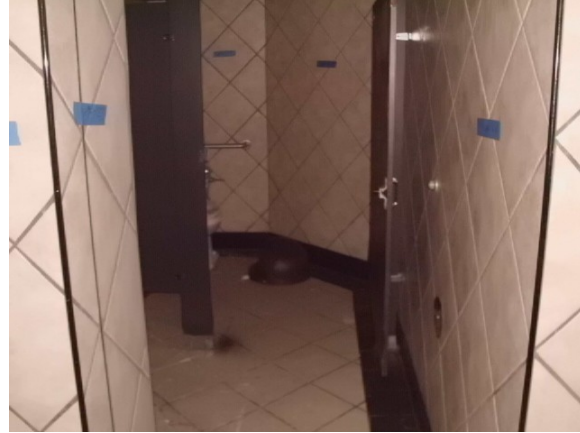
**Item 31. In the Men's public toilet room, the toilet compartment (stall) door does not have adequate maneuvering space on either side of the stall door. See the photo on the right.**

This stall door is pulled to open from outside the stall and pushed to open from inside the stall. 2010 ADA Standard 404.2.4.1, [Doors, Doorways, and Gates] Swinging Doors and Gates, "Swinging doors and gates shall have maneuvering clearances complying with Table 404.2.4.1." Table 404.2.4.1 indicates for a door approached from the forward direction and pulled to open, a space of 18 inches is required parallel to the door on the latch side and 60 inches is required perpendicular to the door. The

**RECOMMENDATION:** Alter the Men's public toilet room to have adequate door maneuvering space on both sides of the accessible toilet stall door.

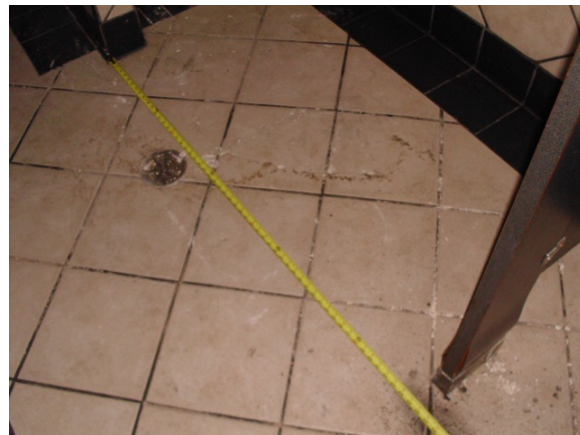
In this installation the 60 inch requirement perpendicular to the stall door is compromised by the "L" shaped wall for the urinal. See the photo on the right.

On the inside of the stall door the door maneuvering space is compromised by the angled rear wall discussed in item 30 above. 2010 ADA Standard 404.2.4.1, [Doors, Doorways, and Gates] Swinging Doors and Gates, "Swinging doors and gates shall have maneuvering clearances complying with Table 404.2.4.1." Table

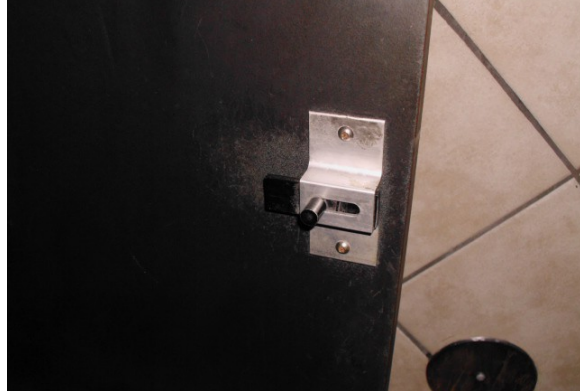
**Item 32. In both public toilet rooms the accessible stall doors are not self-closing and there is not an accessible door handle on the inside of the stall doors.** The photo on the right is representative of the hardware on the inside of the accessible stall doors. The hardware in the photo is a latch that is not an accessible door pull (handle).

2010 ADA Standard 604.8.1.2, [Wheelchair Accessible Compartments] Doors, states in part, “The [compartment] door shall be self-closing. A door pull complying with [Standard] 404.2.7 shall be placed on both sides of the door near the latch.”

2010 ADA Standard 404.2.7, [Doors, Doorways, and Gates] Door and Gate Hardware, states in part, “Handles, pulls, latches, locks, and other operable parts on doors and gates shall comply with [Standard] 309.4. Operable parts of such hardware shall be 34 inches (865 mm) minimum and 48 inches (1220 mm) maximum above the finish floor or ground.”

2010 ADA Standard 309.4, [Operable Parts] Operation, states, “Operable parts shall be operable with one hand and shall not require tight grasping, pinching, or twisting of the wrist. The force required to activate operable parts shall be 5 pounds (22.2 N) maximum.” The graphic below is representative of this Standard.

**RECOMMENDATION:** Alter the toilet compartment (stall) door installations to install an accessible door pull/handle on the inside of the door, and repair or replace the doors to provide stall doors that self-close.

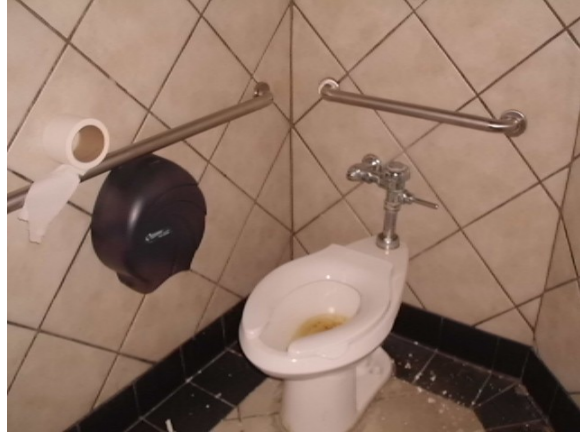
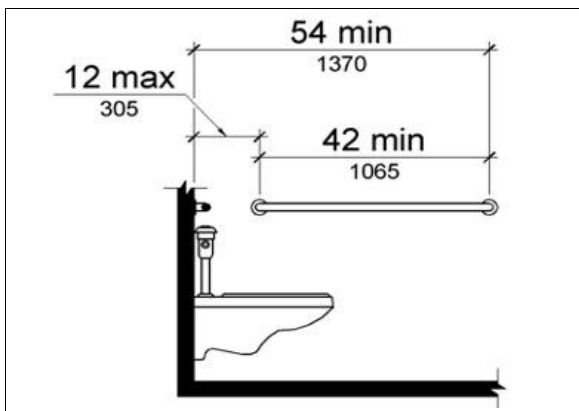
**Item 33. In the Men's and Women's public toilet rooms the side wall grab bars at the accessible toilet do not extend 54 inches from the rear wall, and in the Men's public toilet room the rear wall grab bar is not at least 36 inches long.** The photo on the right shows the toilet grab bars in the Men's public toilet room accessible stall.

2010 ADA Standard 604.5.1, [Grab Bar] Side Wall, states, "The side wall grab bar shall be 42 inches (1065 mm) long minimum, located 12 inches (305 mm) maximum from the rear wall and extending 54 inches (1370 mm) minimum from the rear wall." See the graphic on the left for a representation of this Standard. The grab bars on the side walls in these toilet rooms are installed too

close to the rear wall.

permit a length of 36 inches (915 mm) minimum due to the location of a recessed fixture adjacent to the water closet." The graphic on the right is representative of this Standard. The grab bar in the Men's public toilet room is too short due to the angled rear wall, not due to the location of a recessed fixture adjacent to the water closet. The exception does not apply.

**RECOMMENDATION:** Install grab bars at these toilets that are compliant with the ADA Standards.

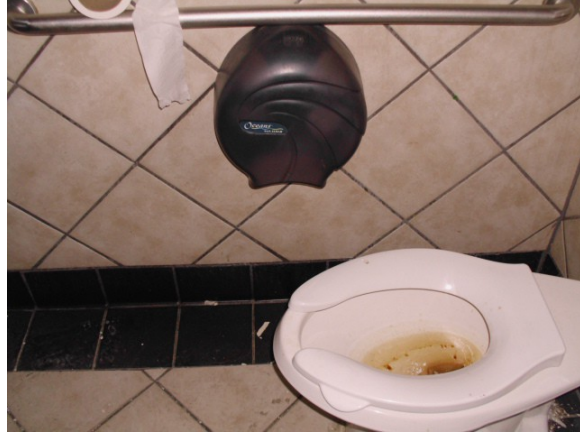
**Item 34. In the Men's public toilet room the toilet paper dispenser is installed too close to the toilet. See the photo on the right.**

**RECOMMENDATION:** Relocate the toilet paper dispenser in the Men's public toilet room accessible stall to a location compliant with the ADA Standards.

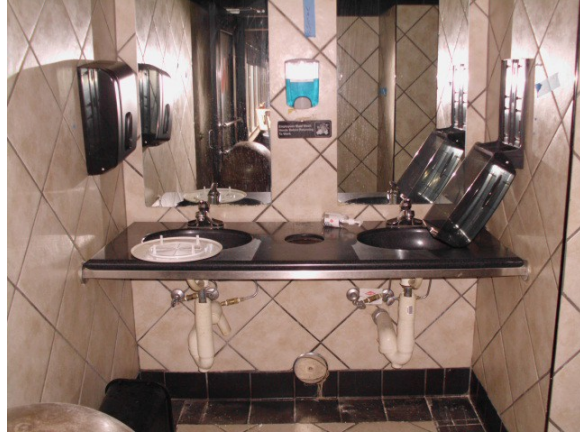
**Item 35. In the Women's public toilet room the height of the sink counter is too high above the finished floor at approximately 34.5 inches and the height of the wall-mounted soap dispenser is too high above the finished floor at approximately 54 inches. See the photo on the right.**

**RECOMMENDATION:** Lower the counter height to 34 inches above the finished floor, maximum, and lower the wall-mounted soap dispenser to a height of 44 inches above the finished floor, maximum.

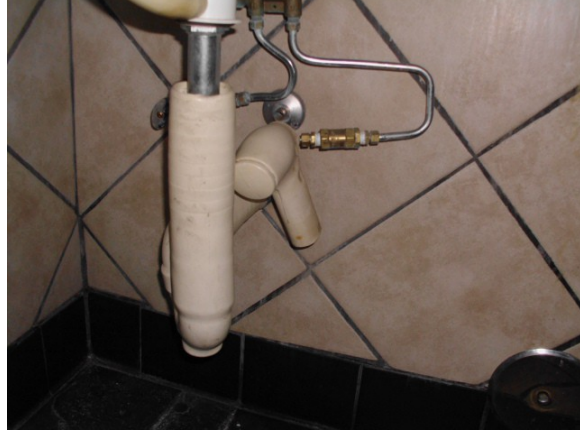
**Item 36. In the Women's public toilet room some of the plumbing pipes below the sinks are not insulated or otherwise protected against contact and some pipes are disconnected.** The photo on the right is representative. Use caution when the water service is turned back ON.

2010 ADA Standard 606.5, [Lavatories and Sinks] Exposed Pipes and Surfaces, states, "Water supply and drain pipes under lavatories and sinks shall be insulated or otherwise configured to protect against contact. There shall be no sharp or abrasive surfaces under lavatories and sinks."

**RECOMMENDATION:** Insulate or otherwise configure the plumbing pipes below the sinks in the Women's public toilet room against contact and against sharp or abrasive surfaces. Re-install all plumbing pipes, as required. Use caution when the water service is turned back ON.
