TOYOTA

Technical Service BULLETIN

WINDSHIELD WIPER BLADE MAINTENANCE AND CLEANING

BODY
REVISED
BO030-01

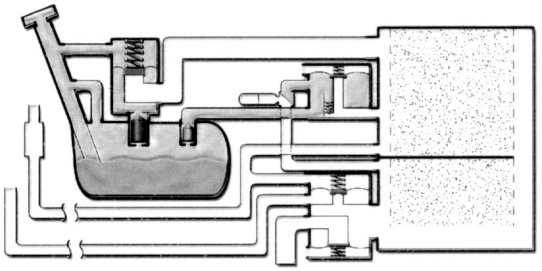
Figure 3. Fuel Tank Side of System

If DTC P0440 is present, the leak is on the fuel tank side of the EVAP system. This also includes the lines between the fuel tank and part of the canister. When the Vapor Pressure sensor is measuring tank pressure, the ECM is observing changes in pressure and comparing tank pressure to atmospheric pressure. No difference in pressure indicates a leak. The ECM may take 20 minutes or more to complete testing the fuel tank side (see Figure 3).

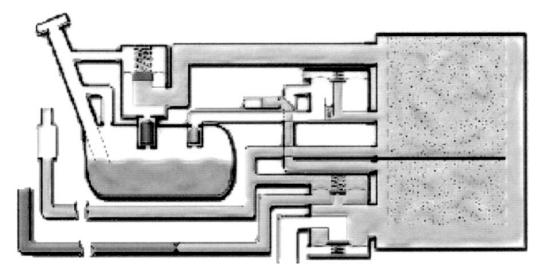
Figure 4. Canister Side of System

When the ECM switches the vapor pressure VSV to canister side, the ECM measures canister pressure. A leak on the canister side can set multiple DTCs (see Figure 4).

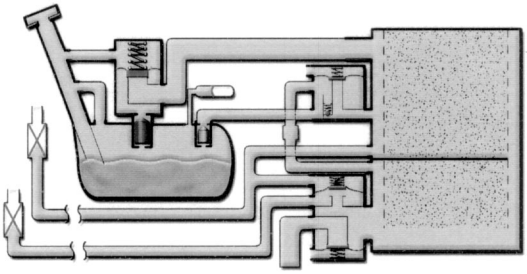
Figure 3. System Sealed

After purge VSV operation, the purge VSV is turned off sealing the vacuum in the system and the ECM begins to monitor the pressure increase (see Figure 3). Some increase is normal. A very rapid, sharp increase in pressure indicates a leak in the EVAP system and sets the DTC P0440.

This monitoring method is also able to distinguish what is called the small leak detection. A pressure rise just above normal indicates a very small hole and will set the DTC P0442.

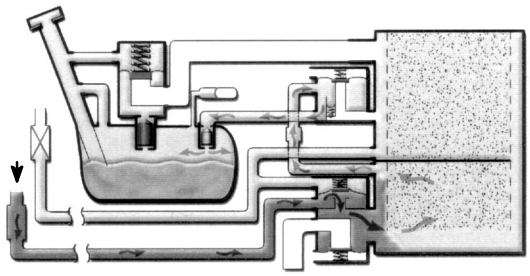
Figure 4. CCV Opens

This stage checks the CCV and vent (air inlet side) operation. When the vapor pressure rises to a specified point, the ECM opens the CCV. Pressure will increase rapidly because of the air allowed into the system. No increase or an increase below specified rate of pressure increase indicates a restriction on the air inlet side (see Figure 4).

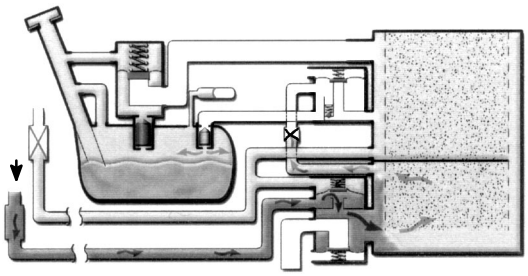
Figure 5. Bypass VSV Closes

In the next stage, the ECM closes the bypass VSV. This action blocks air entering the tank side of the system. The pressure rise on the fuel tank side is no longer as great. If there was no change in pressure, the ECM will conclude the bypass VSV did not close (see Figure 5).

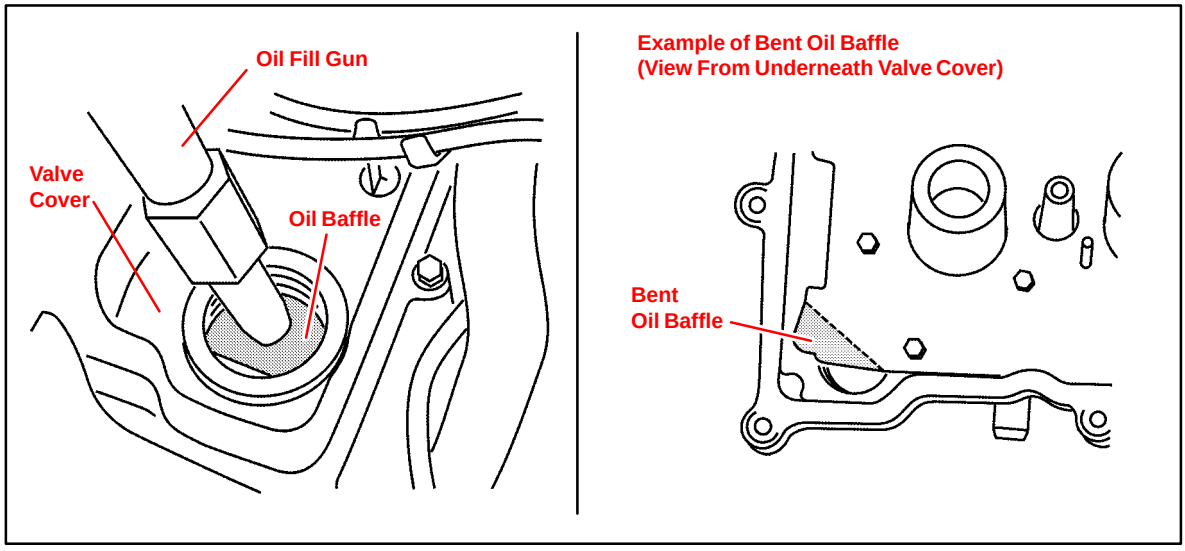
Please take measures to ensure that the baffle is not damaged during the oil fill process. If it does become damaged, repair it before any collateral damage occurs.

1. Inspect the condition of the valve cover oil baffle as per TSB EG007–02. If camshaft or camshaft position sensor damage resulting from a bent baffle is identified, repair the damage as necessary.
2. Make sure the vehicle is in "PARK" with the engine idling.
3. Referring to the screen flow below, connect the Toyota Diagnostic Tester to the vehicle and select the VVT Control Bank One Active Test (VVT CTRL B1) from the Active Test Menu.

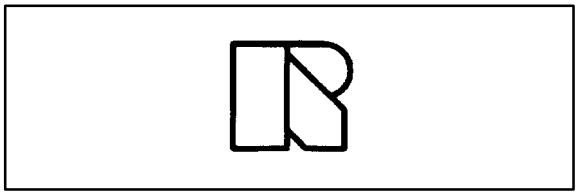
*1 This seat belt was supplied by TOKAI RIKA. Make sure that the I/D mark on the back side of the seat belt buckle is the same as shown.

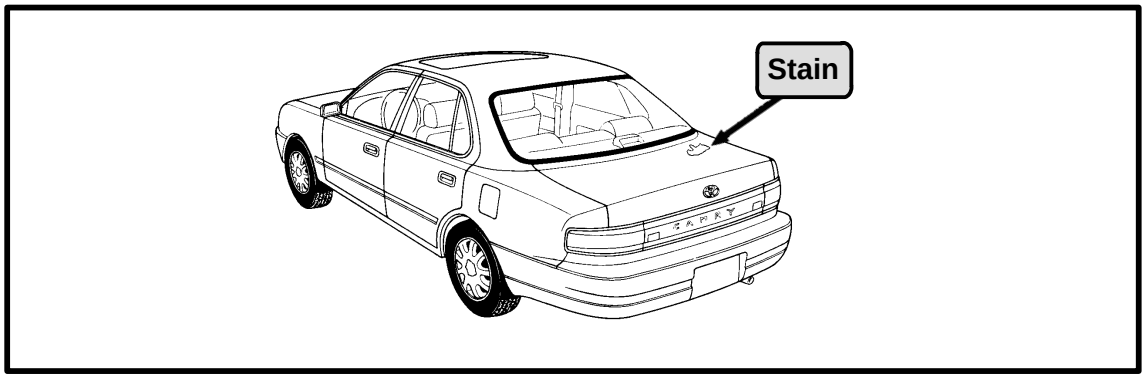
On some Toyota models, when Rapgard is removed from the vehicle, a stain is left on the paint surface. This stain can be seen under the clear coat and is not a defect of the clear coat. The stain corresponds to a wrinkled area of Rapgard which retained liquids, such as window washer fluid, that left a discoloration.

REPAIR PROCEDURE:

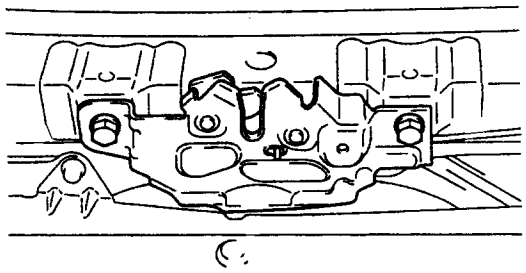
Engine Hood Lock Assembly

A new hood lock assembly with two new springs has been developed to improve inoperative and difficult–to–open conditions.

After installation of the new part, refer to the MR2 Repair Manual for adjustment instructions:

- 2000 MR2 Repair Manual (Pub. No. RM760U) pages BO–9 and BO–10.
- 2001 MR2 Repair Manual (Pub. No. RM801U) page BO–10.

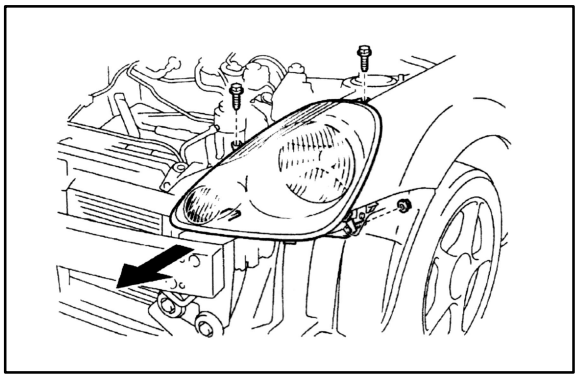
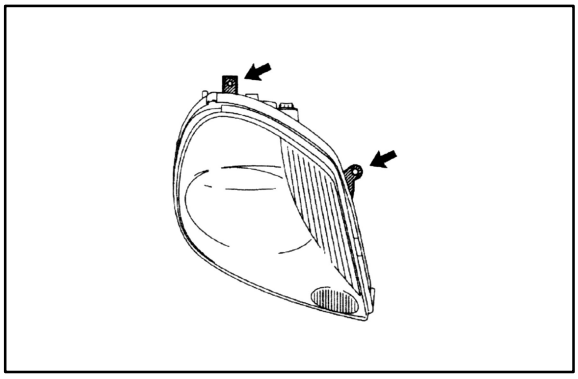
To improve the serviceability of the 2000 model year MR2 Spyder headlight, bosses have been added to the headlights. If a headlight mounting tab is damaged, the headlight can be reused by following the procedure on page 2.

1. Remove the front bumper cover. Refer to the 2000 model year MR2 Spyder Repair Manual, page BO-4.
2. Remove the luggage compartment trim box cover.
3. Remove the headlight assembly.
   A. Remove the 2 bolts and 1 nut.
   B. Disconnect the connectors.
   C. Remove the headlight as shown.
   D. Use the same procedure to remove the other side, if necessary.

4. If the mounting tabs are damaged, cut off the mounting tabs at the base of the housing.

5. Install the new mounting tabs with the provided screws to the base of the housing.
6. Reinstall the headlight assembly and other components in the reverse order of disassembly.

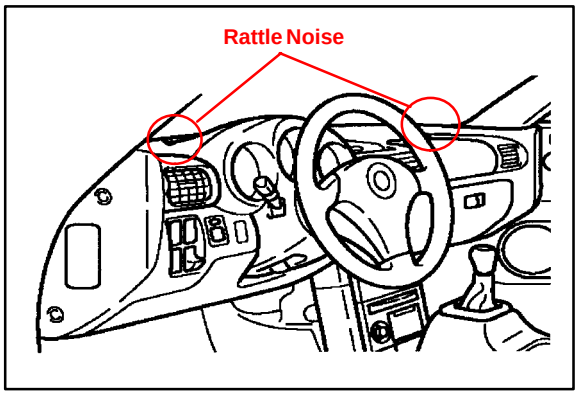
To eliminate a rattle noise from the upper instrument panel area:

1. Loosen the two (2) bolts on each side of the instrument panel.
2. While another technician pushes forward on the instrument panel, retighten the bolts as shown below.

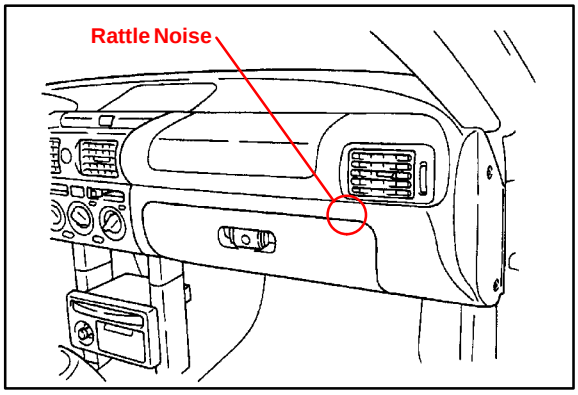
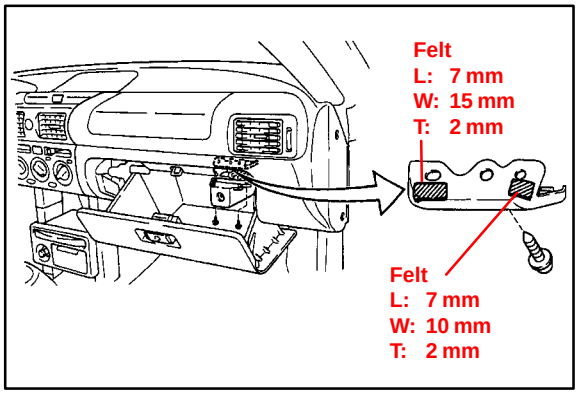
Passenger Airbag Cutoff Switch Rattle Noise

To eliminate a rattle noise from the airbag cutoff switch area:

1. Remove the two (2) bolts that hold the passenger airbag cutoff switch in place.
2. Cut two (2) pieces of felt in the following dimensions:

3. Fit felt pieces in the positions shown.
4. Reassemble in the reverse order of disassembly.

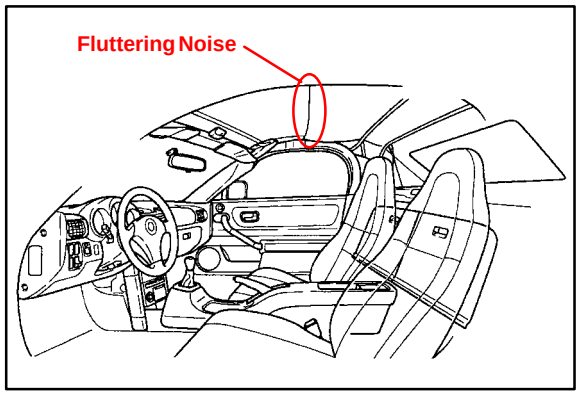
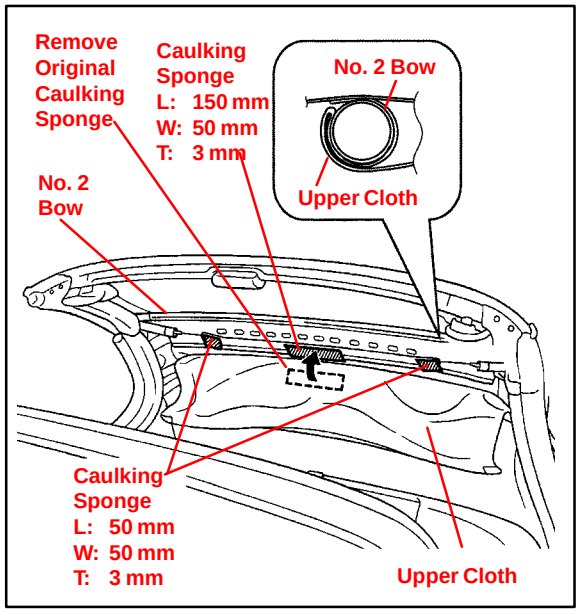
Convertible Top Fluttering Noise

To eliminate a fluttering noise from the convertible top number 2 bow:

1. Remove the convertible top upper cloth (refer to the 2000 MR2 Spyder Repair Manual, pages BO–77 to BO–78).
2. Remove EPT Sealer (caulking sponge) from the center of the inner upper cloth (see illustration).
3. Clean area with Kent® Acrysol (or equivalent).
4. Cut three (3) pieces of EPT Sealer (caulking sponge) in the following dimensions:

5. Install EPT Sealer (caulking sponge) in the positions shown.
6. Reassemble in the reverse order of disassembly.

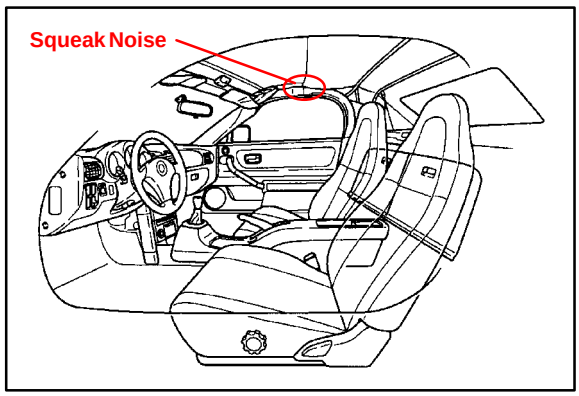
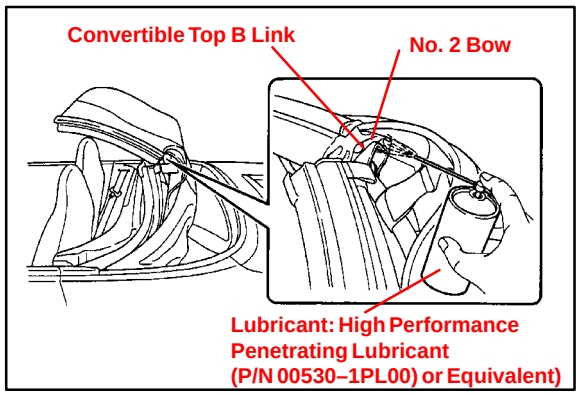
Convertible Top B Link Squeak Noise

To eliminate a squeak noise from the convertible top B link:

1. Open the convertible top to a half–open position.
2. Spray High Performance Penetrating Lubricant (P/N 00530–1PL00) or equivalent in the area shown, being careful to avoid overspray on interior components.
3. Wipe off excess lubricant.

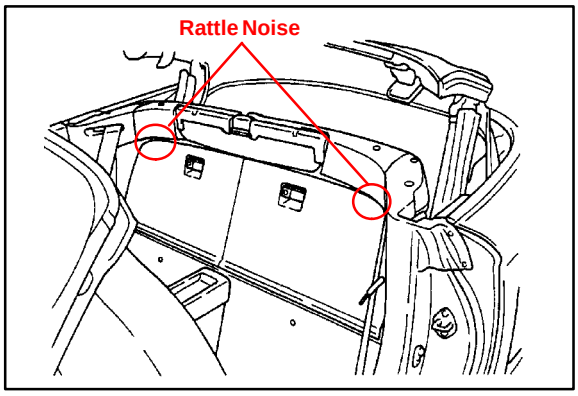
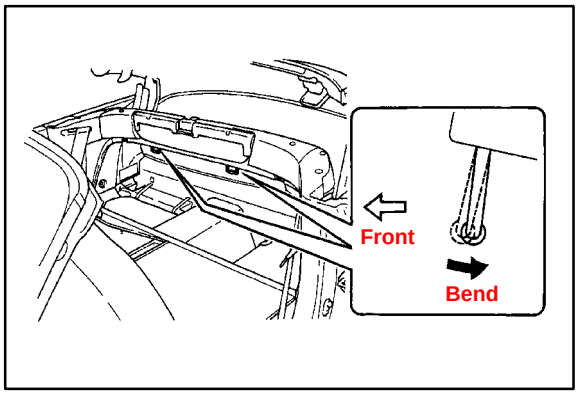
Luggage Compartment Lid Rattle Noise

To eliminate a rattle noise from the luggage compartment lid:

1. Bend the luggage compartment lid striker approximately 3 mm rearward as shown.

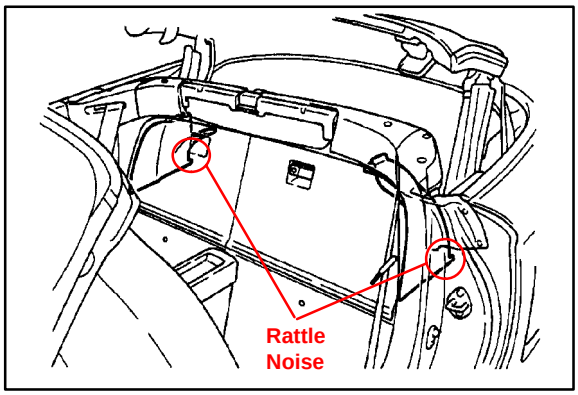
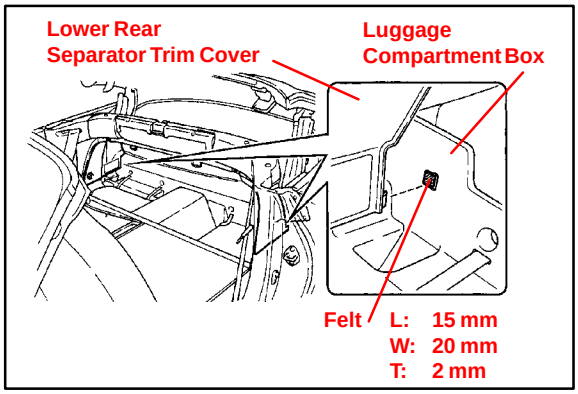
Luggage Compartment Lower Rear Separator Trim Cover Rattle Noise

To eliminate a rattle noise from the luggage compartment lower rear separator trim cover:

1. Cut two (2) pieces of felt in the following dimensions:

2. Install felt in the positions shown.

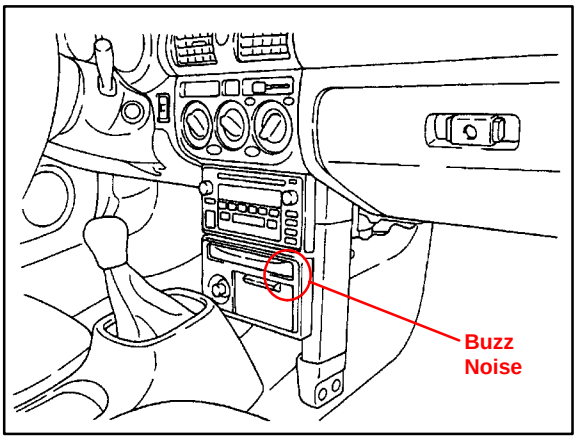
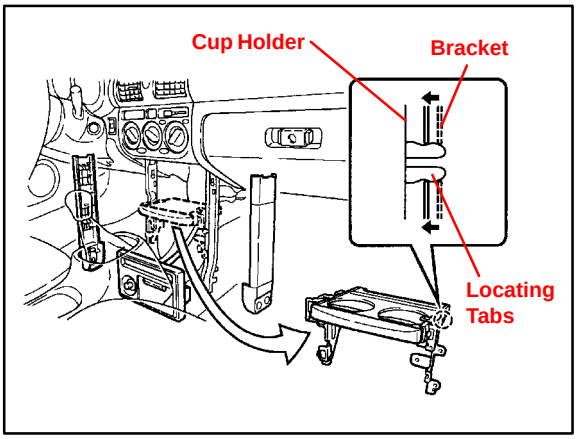
Cup Holder Buzz Noise

To eliminate a buzz noise from the cup holder area:

1. Remove cup holder assembly (refer to the 2000 MR2 Spyder Repair Manual, page BO–42).
2. Reposition cup holder brackets as shown.

It may be necessary to spread the locating tabs slightly for tighter fit.

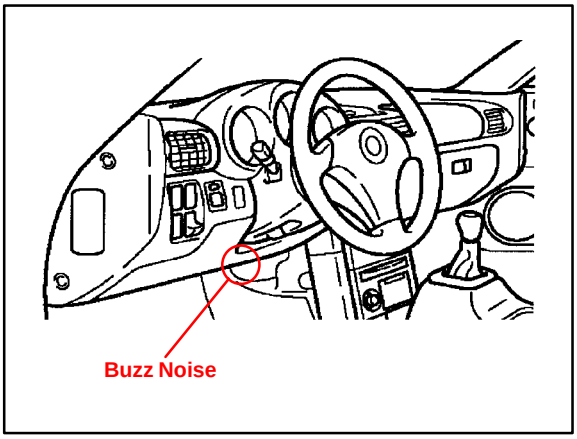
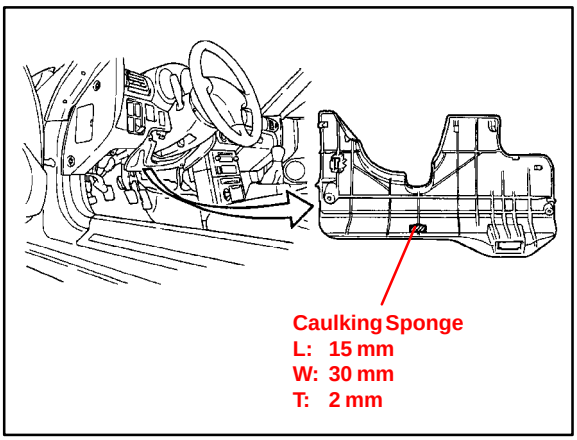
Instrument Panel Lower Finish Panel Buzz Noise

To eliminate a buzz noise from the No. 1 lower finish panel area:

1. Remove the No. 1 lower finish panel.
2. Cut a piece of EPT Sealer (caulking sponge) in the following dimensions:

3. Install EPT Sealer (caulking sponge) in the position shown.
4. Reassemble in the reverse order of disassembly.

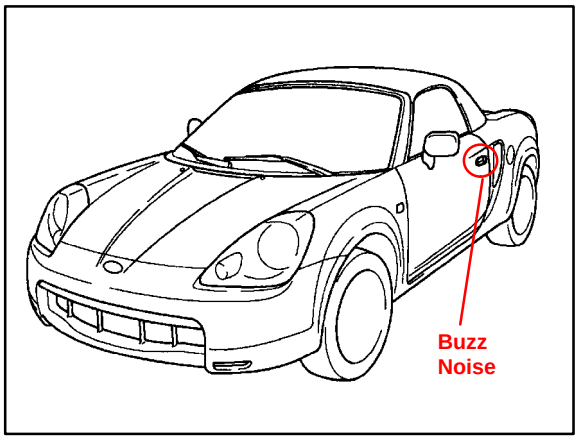
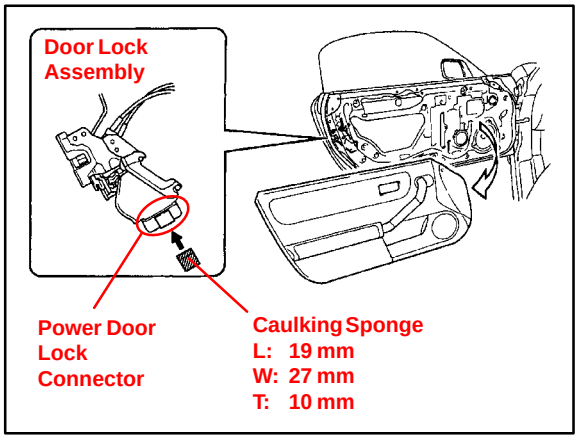
Outside Door Handle Area Buzz Noise

To eliminate a buzz noise near the outside door handle area:

1. Remove the door trim panel (refer to the 2000 MR2 Spyder Repair Manual, pages BO–12 to BO–13).
2. Cut a piece of EPT Sealer (caulking sponge) in the following dimensions:

3. Install EPT Sealer (caulking sponge) on the power door lock connector in the position shown.
4. Reassemble in the reverse order of disassembly.
