APPLICATION STORIES

Machinery Involved: Induction Bonding Press

Simplicity Part Used: DDS-48 mount with FL 48 D

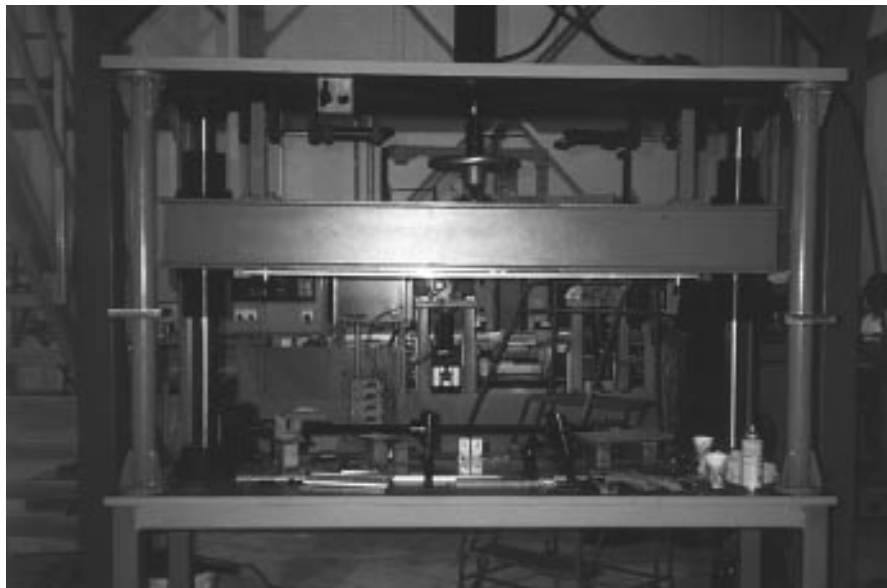
Description of Environment: Hydraulic press, induction heat on Platen

Solution: DDS mounts were used without lubrication. They tolerated heat and prevented contamination.
